**ALASKA DEPARTMENT OF TRANSPORTATION**

**Evaluation of Bioengineered Stream Bank  
Stabilization in Alaska**

**Date** June 2003

FHWA-AK-RD-03-03

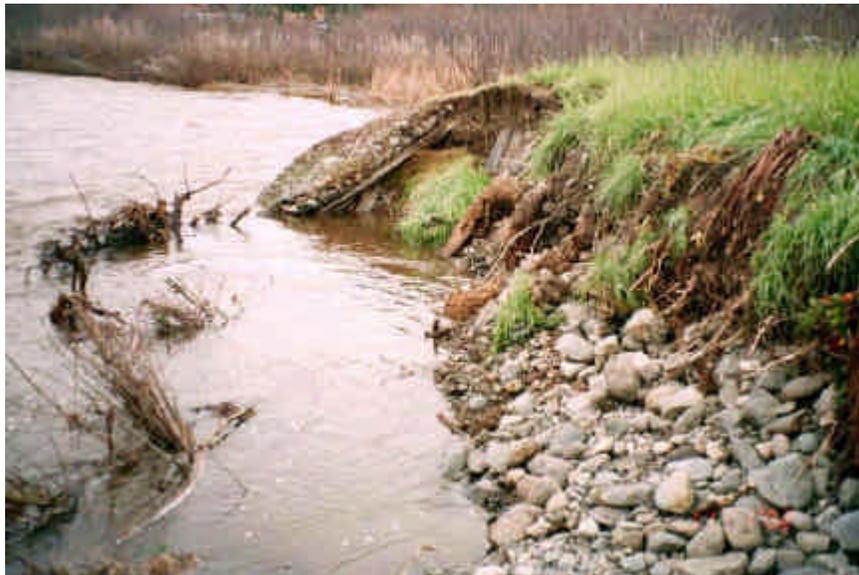
Figure 4. Looking upstream at the failed root wad/brush layering section at Anchor River-Steelhead Campground.

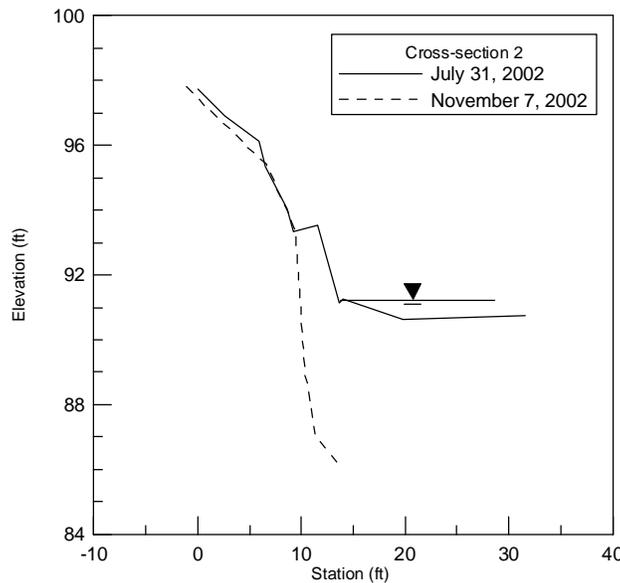
A cross-section was surveyed through the BECS at this site, before and after the late October flood (Figure 5). The cross-section indicates significant scour at the toe of the bank and adjacent channel. The shear stress analysis is corroborated by the pre- and post-flood cross-section survey. The mechanism for failure of the BECS at this site appeared to be the erosion of the channel bed and bank toe at the BECS location.

Figure 5. Left bank at Anchor River-Steelhead Campground BECS, before and after passage of the October 2002 flood event.

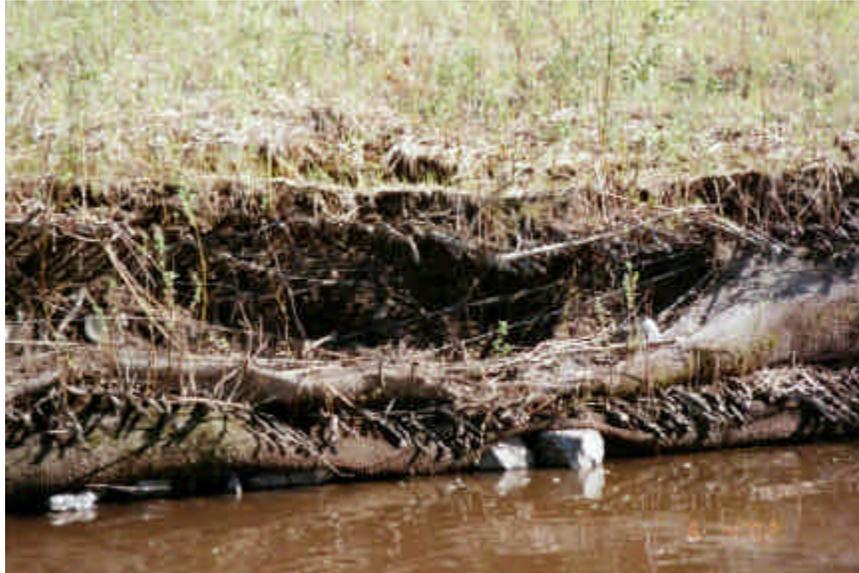
layer, rather than the silt layer itself (Robert Burrows, USGS hydrologist, oral commun., 2003). As such, the critical shear stress estimation may not be valid.

Figure 6. Failed FESL at Chena River-Doyon Estates.

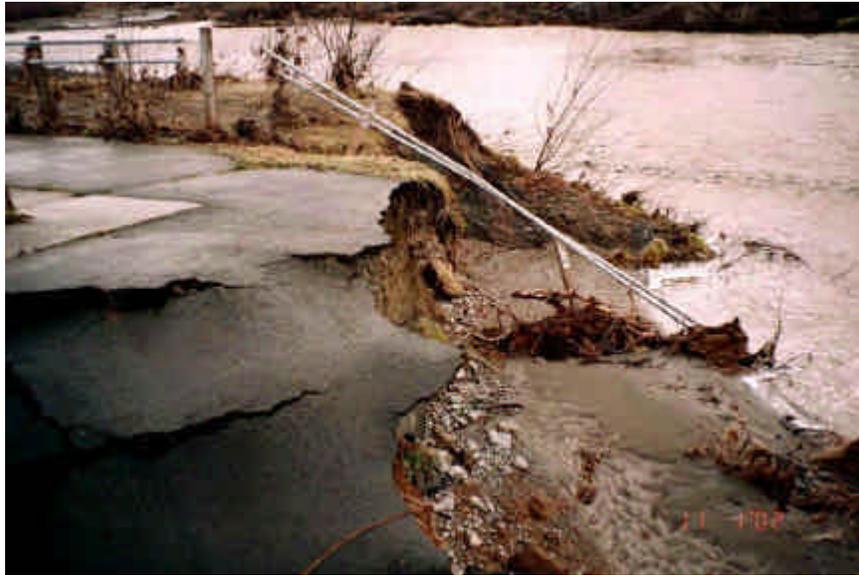
Figure 7. Failed bank at downstream end of Deep Creek BECS.

As mentioned, the mode of failure at the lower section was most likely not related to toe failure from channel erosion. A layer of large diameter armor stone was used to protect the toe of the structure. The entire bank was overtopped by the October flood, to a depth of several feet, and the downstream structure was probably subject to erosion from a strong back eddy. This section of bank was almost vertical, and was much steeper than adjacent sections upstream. In addition, gravel and soil in the lifts were most likely removed from the front of the structure through the holes in the wrap material. The material used for the soil lifts on this project differed from other projects, which commonly use 2 layers of biodegradable fabric wrap. The brush layering soil wraps were constructed using a geosynthetic grid material, rather than a traditional ‘coir fiber’ material (Figure 8). Geogrids are net-shaped synthetic polymer-coated fibers that are normally used to reinforce earth-fill slope, wall and base layer construction. Geogrid is not a filter material, and will not retain soil particles smaller than the open gridding spaces. A burlap fabric used inside the geogrid at the front face to contain the fines had deteriorated completely, which most likely allowed material to be eroded out from the soil lifts.

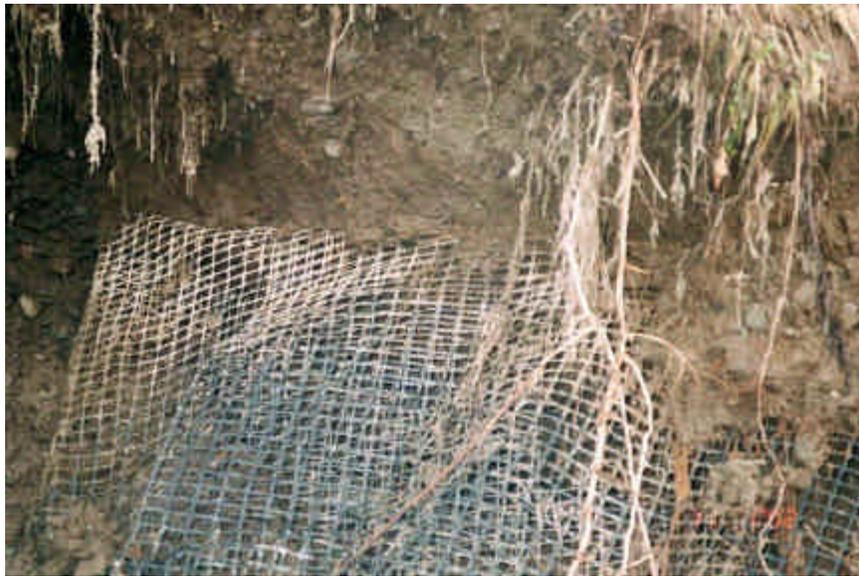
Figure 8. Geogrid used at Deep Creek.

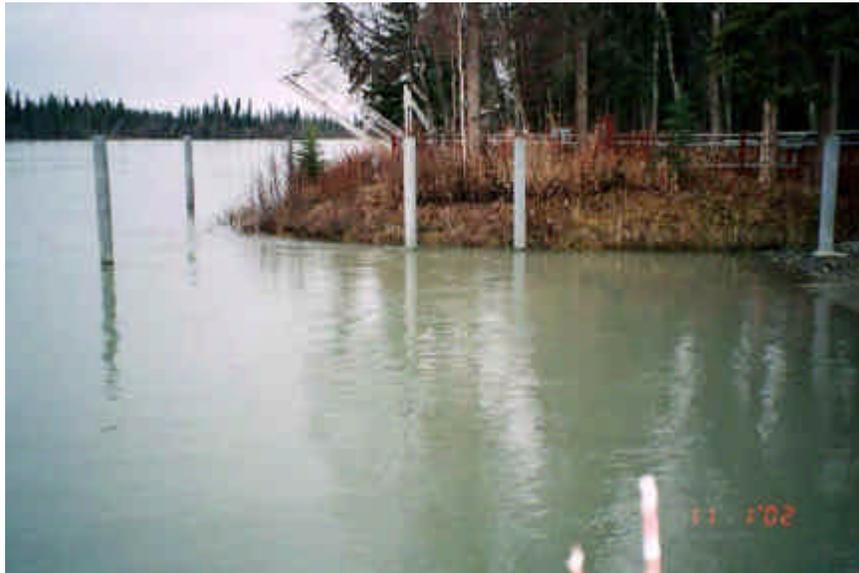
Other sites inspected included a root wad-protected culvert road crossing on Slikok Creek in Soldotna, and a coir log/grass roll site on the Kasilof River at the Crooked Creek State Recreation Site. High water had receded somewhat at both sites. Flow velocities were not measured, though they appeared to be slow. Both structures were in excellent condition.

Figure 11. Pillars State Park BECS.

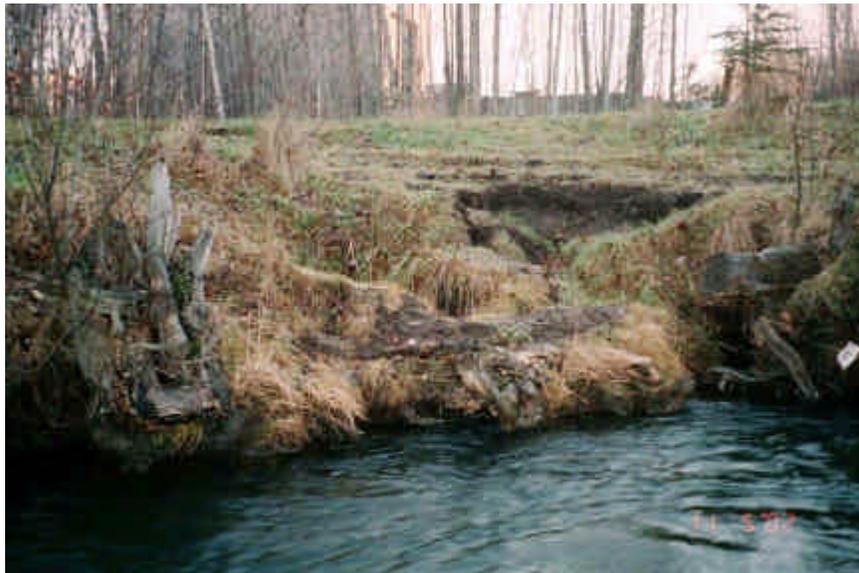
During the course of this study, three study sites suffered partial or complete failure from erosion of the bank toe which supported the BECS. These three sites were identified in the shear stress analysis as having a high potential for erosion from bed and bank shear stresses. The two Anchor River sites were subjected to extremely large flooding conditions in October and November 2002. Cross-sections surveyed before and after the October flood showed extensive toe erosion which led to the failure of the BECSs. The Campbell Creek-Taku Park site suffered not only from bank toe erosion, but from removal of bank material behind the root wad fans (Figure 12). The inner bank material erosion was most likely due to the lack of a liner material or coir log behind the root fans. Once toe erosion removed the material around the root wad fans, the inner bank material was easily eroded by the flowing water. Techniques utilized on more recent root wad installations are designed to alleviate this type of erosion; such techniques include embedding root wads in large gravel and cobble base, and using fabric encapsulated soil lifts constructed on top of the root wad base.

Figure 12. Failed bank at Campbell Creek-Taku Park.

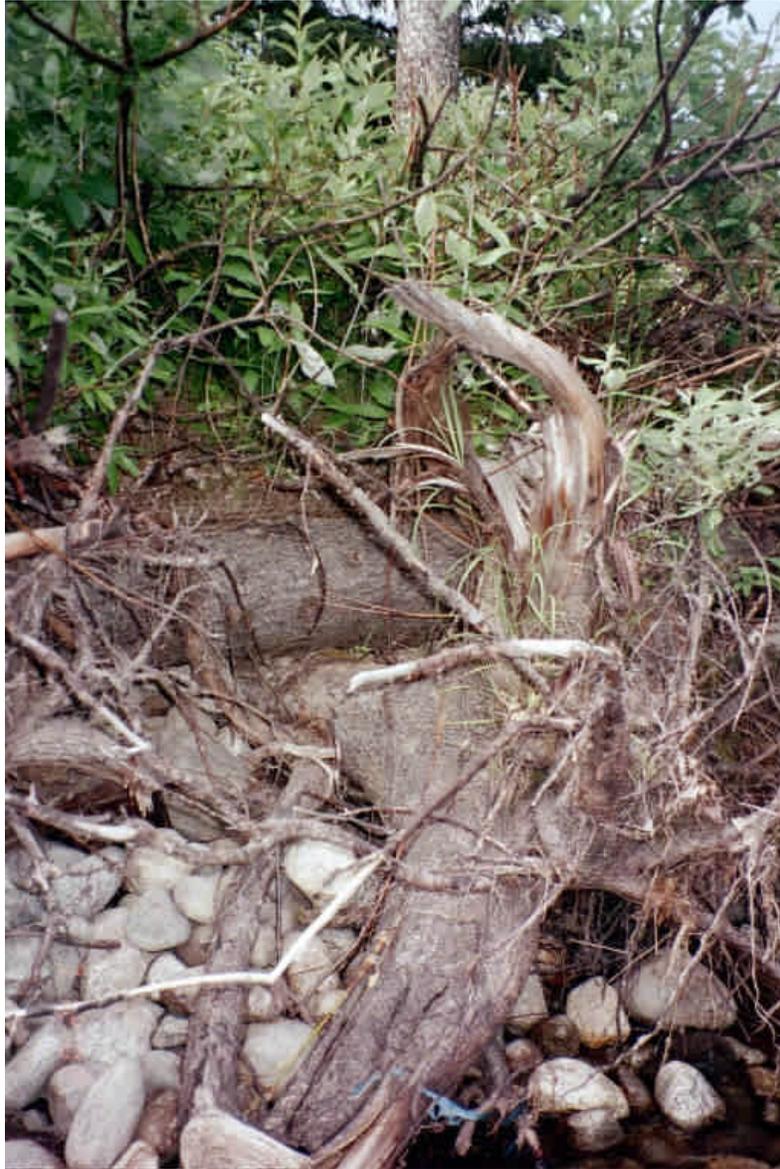
In high shear stress channels, these design features appear to be insufficient protection against erosion. Root fans, by their nature, are non-geometric in shape, which results in large gaps between the root masses after placement. Such gaps were readily apparent in several of the root wad structures in the study. Either bank material or a face of the sorted rocks used as bedding for the root boles was visible along much of the root fan face (Figure 13). In a channel reach with high tractive forces, unprotected bank material will be subject to transport forces.

Figure 13. Poorly embedded root fans with large gaps in lateral coverage at Willow Creek-Lapham.

- Design improvements are needed to protect the foundations of BECSs from large tractive forces. In particular, techniques should be developed for root wad structures. Current methodology relies on an embedded root fan to provide toe scour protection. New techniques should focus on providing flexible, self-healing, seamless, and substantial toe protection capabilities, based on design flood criteria.
