# Wetlands and Waters Delineation Report

Marshall Airport and Access Road Improvements

November 14, 2022

Alaska Department of Transportation and Public Facilities

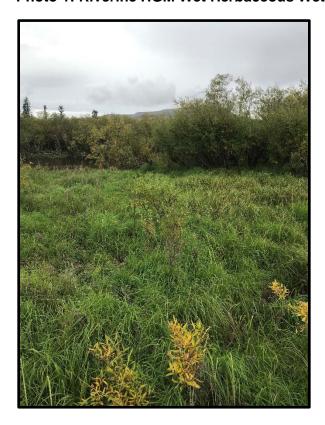
Photo 1: Riverine HGM Wet Herbaceous Wetland

Riverine wetlands in the study area occur within the floodplains of Wilson Creek and Hungry Creek (Photo 1).

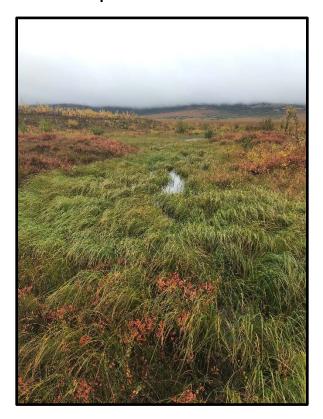
**Photo 2: Slope HGM Wetland**

Slope wetlands account for the majority of wetlands found within the study area, receiving groundwater output from the hills to the north (Photo 2).

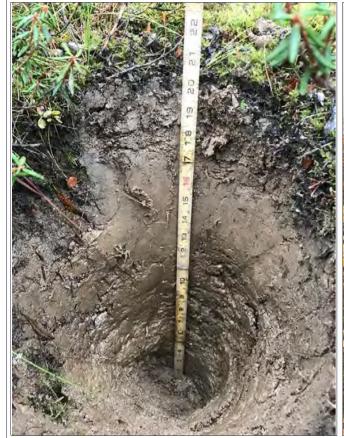
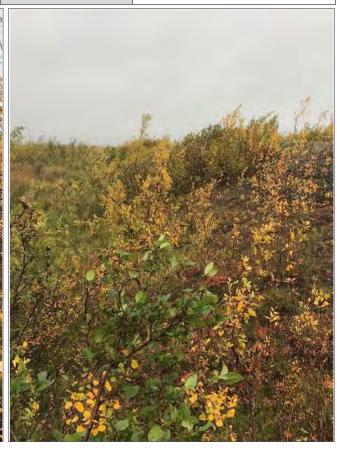
Plot Number	HDR500	Wetland Status	Upland	Vegetation Type	Deciduous Shrub and Sapling Regrowth	
Plot Type	WD: Wetland Determination	NWI Classification	U	Latitude (DD)	61.86426	
Plot Date	9/11/2022	ндм	N/A	Longitude (DD)	-162.01722

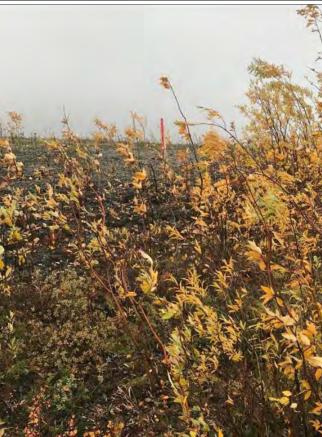
Photo Type: Soils

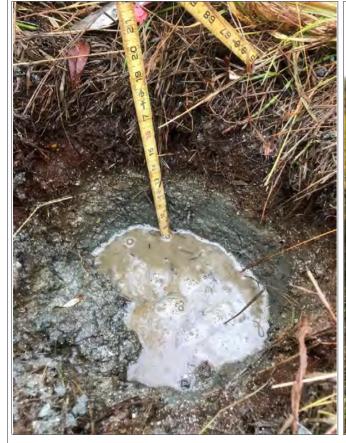
Plot Number	HDR501	Wetland Status	Wetland	Vegetation Type	Wet Herbaceous
Plot Type	WD: Wetland Determination	NWI Classification	PEM1C	Latitude (DD)	61.86422
Plot Date	9/11/2022	ндм	Slope	Longitude (DD)	-162.01711

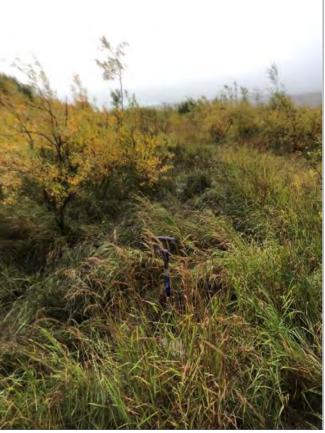
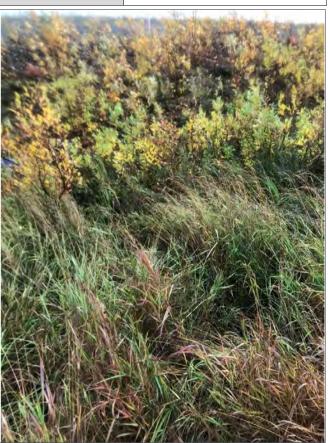
Photo Type: Soils

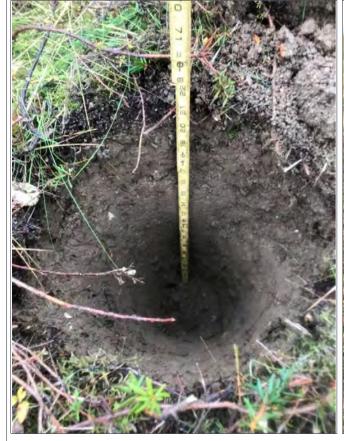
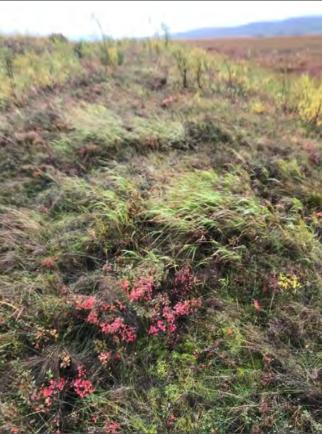
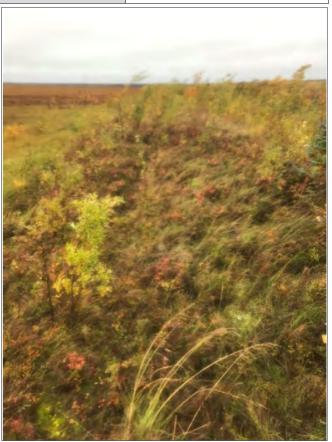
Plot Number	HDR502	Wetland Status	Upland	Vegetation Type	Deciduous Shrub and Sapling Regrowth
Plot Type	WD: Wetland Determination	NWI Classification	U	Latitude (DD)	61.86419
Plot Date	9/11/2022	ндм	N/A	Longitude (DD)	-162.01712

Photo Type: Soils

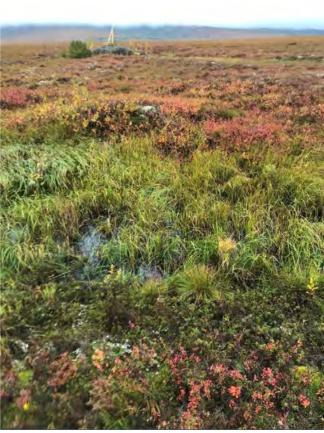
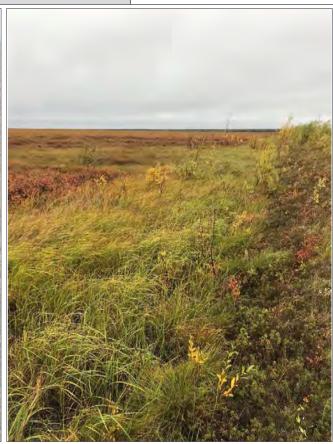
Plot Number	HDR503	Wetland Status	Wetland	Vegetation Type	Wet Herbaceous
Plot Type	FVP: Field Verification Point	NWI Classification	PEM1F	Latitude (DD)	61.86408
Plot Date	9/11/2022	ндм	Slope	Longitude (DD)	-162.01728

Photo Type: Vegetation

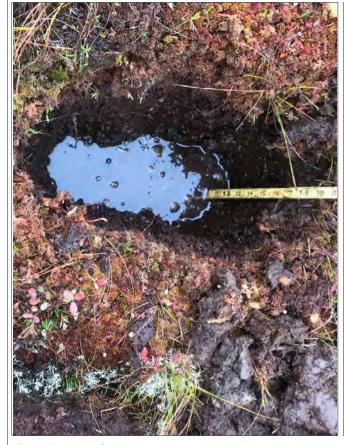
Plot Number	HDR504	Wetland Status	Wetland	Vegetation Type	Open Mixed Shrub Sedge Tundra
Plot Type	WD: Wetland Determination	NWI Classification	PSS3/EM1B	Latitude (DD)	61.86395
Plot Date	9/11/2022	ндм	Slope	Longitude (DD)	-162.01692

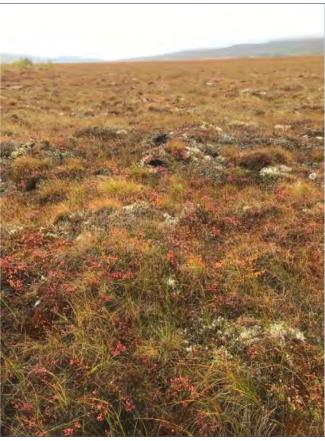
Photo Type: Soils

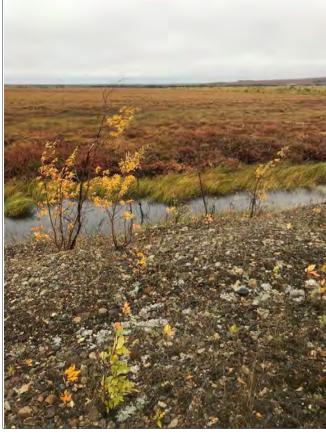
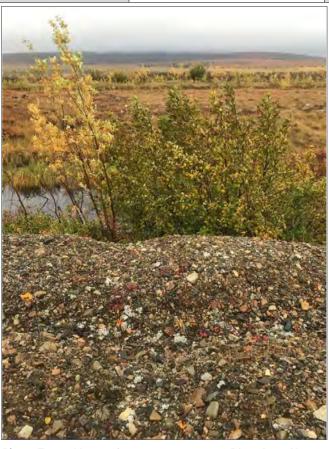
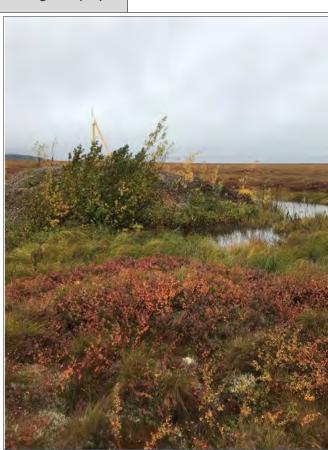
Plot Number	HDR505	Wetland Status	Upland	Vegetation Type	Bare Ground (Disturbed)
Plot Type	FVP: Field Verification Point	NWI Classification	U	Latitude (DD)	61.8636
Plot Date	9/11/2022	ндм	N/A	Longitude (DD)	-162.0167

Photo Type: Hydrology

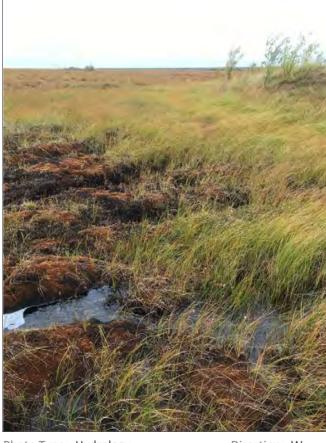
Plot Number	HDR506	Wetland Status	Wetland	Vegetation Type	Wet Herbaceous
Plot Type	FVP: Field Verification Point	NWI Classification	PEM1F	Latitude (DD)	61.86425
Plot Date	9/11/2022	ндм	Slope	Longitude (DD)	-162.01466

Photo Type: Hydrology

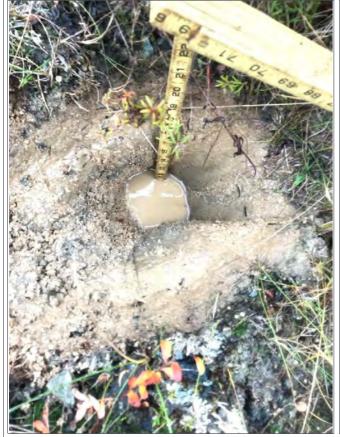
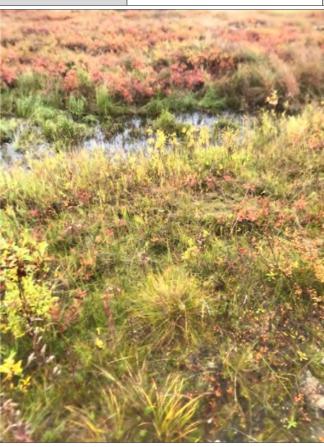
Plot Number	HDR507	Wetland Status	Upland	Vegetation Type	Deciduous Shrub and Sapling Regrowth
Plot Type	WD: Wetland Determination	NWI Classification	U	Latitude (DD)	61.86467
Plot Date	9/11/2022	ндм	N/A	Longitude (DD)	-162.02133

Photo Type: Soils Direction: NA

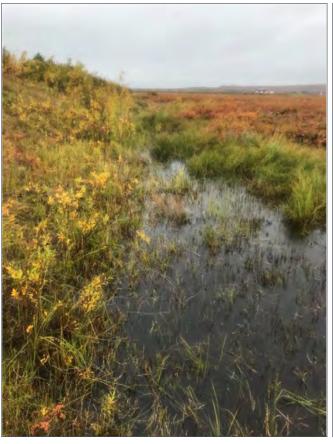
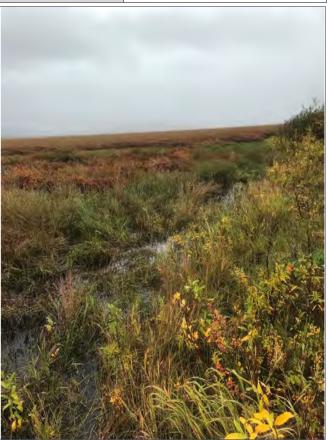
Plot Number	HDR508	Wetland Status	Wetland	Vegetation Type	Wet Herbaceous
Plot Type	FVP: Field Verification Point	NWI Classification	PEM1F	Latitude (DD)	61.86472
Plot Date	9/11/2022	ндм	Slope	Longitude (DD)	-162.02133

Photo Type: Hydrology

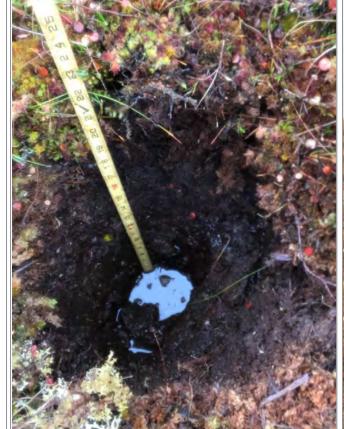
Plot Number	HDR509	Wetland Status	Wetland	Vegetation Type	Open Mixed Shrub Sedge Tundra	
Plot Type	WD: Wetland Determination	NWI Classification	PSS1/EM1B	Latitude (DD)	61.86484	
Plot Date	9/11/2022	ндм	Slope	Longitude (DD)	-162.02171

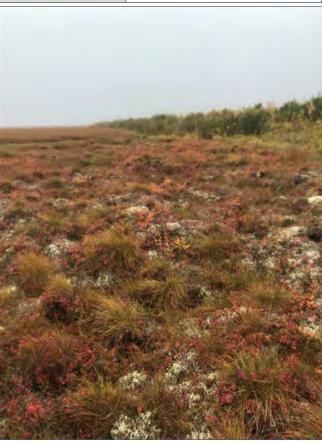
Photo Type: Soils

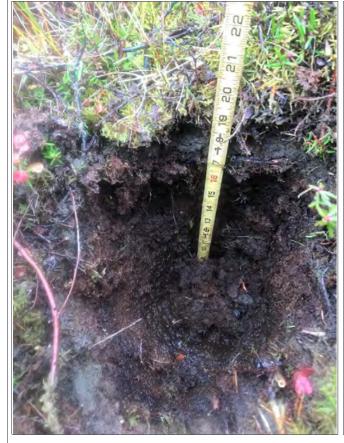
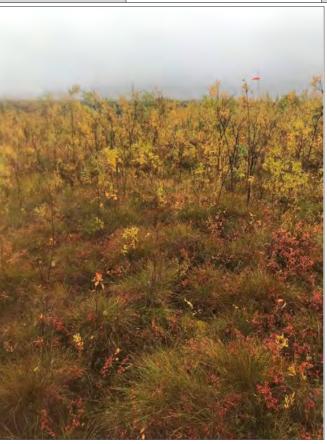
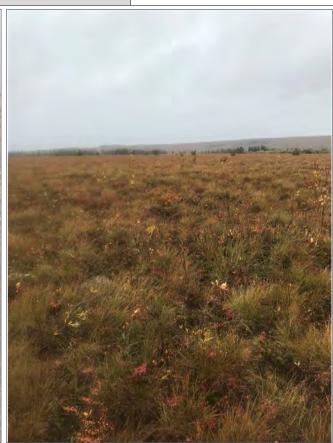
Plot Number	HDR510	Wetland Status	Wetland	Vegetation Type	Open Mixed Shrub Sedge Tundra
Plot Type		WD: Wetland Determination	NWI Classification	PSS1/EM1B	Latitude (DD)	61.86563
	Plot Date	9/11/2022	ндм	Slope	Longitude (DD)	-162.03417

Photo Type: Soils

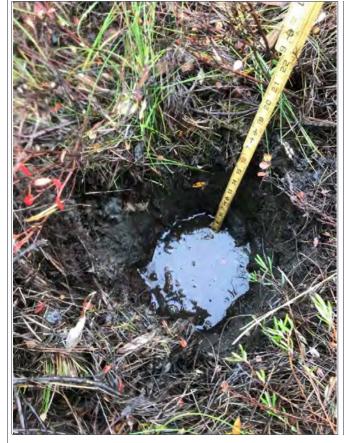
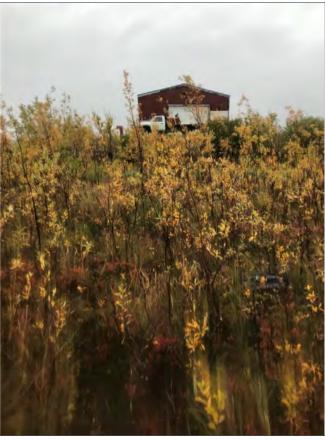
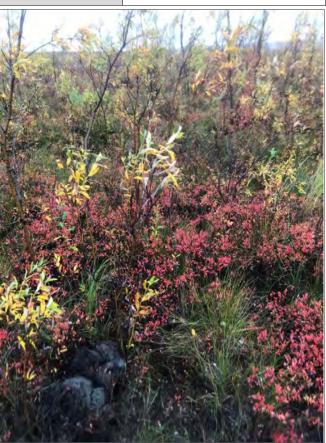
Plo	t Number	HDR511	Wetland Status	Wetland	Vegetation Type	Shrub Birch Willow
Pl	lot Type	WD: Wetland Determination	NWI Classification	PSS1/EM1C	Latitude (DD)	61.86566
P	lot Date	9/11/2022	ндм	Slope	Longitude (DD)	-162.03367

Photo Type: Soils

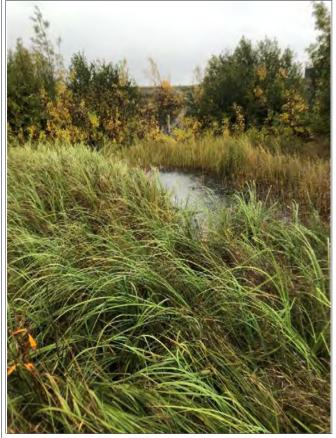
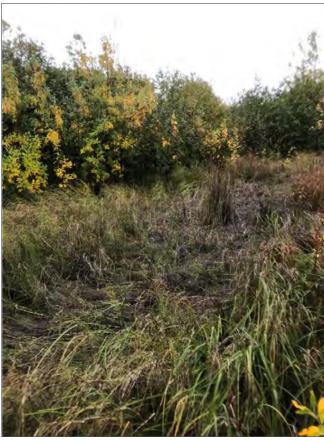
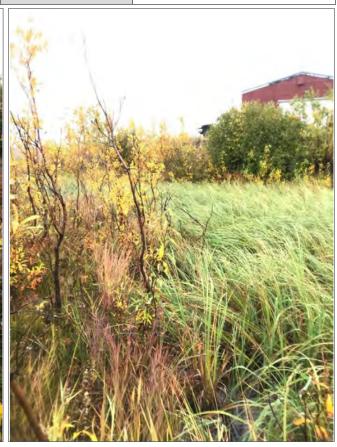
Plot Number	HDR512	Wetland Status	Wetland	Vegetation Type	Wet Herbaceous
Plot Type	FVP: Field Verification Point	NWI Classification	PEM1F	Latitude (DD)	61.86577
Plot Date	9/11/2022	ндм	Slope	Longitude (DD)	-162.03352

Photo Type: Hydrology

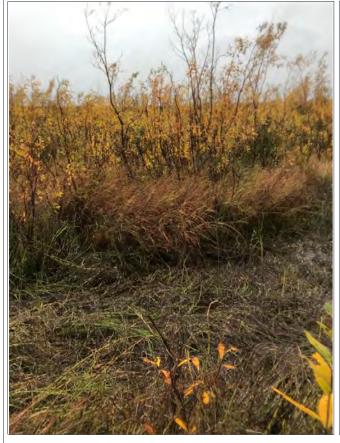
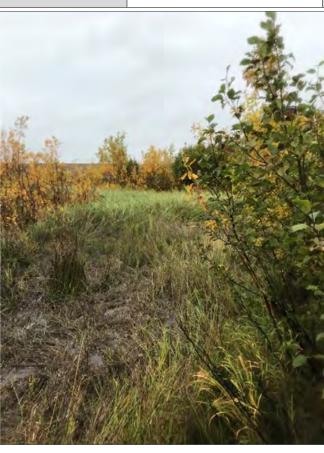
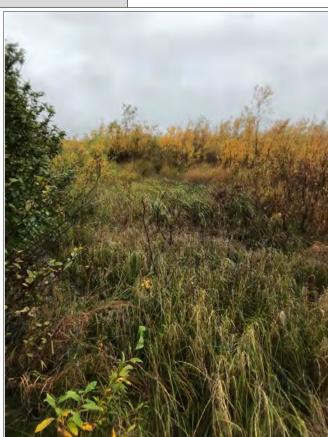
Plot Number	HDR513	Wetland Status	Upland	Vegetation Type	Closed Tall Alder Willow Shrub
Plot Type	FVP: Field Verification Point	NWI Classification	U	Latitude (DD)	61.86571
Plot Date	9/11/2022	ндм	N/A	Longitude (DD)	-162.03333

Photo Type: Soils

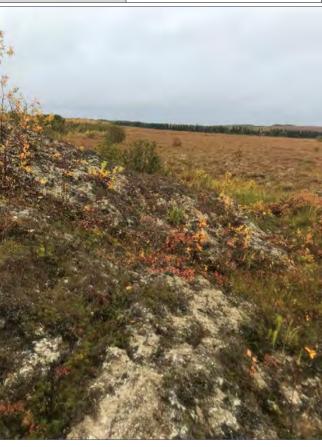
Plot Number	HDR514	Wetland Status	Upland	Vegetation Type	Deciduous Shrub and Sapling Regrowth
Plot Type	FVP: Field Verification Point	NWI Classification	U	Latitude (DD)	61.86431
Plot Date	9/11/2022	ндм	N/A	Longitude (DD)	-162.03323

Photo Type: Vegetation Direction: W Photo Type: Direction:

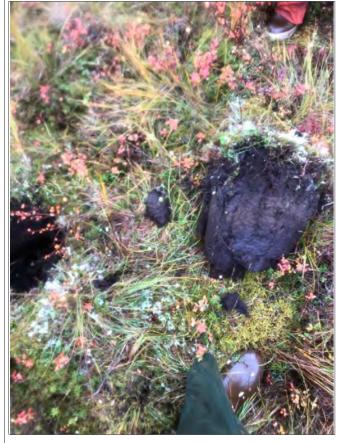
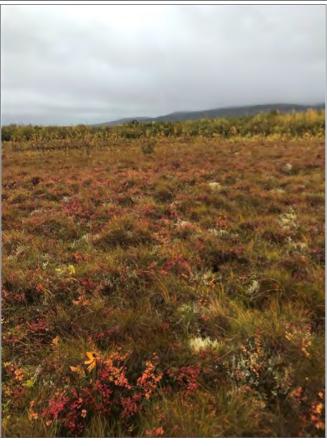
Plot Number	HDR515	Wetland Status	Wetland	Vegetation Type	Open Mixed Shrub Sedge Tundra
Plot Type	FVP: Field Verification Point	NWI Classification	PSS1/EM1B	Latitude (DD)	61.86438
Plot Date	9/11/2022	ндм	Slope	Longitude (DD)	-162.03321

Photo Type: Soils

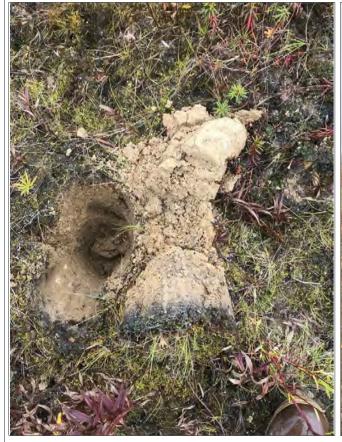
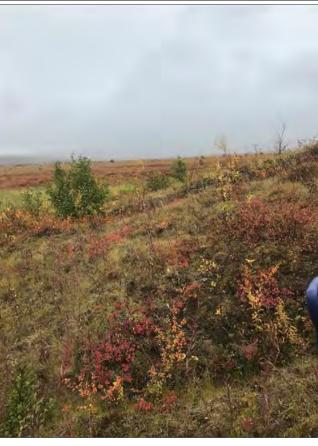
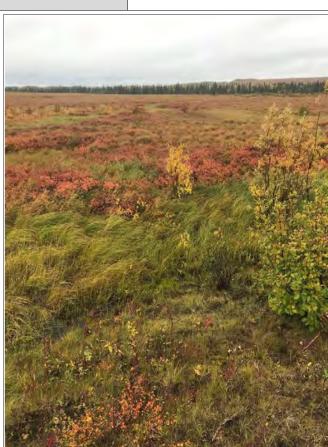
Plot Number	HDR516	Wetland Status	Upland	Vegetation Type	Deciduous Shrub and Sapling Regrowth
Plot Type	FVP: Field Verification Point	NWI Classification	U	Latitude (DD)	61.86386
Plot Date	9/11/2022	НСМ	N/A	Longitude (DD)	-162.0373

Photo Type: Soils Direction: NA Photo Type: Vegetation Direction: N Photo Type: Vegetation Direction: W

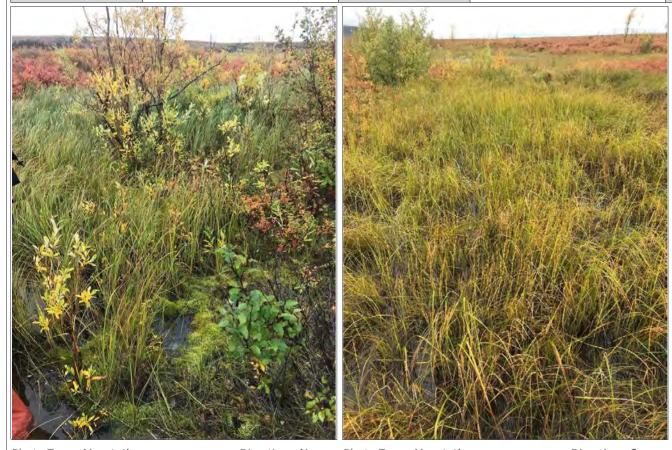
Plot Number	HDR517	Wetland Status	Wetland	Vegetation Type	Wet Herbaceous
Plot Type	FVP: Field Verification Point	NWI Classification	PEM1F	Latitude (DD)	61.86383
Plot Date	9/11/2022	ндм	Slope	Longitude (DD)	-162.03741

Photo Type: Vegetation Direction: N Photo Type: Vegetation Direction: S Photo Type: Direction:

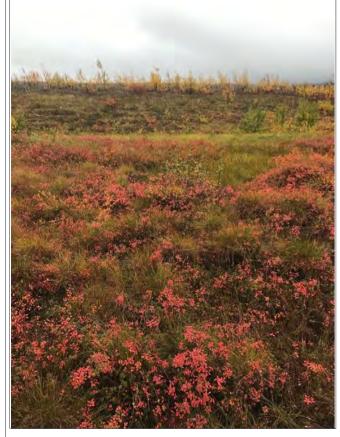
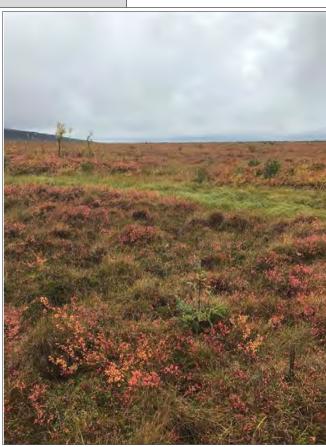
Plot Number	HDR518	Wetland Status	Wetland	Vegetation Type	Open Mixed Shrub Sedge Tundra
Plot Type	FVP: Field Verification Point	NWI Classification	PSS1/EM1B	Latitude (DD)	61.86381
Plot Date	9/11/2022	ндм	Slope	Longitude (DD)	-162.03776

Photo Type: Vegetation

Direction: E

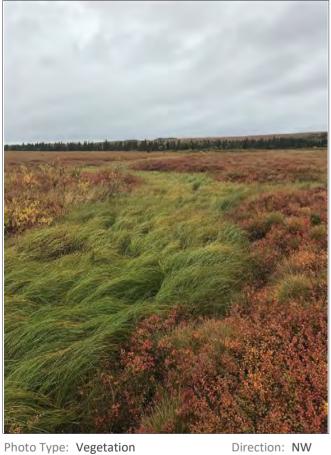
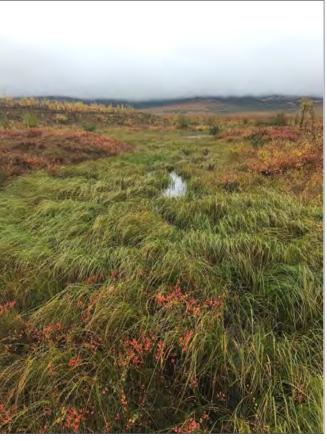
Plot Number	HDR519	Wetland Status	Wetland	Vegetation Type	Wet Herbaceous
Plot Type	FVP: Field Verification Point	NWI Classification	PEM1F	Latitude (DD)	61.86383
Plot Date	9/11/2022	ндм	Slope	Longitude (DD)	-162.03805

Photo Type: Vegetation Direction: SE Photo Type: Direction:

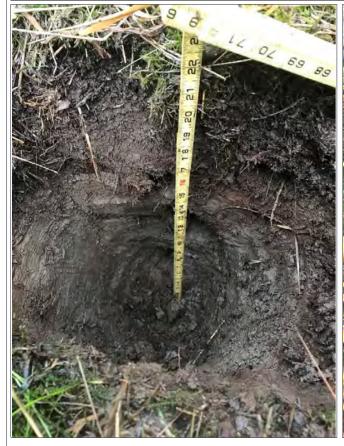
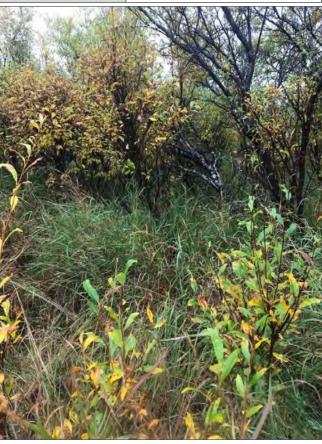
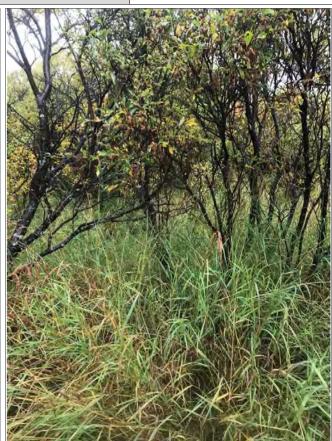
Plot Number	HDR520	Wetland Status	Upland	Vegetation Type	Open Tall Willow Shrub
Plot Type	WD: Wetland Determination	NWI Classification	U	Latitude (DD)	61.87159
Plot Date	9/11/2022	ндм	N/A	Longitude (DD)	-162.03853

Photo Type: Soils

Direction: NA

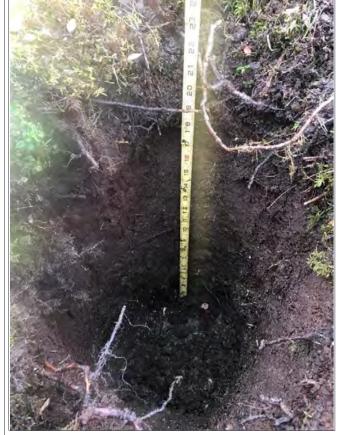
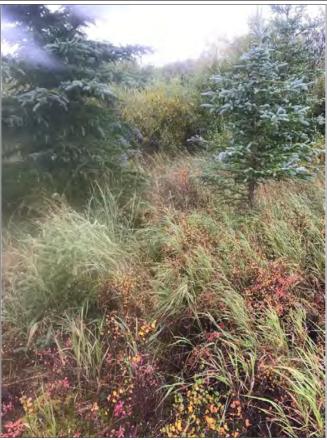
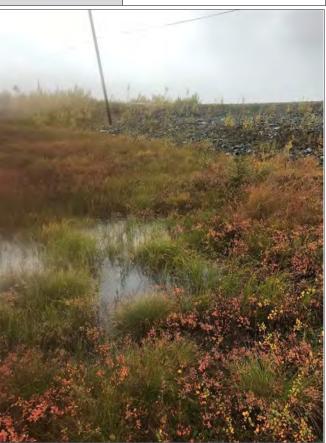
Plot Number	Number HDR521 Wetland Status Wetland		Vegetation Type	Open Mixed Shrub Sedge Tundra	
Plot Type WD: Wetland Determination		NWI Classification	PSS1/EM1B	Latitude (DD)	61.87136
Plot Date	Plot Date 9/11/2022		Slope	Longitude (DD)	-162.03828

Photo Type: Soils

Direction: NA

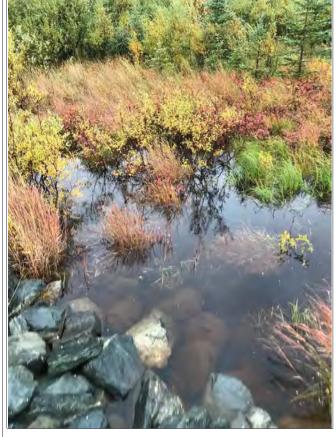
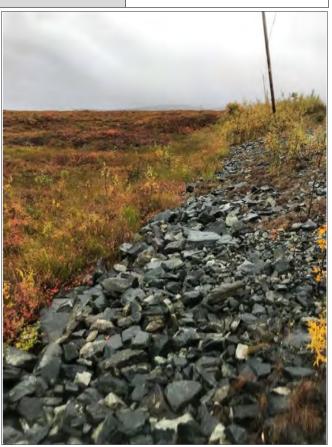
Plot Number	HDR522 Wetland Status Upland		Vegetation Type	Bare Ground (Disturbed)	
Plot Type FVP: Field Verification Point		NWI Classification	U	Latitude (DD)	61.87131
Plot Date	<b>Plot Date</b> 9/11/2022		N/A	Longitude (DD)	-162.03851

Photo Type: Hydrology

Direction: NA

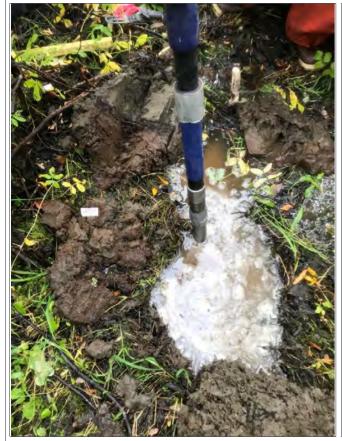
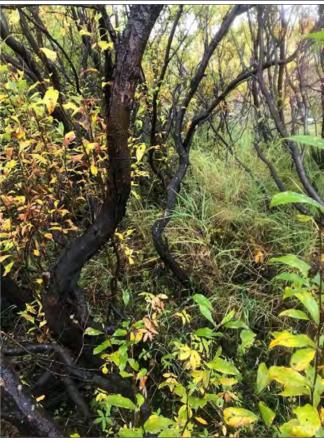
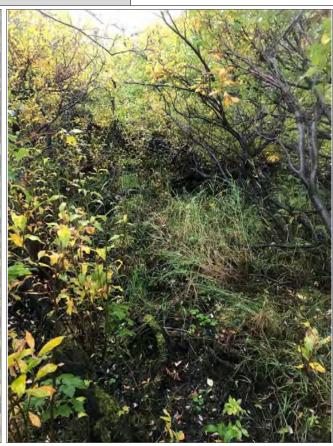
Plot Number	HDR523	Wetland Status	Wetland	Vegetation Type	Open Tall Willow Shrub
Plot Type	Plot Type WD: Wetland Determination NWI Plot Date 9/12/2022		PSS1/EM1C	Latitude (DD)	61.87124
Plot Date			Riverine	Longitude (DD)	-162.03917

Direction: W

Photo Type: Soils Direction: NA Photo Type: Vegetation Direction: N Photo Type: Vegetation

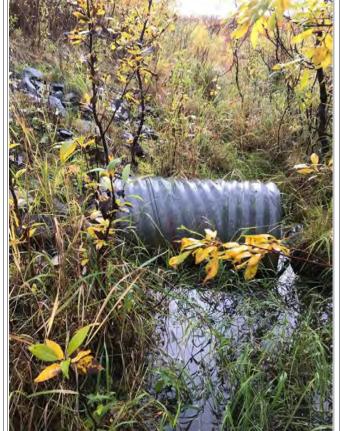
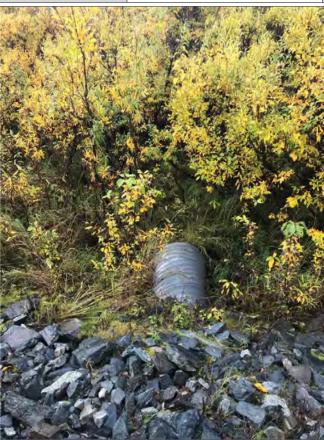
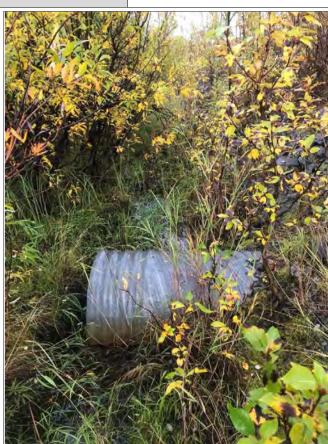
Plot Number	HDR524	Wetland Status Upland		Vegetation Type	Open Tall Willow Shrub
Plot Type	FVP: Field Verification Point	NWI Classification	U	Latitude (DD)	61.87127
Plot Date	9/12/2022	ндм	N/A	Longitude (DD)	-162.03904

Photo Type: Hydrology

Direction: NW

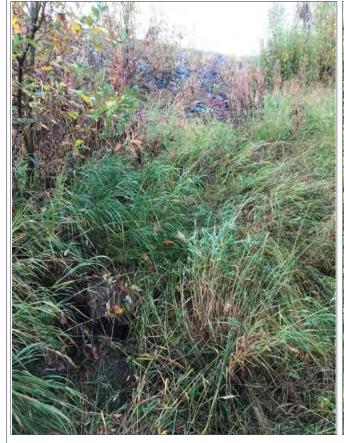
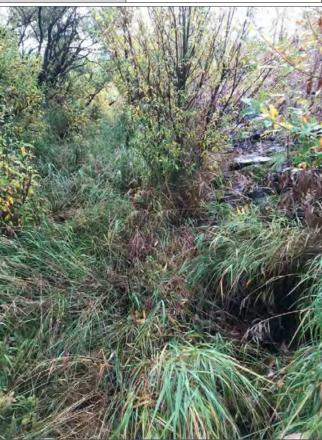
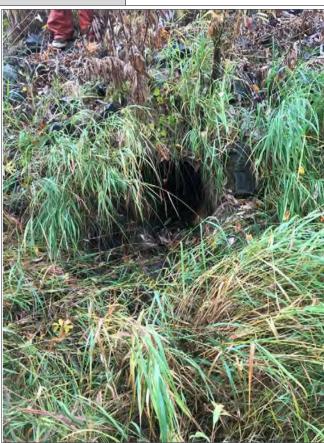
Plot Number	HDR525 Wetland Status Upland Vegetation				Open Tall Willow Shrub
Plot Type FVP: Field Verification Point		NWI Classification	U	Latitude (DD)	61.87143
Plot Date	Plot Date 9/12/2022		N/A	Longitude (DD)	-162.03874

Photo Type: Vegetation

Direction: NW

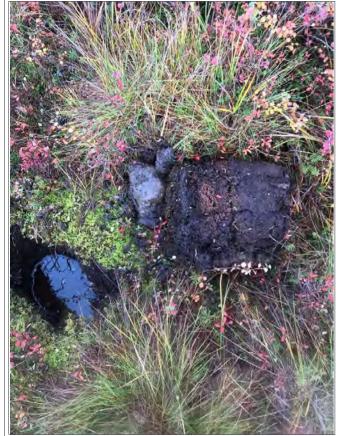
Plot Number	HDR526 Wetland Status Wetland		Vegetation Type	Open Mixed Shrub Sedge Tundra	
	Plot Type	FVP: Field Verification Point	NWI Classification	PSS1/EM1B	Latitude (DD)	61.8711
Plot Date		9/12/2022	НСМ	Slope	Longitude (DD)	-162.03897

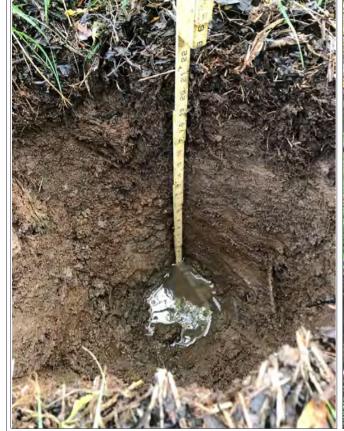
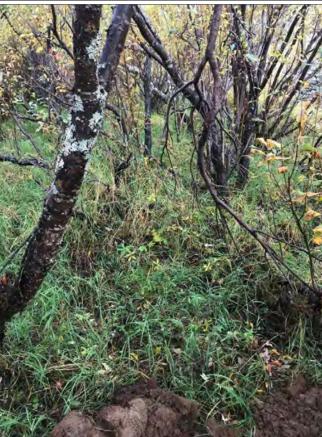
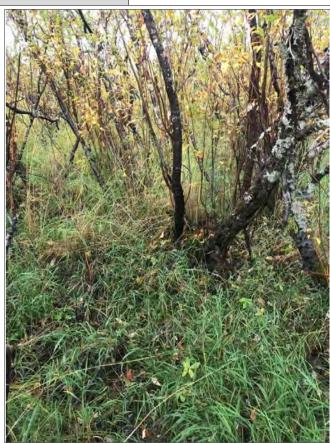
Plot Number	HDR527	Wetland Status	Wetland	Vegetation Type	Open Tall Willow Shrub
Plot Type	WD: Wetland Determination	NWI Classification	PSS1/EM1C	Latitude (DD)	61.87158
Plot Date	9/12/2022	ндм	Riverine	Longitude (DD)	-162.03997

Photo Type: Soils Direction: NA Photo Type: Vegetation Direction: N Photo Type: Vegetation Direction: W

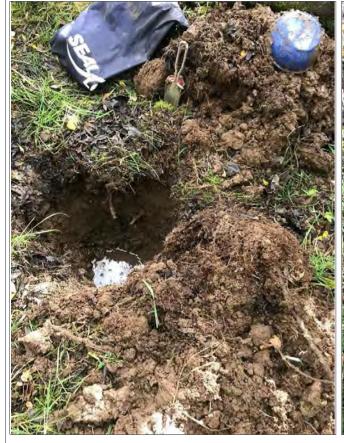
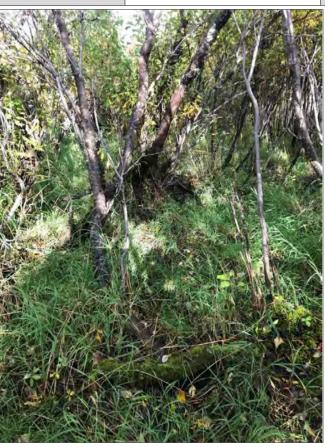
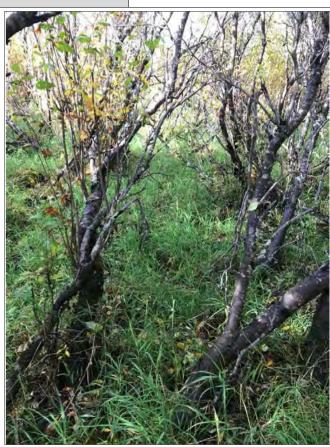
Plot Number	HDR528	Wetland Status	Wetland	Vegetation Type	Open Tall Willow Shrub
Plot Type	FVP: Field Verification Point	NWI Classification	PSS1/EM1B	Latitude (DD)	61.87214
Plot Date	9/12/2022	ндм	Riverine	Longitude (DD)	-162.04137

Photo Type: Soils

Direction: NA

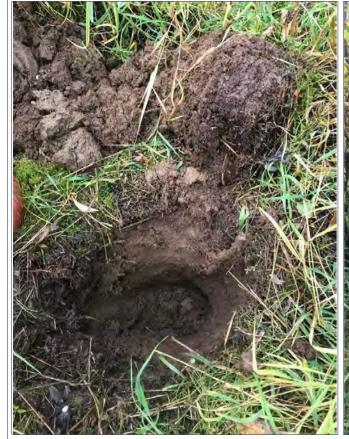
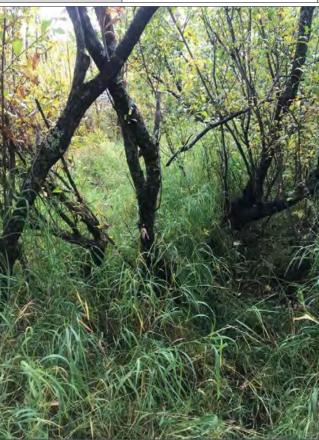
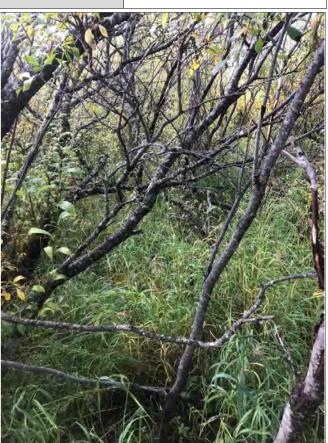
Plot Number	HDR529	Wetland Status	Wetland	Vegetation Type	Open Tall Willow Shrub
Plot Type	FVP: Field Verification Point	NWI Classification	PSS1/EM1B	Latitude (DD)	61.87264
Plot Date	9/12/2022	НСМ	Riverine	Longitude (DD)	-162.04241

Photo Type: Soils Direction: NA Photo Type: Vegetation Direction: E Photo Type: Vegetation Direction: S

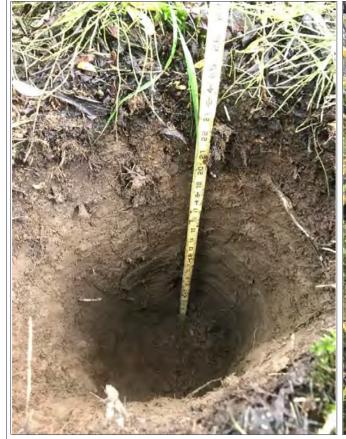
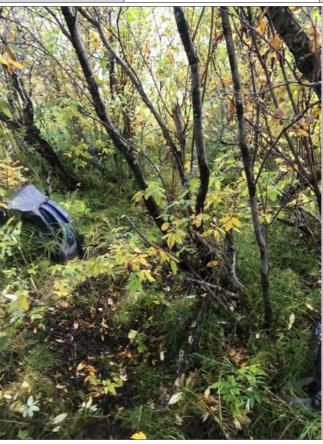
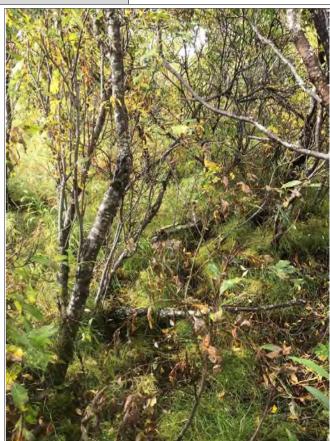
Plot Number	HDR530	Wetland Status	Upland	Vegetation Type	Open Tall Willow Shrub
Plot Type	WD: Wetland Determination	NWI Classification	U	Latitude (DD)	61.87285
Plot Date	9/12/2022	ндм	N/A	Longitude (DD)	-162.04296

Photo Type: Soils Direction: NA Photo Type: Vegetation Direction: E Photo Type: Vegetation Direction: W

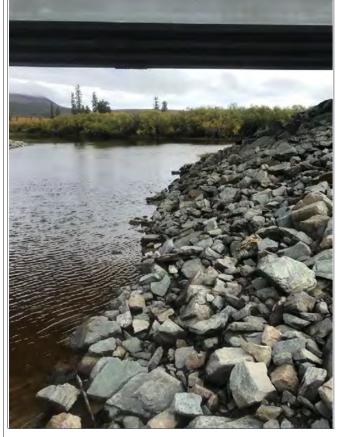
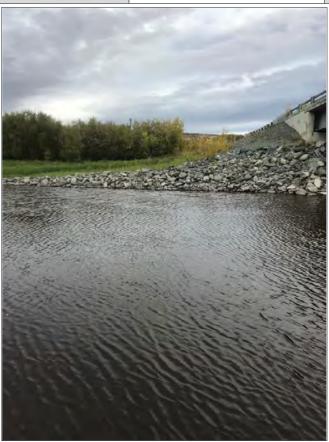
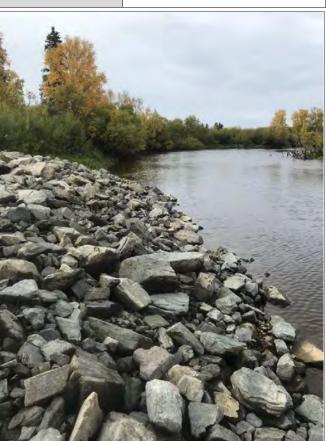
Plot Number	HDR531	Wetland Status	RPW	Vegetation Type	Open Water
Plot Type	SC: Stream Crossing	NWI Classification	R3UBH	Latitude (DD)	61.87306
Plot Date	9/12/2022	ндм	Riverine Channel	Longitude (DD)	-162.04327

Photo Type: Hydrology

Direction: NE

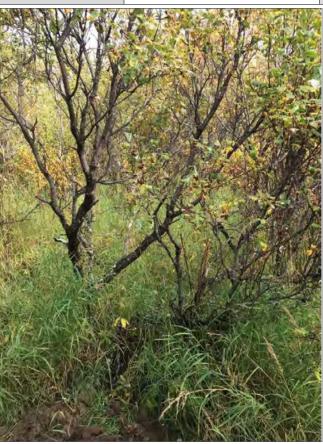
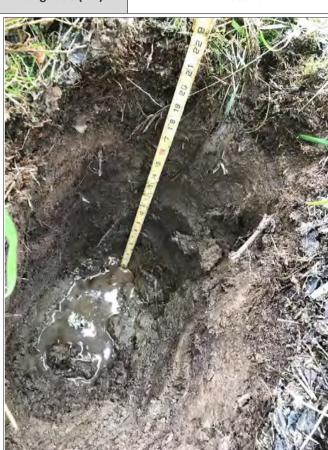
Plot Number	HDR532	Wetland Status	Wetland	Vegetation Type	Open Tall Willow Shrub
Plot Type	WD: Wetland Determination	NWI Classification	PSS1/EM1B	Latitude (DD)	61.87173
Plot Date	9/12/2022	ндм	Riverine	Longitude (DD)	-162.03923

Photo Type: Hydrology

Direction: E

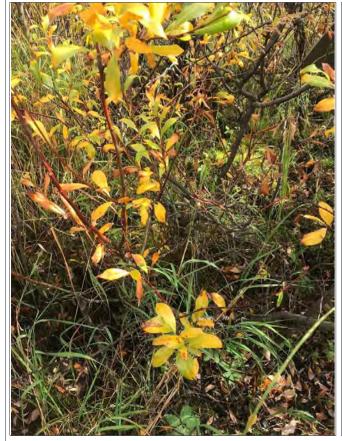
Plot Number	HDR533	Wetland Status	Wetland	Vegetation Type	Open Tall Willow Shrub
Plot Type	FVP: Field Verification Point	NWI Classification	PSS1/EM1C	Latitude (DD)	61.87195
Plot Date	9/12/2022	ндм	Riverine	Longitude (DD)	-162.03974

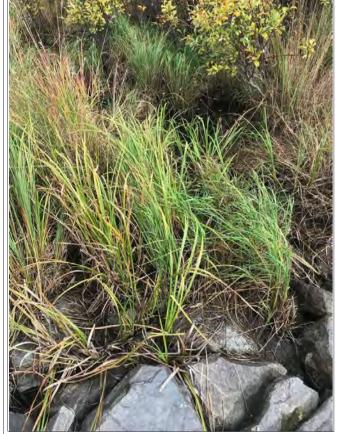
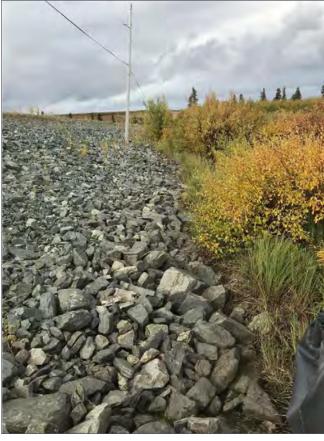
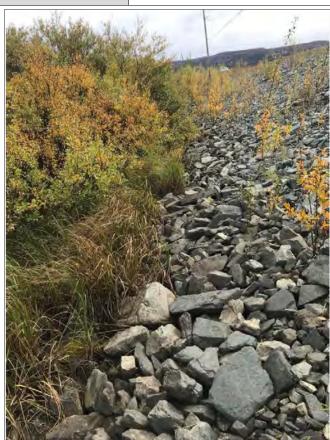
Plot Number	HDR534	Wetland Status	Upland	Vegetation Type	Bare Ground (Disturbed)
Plot Type	FVP: Field Verification Point	NWI Classification	C	Latitude (DD)	61.87183
Plot Date	9/12/2022	НСМ	N/A	Longitude (DD)	-162.03982

Photo Type: Vegetation

Direction: N

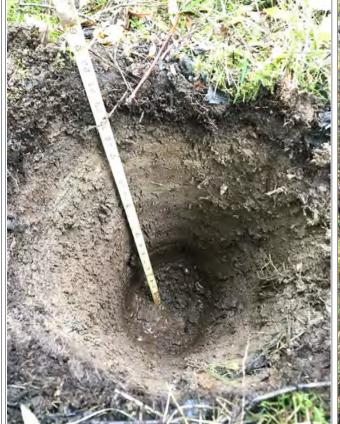
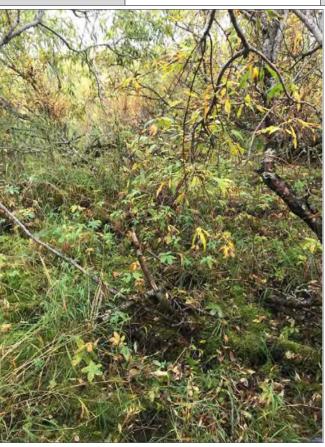
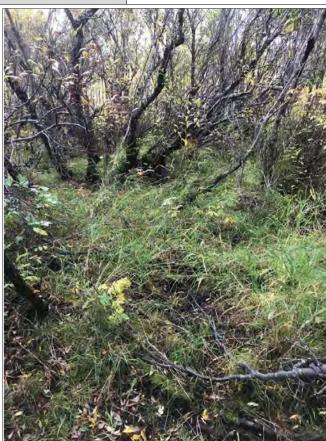
Plot Number	HDR535	Wetland Status	Wetland	Vegetation Type	Open Tall Willow Shrub
Plot Type	WD: Wetland Determination	NWI Classification	PSS1/EM1B	Latitude (DD)	61.87279
Plot Date	9/12/2022	ндм	Riverine	Longitude (DD)	-162.0417

Photo Type: Soils Direction: NA Photo Type: Vegetation Direction: N Photo Type: Vegetation Direction: S

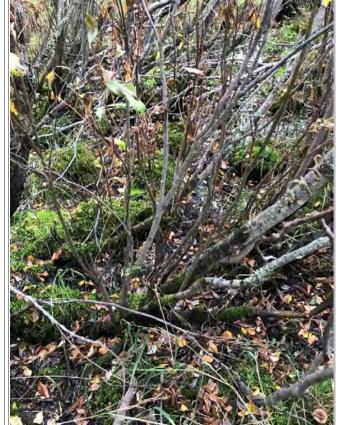
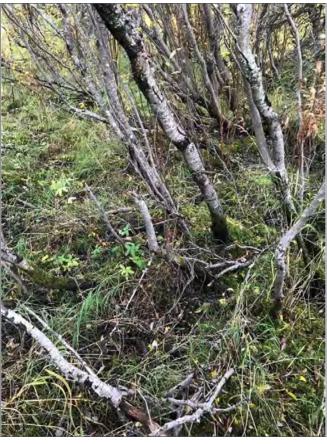
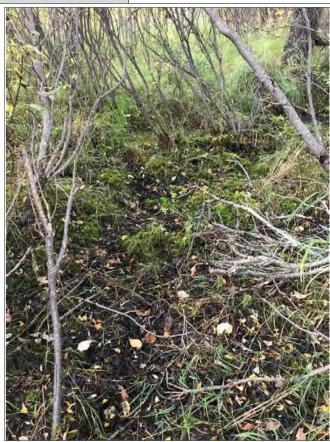
Plot Number	HDR536	Wetland Status	Wetland	Vegetation Type	Open Tall Willow Shrub
Plot Type	FVP: Field Verification Point	NWI Classification	PSS1/EM1C	Latitude (DD)	61.87268
Plot Date	9/12/2022	ндм	Riverine	Longitude (DD)	-162.04148

Photo Type: Vegetation

Direction: E

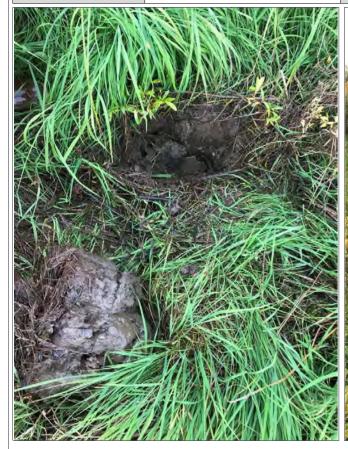
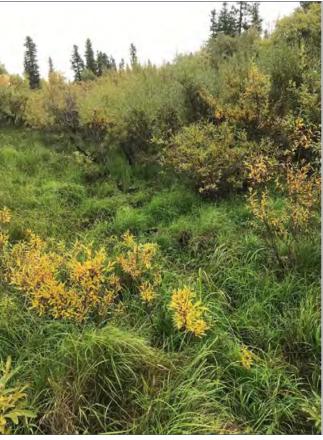
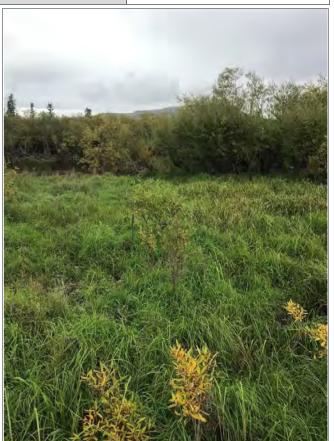
Plot Number	HDR537	Wetland Status	Wetland	Vegetation Type	Wet Herbaceous
Plot Type	FVP: Field Verification Point	NWI Classification	PEM1C	Latitude (DD)	61.87289
Plot Date	9/12/2022	ндм	Riverine	Longitude (DD)	-162.04181

Photo Type: Soils

Direction: NA

Direction: N

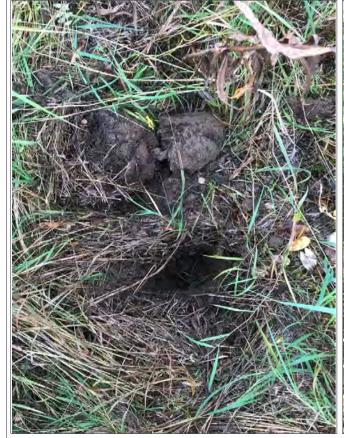
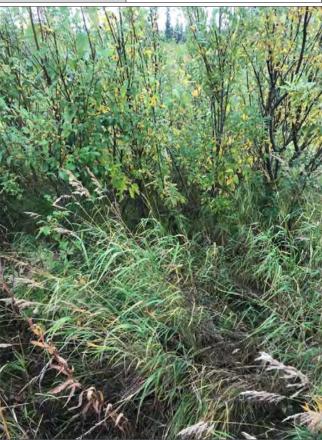
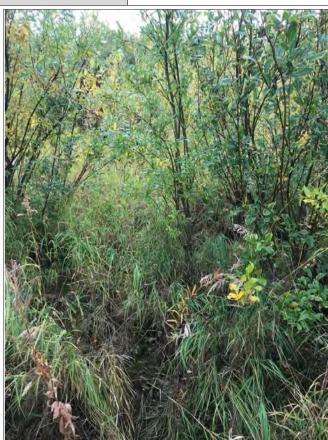
Plot Number	HDR538	Wetland Status	Upland	Vegetation Type	Open Tall Willow Shrub
Plot Type	FVP: Field Verification Point	NWI Classification	U	Latitude (DD)	61.87304
Plot Date	9/12/2022	ндм	N/A	Longitude (DD)	-162.04218

Photo Type: Soils Direction: NA Photo Type: Vegetation Direction: E Photo Type: Vegetation Direction: S

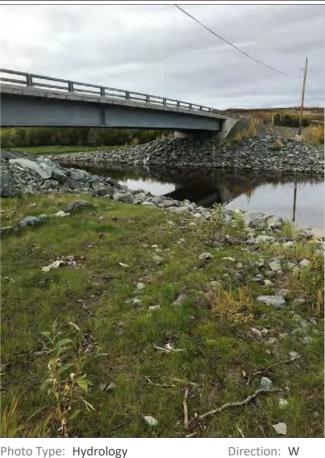
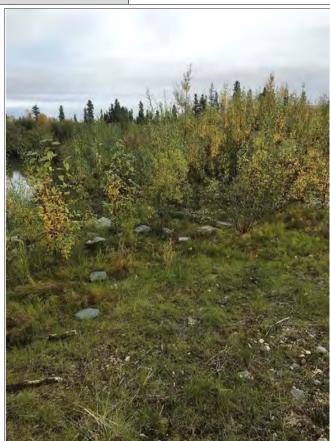
Plot Number	HDR539	Wetland Status	Upland	Vegetation Type	Mesic Herbaceous
Plot Type	FVP: Field Verification Point	NWI Classification	U	Latitude (DD)	61.87312
Plot Date	9/12/2022	ндм	N/A	Longitude (DD)	-162.04263

Photo Type: Hydrology

Direction: N

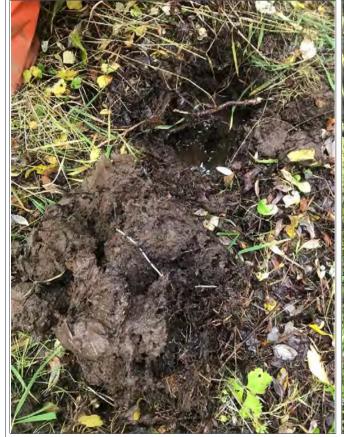
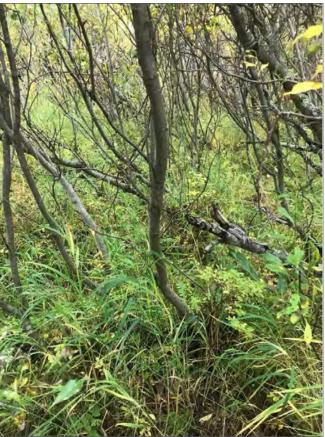
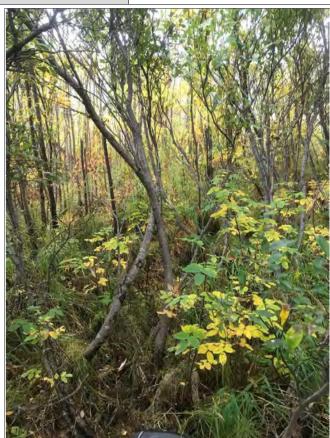
Plot Number	HDR540	Wetland Status	Wetland	Vegetation Type	Open Tall Willow Shrub
Plot Type	FVP: Field Verification Point	NWI Classification	PSS1B	Latitude (DD)	61.8736
Plot Date	9/12/2022	ндм	Riverine	Longitude (DD)	-162.04344

Direction: S

Photo Type: Soils Direction: NA Photo Type: Vegetation Direction: N Photo Type: Vegetation

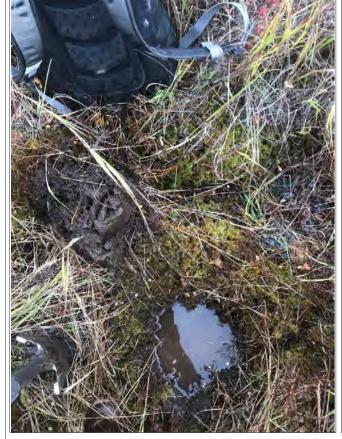
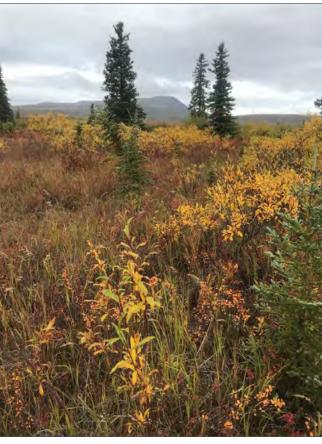
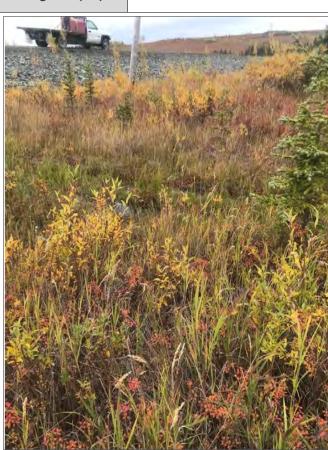
Plot Number	HDR541	Wetland Status	Wetland	Vegetation Type	Shrub Birch Willow
Plot Type	FVP: Field Verification Point	NWI Classification	PSS1/EM1B	Latitude (DD)	61.87371
Plot Date	9/12/2022	ндм	Slope	Longitude (DD)	-162.04381

Photo Type: Soils Direction: NA Photo Type: Vegetation Direction: N Photo Type: Vegetation Direction: W

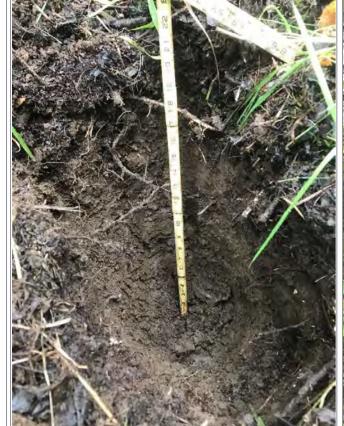
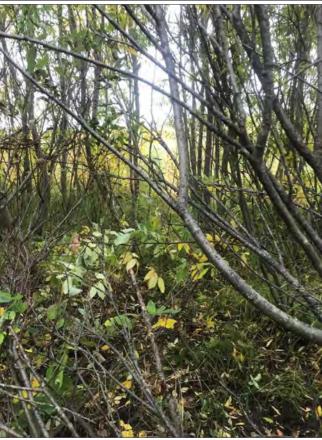
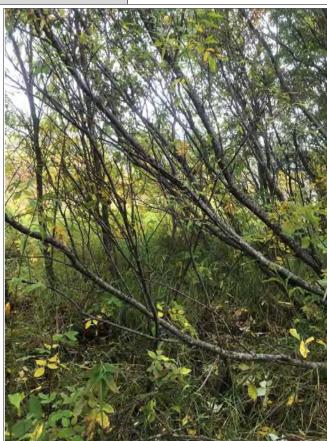
Plot Number	HDR542	Wetland Status	Upland	Vegetation Type	Closed Tall Willow Shrub
Plot Type	WD: Wetland Determination	NWI Classification	U	Latitude (DD)	61.87336
Plot Date	9/12/2022	ндм	N/A	Longitude (DD)	-162.04412

Photo Type: Soils

Direction: NA

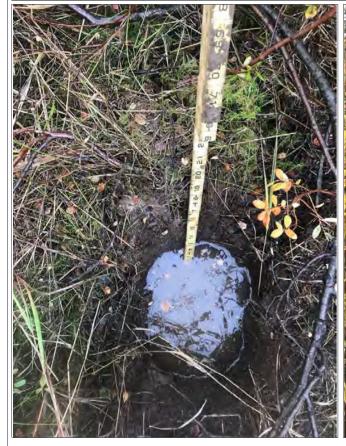
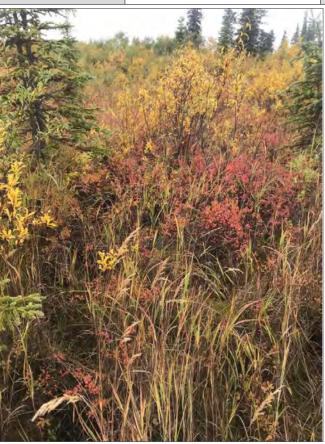
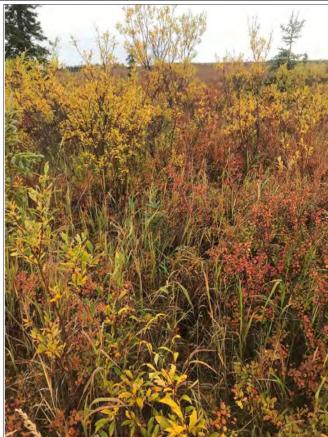
Plot Number	HDR543	Wetland Status	Wetland	Vegetation Type	Shrub Birch Willow
Plot Type	WD: Wetland Determination	NWI Classification	PSS1/EM1B	Latitude (DD)	61.87355
Plot Date	9/12/2022	ндм	Slope	Longitude (DD)	-162.04467

Photo Type: Soils

Direction: NA

Direction: W

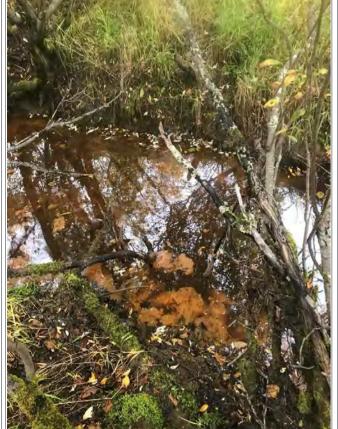
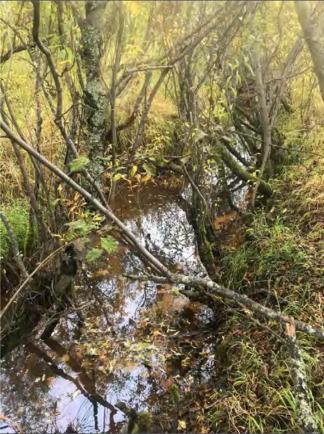
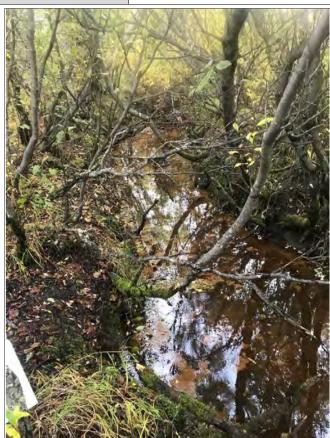
Plot Number	HDR544	Wetland Status	RPW	Vegetation Type	Open Water
Plot Type	SC: Stream Crossing	NWI Classification	R3UBH	Latitude (DD)	61.87456
Plot Date	9/12/2022	ндм	Riverine Channel	Longitude (DD)	-162.04563

Photo Type: Hydrology

Direction: N

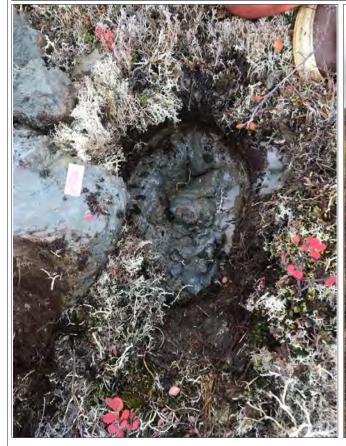
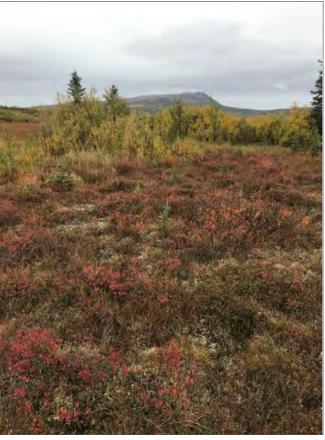
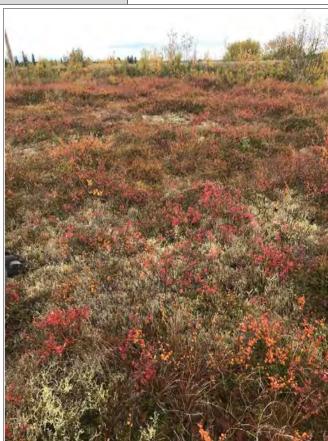
Plot Number	HDR545	Wetland Status	Wetland	Vegetation Type	Open Mixed Shrub Sedge Tundra
Plot Type	WD: Wetland Determination	NWI Classification	PSS3/1B	Latitude (DD)	61.87495
Plot Date	9/12/2022	НСМ	Slope	Longitude (DD)	-162.04631

Photo Type: Soils

Direction: NA

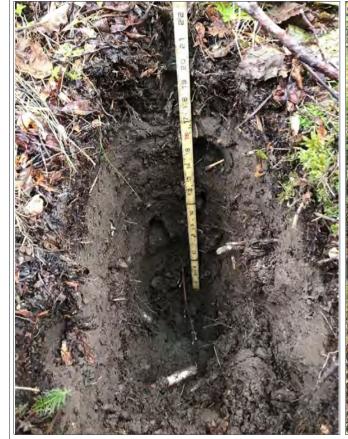
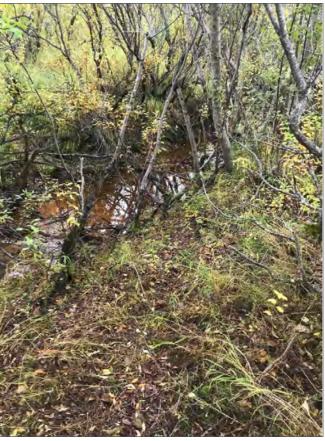
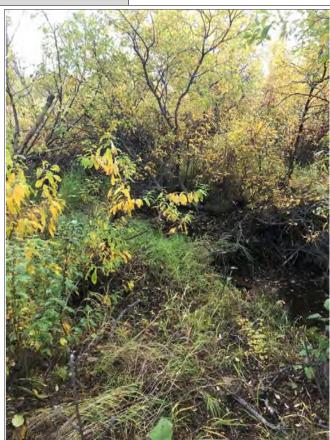
Plot Number	HDR546	Wetland Status	Upland	Vegetation Type	Open Tall Alder Willow Shrub
Plot Type	WD: Wetland Determination	NWI Classification	O	Latitude (DD)	61.87467
Plot Date	9/12/2022	ндм	N/A	Longitude (DD)	-162.04578

Photo Type: Soils Direction: NA Photo Type: Vegetation Direction: E Photo Type: Vegetation Direction: N

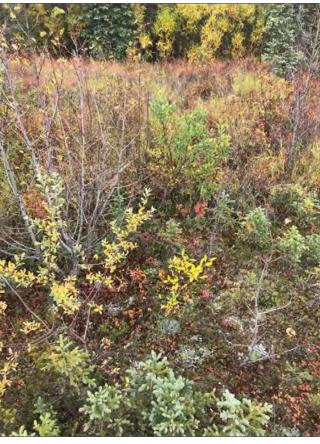
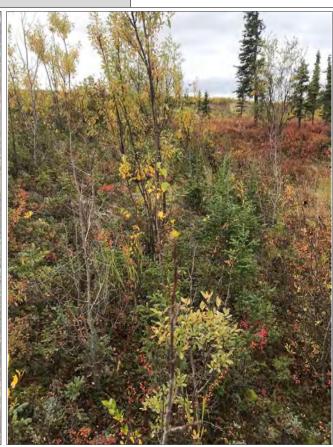
Plot Number	HDR548	Wetland Status	Upland	Vegetation Type	Deciduous Shrub and Sapling Regrowth
Plot Type	FVP: Field Verification Point	NWI Classification	U	Latitude (DD)	61.87448
Plot Date	9/12/2022	ндм	N/A	Longitude (DD)	-162.04593

Photo Type: Soils Direction: NA Photo Type: Vegetation Direction: E Photo Type: Vegetation Direction: S

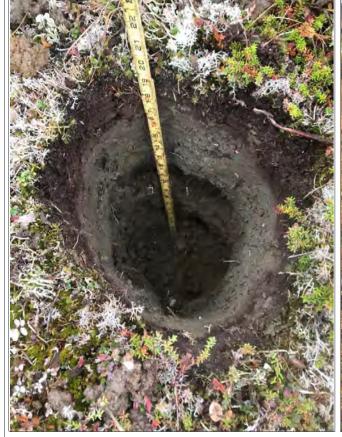
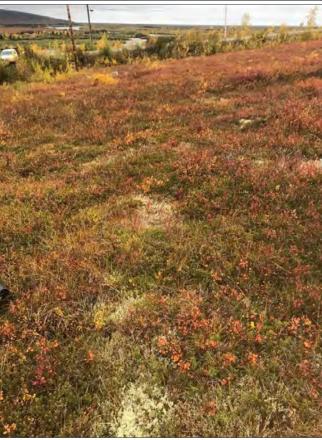
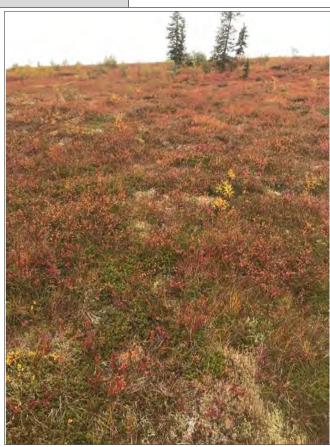
Plot I	Number	HDR585	Wetland Status	Wetland	Vegetation Type	Dwarf Shrub Tundra
Plot	t Type	WD: Wetland Determination	NWI Classification	PSS1/3B	Latitude (DD)	61.87608
Plot	t Date	9/14/2022	ндм	Slope	Longitude (DD)	-162.05592

Photo Type: Soils

Direction: NA
