# Wetlands and Waters Delineation Report

Marshall Airport and Access Road Improvements

November 14, 2022

Alaska Department of Transportation and Public Facilities

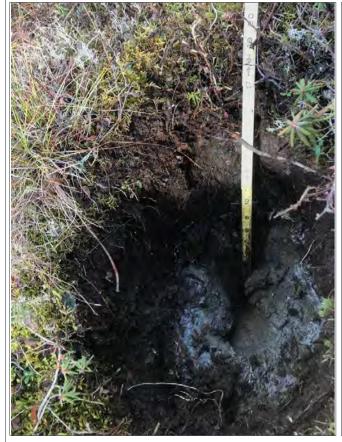
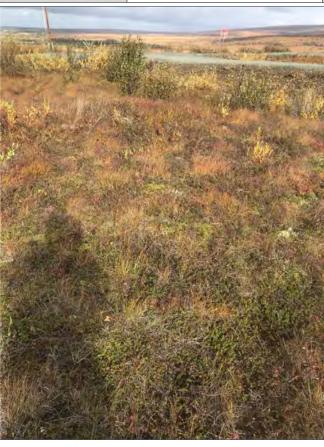
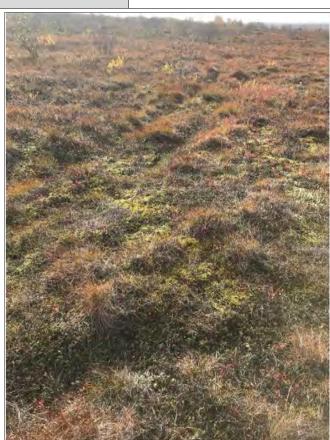
PI	lot Number	HDR586	Wetland Status	Wetland	Vegetation Type	Open Mixed Shrub Sedge Tundra
	Plot Type	WD: Wetland Determination	NWI Classification PSS3/EM1B		Latitude (DD)	61.87677
	Plot Date	9/18/2022	ндм	Slope	Longitude (DD)	-162.07525

Photo Type: Soils Direction: NA Photo Type: Vegetation Direction: N Photo Type: Vegetation Direction: S

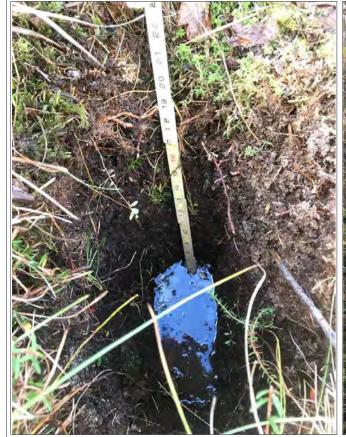
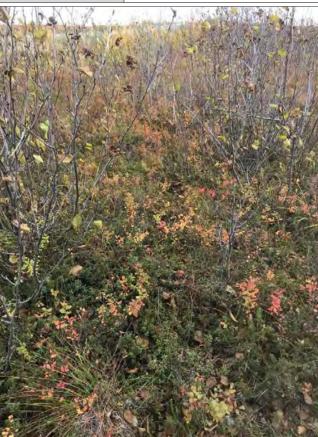
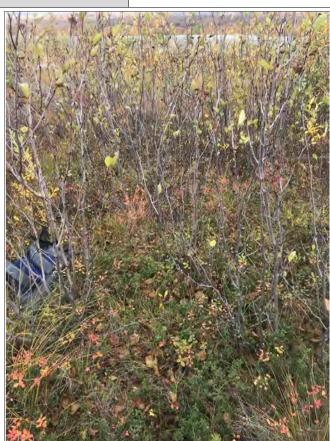
Plot Number	HDR590	Wetland Status	Wetland	Vegetation Type	Open Low Willow Shrub
Plot Type	WD: Wetland Determination	NWI Classification	PSS1/3B	Latitude (DD)	61.87632
Plot Date	9/18/2022	ндм	Slope	Longitude (DD)	-162.07436

Photo Type: Soils Direction: NA Photo Type: Vegetation Direction: E Photo Type: Vegetation Direction: N

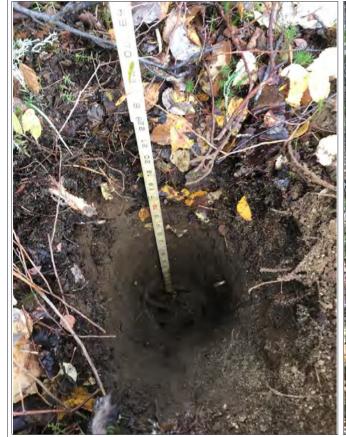
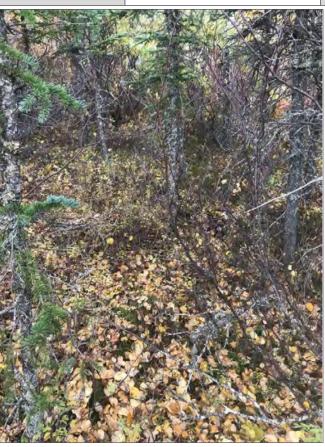
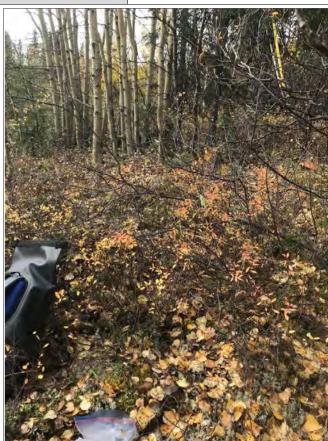
Plot Number	Plot Number HDR595  Plot Type WD: Wetland Determination		Upland	Vegetation Type	Open Mixed Forest
Plot Type			U	<b>Latitude (DD)</b> 61.87588	
<b>Plot Date</b> 9/18/2022		ндм	N/A	Longitude (DD)	-162.04914

Photo Type: Soils Direction: NA Photo Type: Vegetation Direction: N Photo Type: Vegetation Direction: W

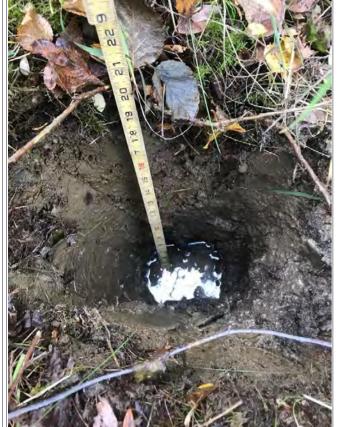
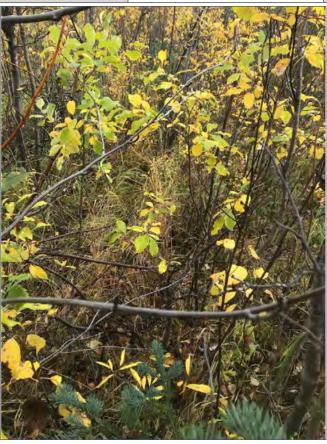
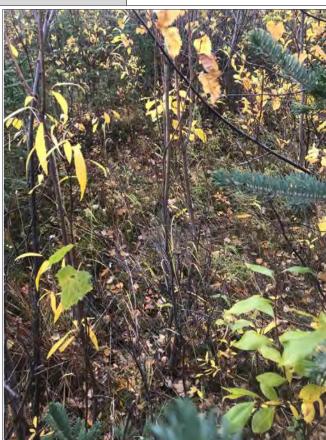
Plot Number	HDR596	Wetland Status	7,7		Open Tall Willow Shrub
Plot Type	WD: Wetland Determination	NWI Classification			61.87598
Plot Date	9/18/2022	ндм	Slope	Longitude (DD)	-162.05027

Photo Type: Soils Direction: NA Photo Type: Vegetation Direction: S Photo Type: Vegetation Direction: W

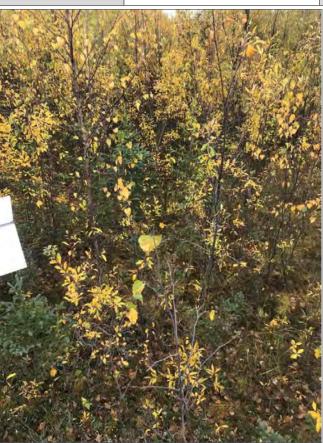
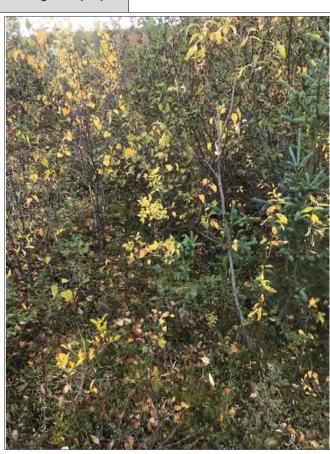
Plot Number	HDR597	Wetland Status	Upland	Vegetation Type	Open Low Willow Shrub
Plot Type	FVP: Field Verification Point	NWI Classification	U	Latitude (DD)	61.87593
Plot Date	9/18/2022	ндм	N/A	Longitude (DD)	-162.05029

Photo Type: Vegetation

Direction: E

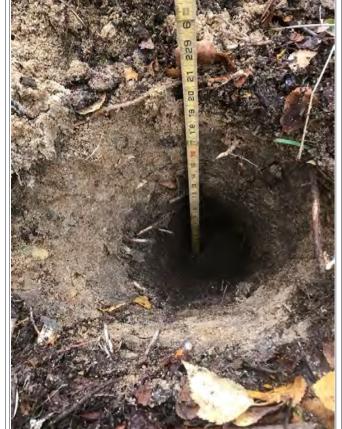
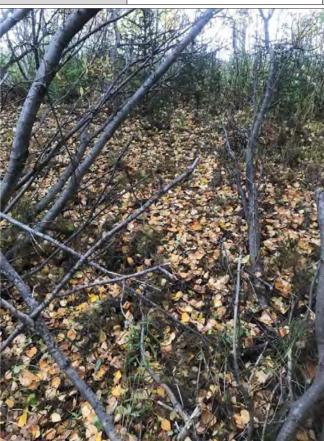
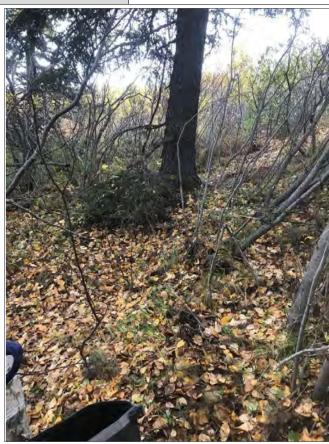
Plot Number	HDR598	Wetland Status	Upland	Vegetation Type	Open Mixed Forest
Plot Type	WD: Wetland Determination	NWI Classification	U	Latitude (DD)	61.87569
Plot Date	9/18/2022	ндм	N/A	Longitude (DD)	-162.05071

Photo Type: Soils

Direction: NA

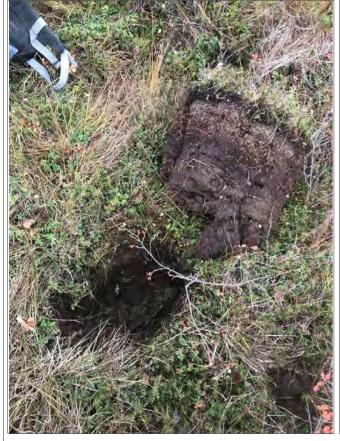
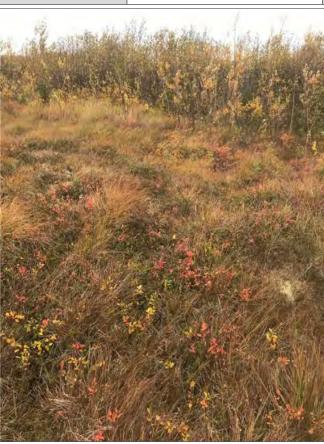
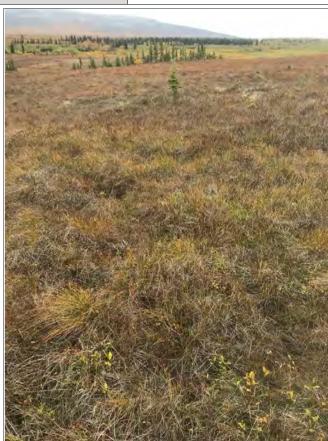
Plot Number	HDR599	Wetland Status	Wetland	Vegetation Type	Open Mixed Shrub Sedge Tundra
Plot Type	FVP: Field Verification Point	NWI Classification	PSS3/EM1B	Latitude (DD)	61.87566
Plot Date	9/18/2022	ндм	Slope	Longitude (DD)	-162.05099

Photo Type: Soils

Direction: NA

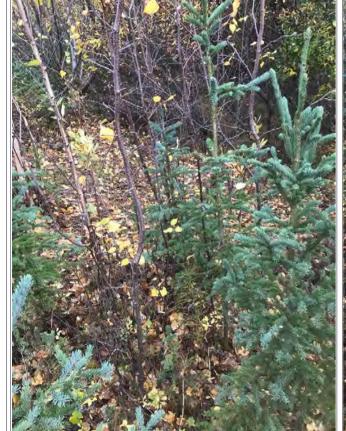
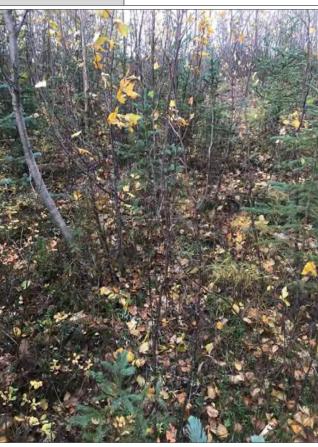
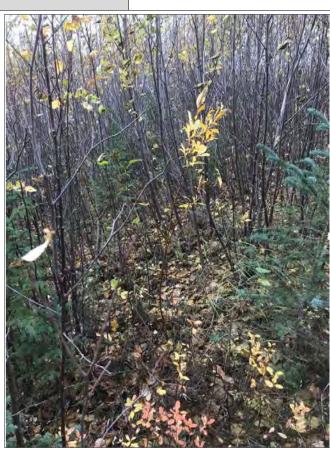
Plot Number	HDR600	Wetland Status	Upland	Vegetation Type	Closed Tall Alder Willow Shrub
Plot Type	FVP: Field Verification Point	NWI Classification	U	Latitude (DD)	61.87569
Plot Date	9/18/2022	ндм	N/A	Longitude (DD)	-162.05084

Photo Type: Vegetation

Direction: E
