STATEWIDE MATERIAL SITE INVENTORY

POTENTIAL HARD AGGREGATE
SOURCE REPORT

Federal Project No. STP-000S(823)
AKSAS Project No. 76149

CHUGACH MOUNTAINS
BURNT BUTTE

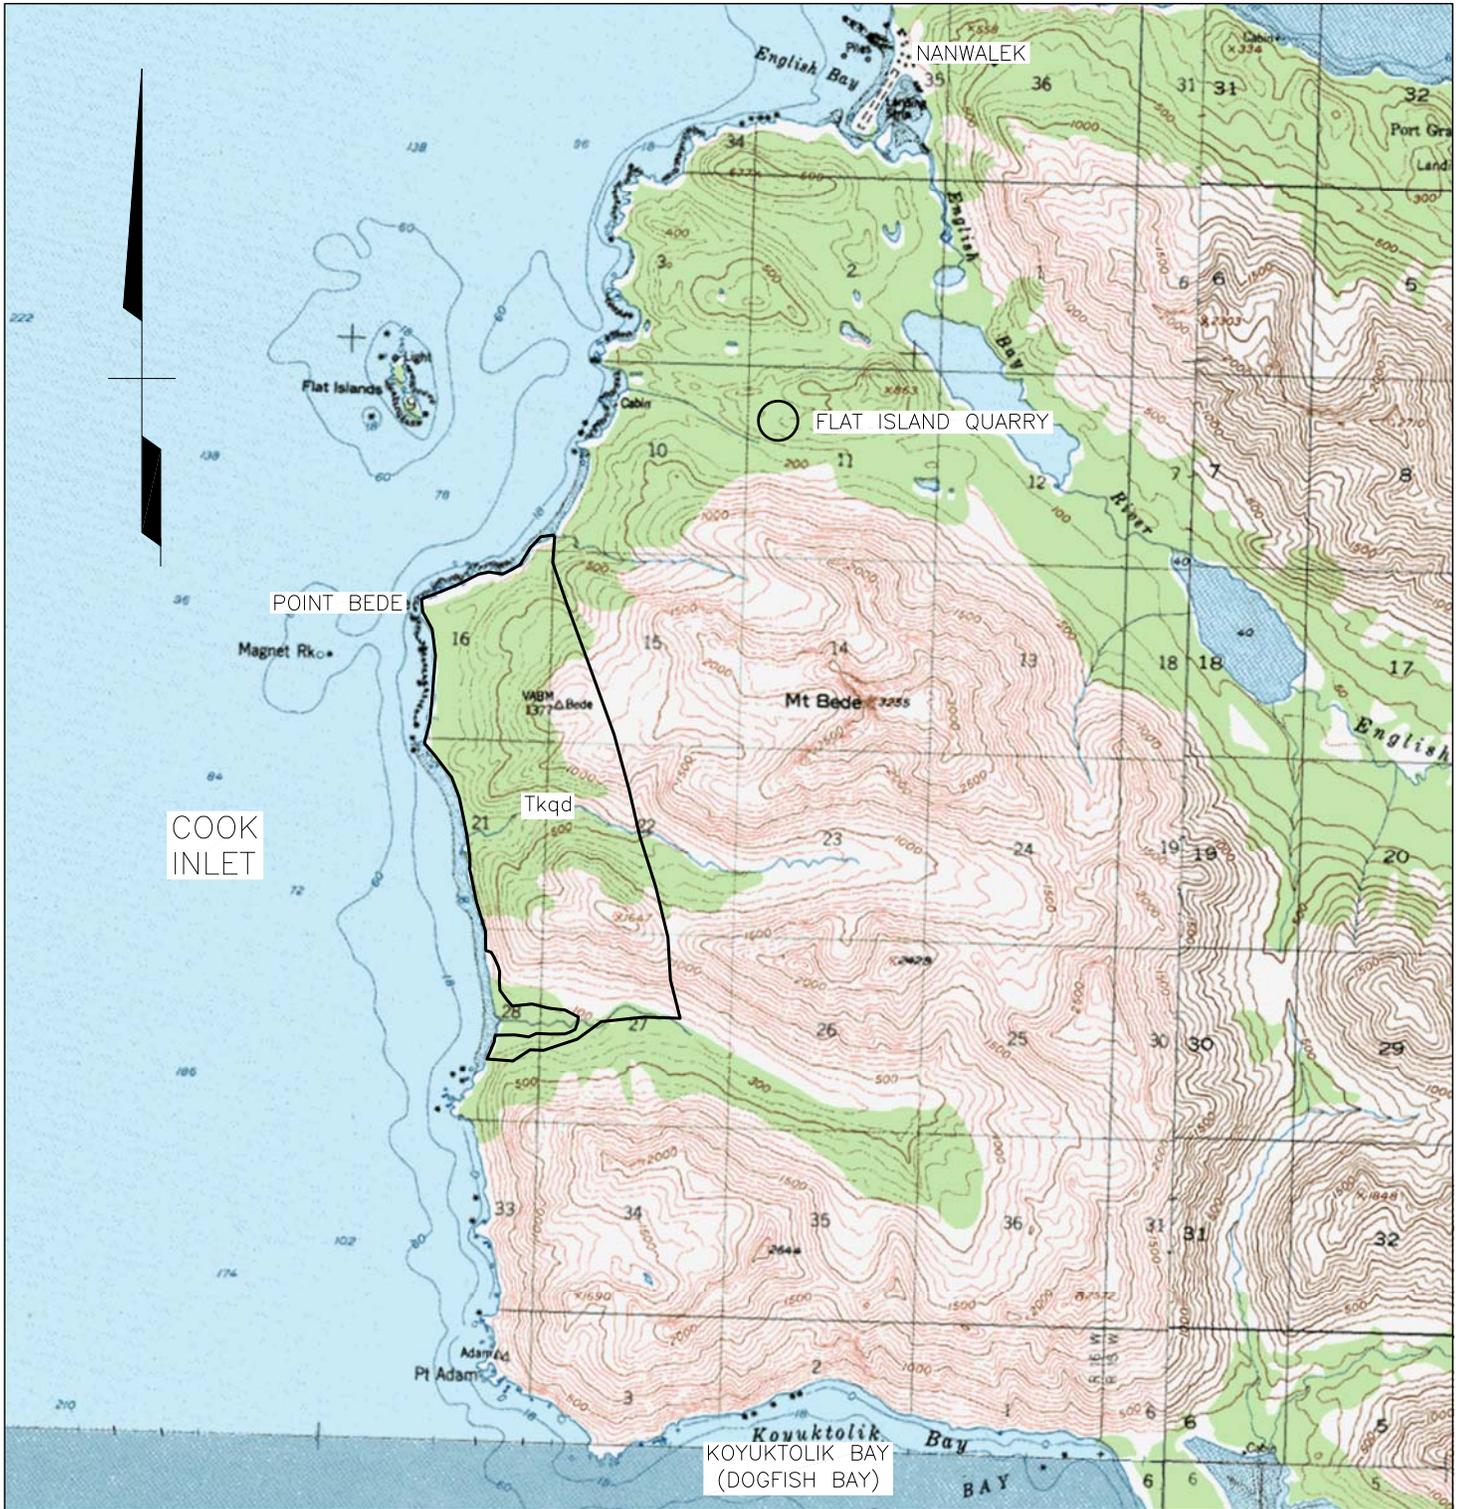
LOCATION MAP (HA-B1)

U.S.G.S. QUADRANGLE: SELDOVIA (A-5), (A-6), (B-5) & (B-6)

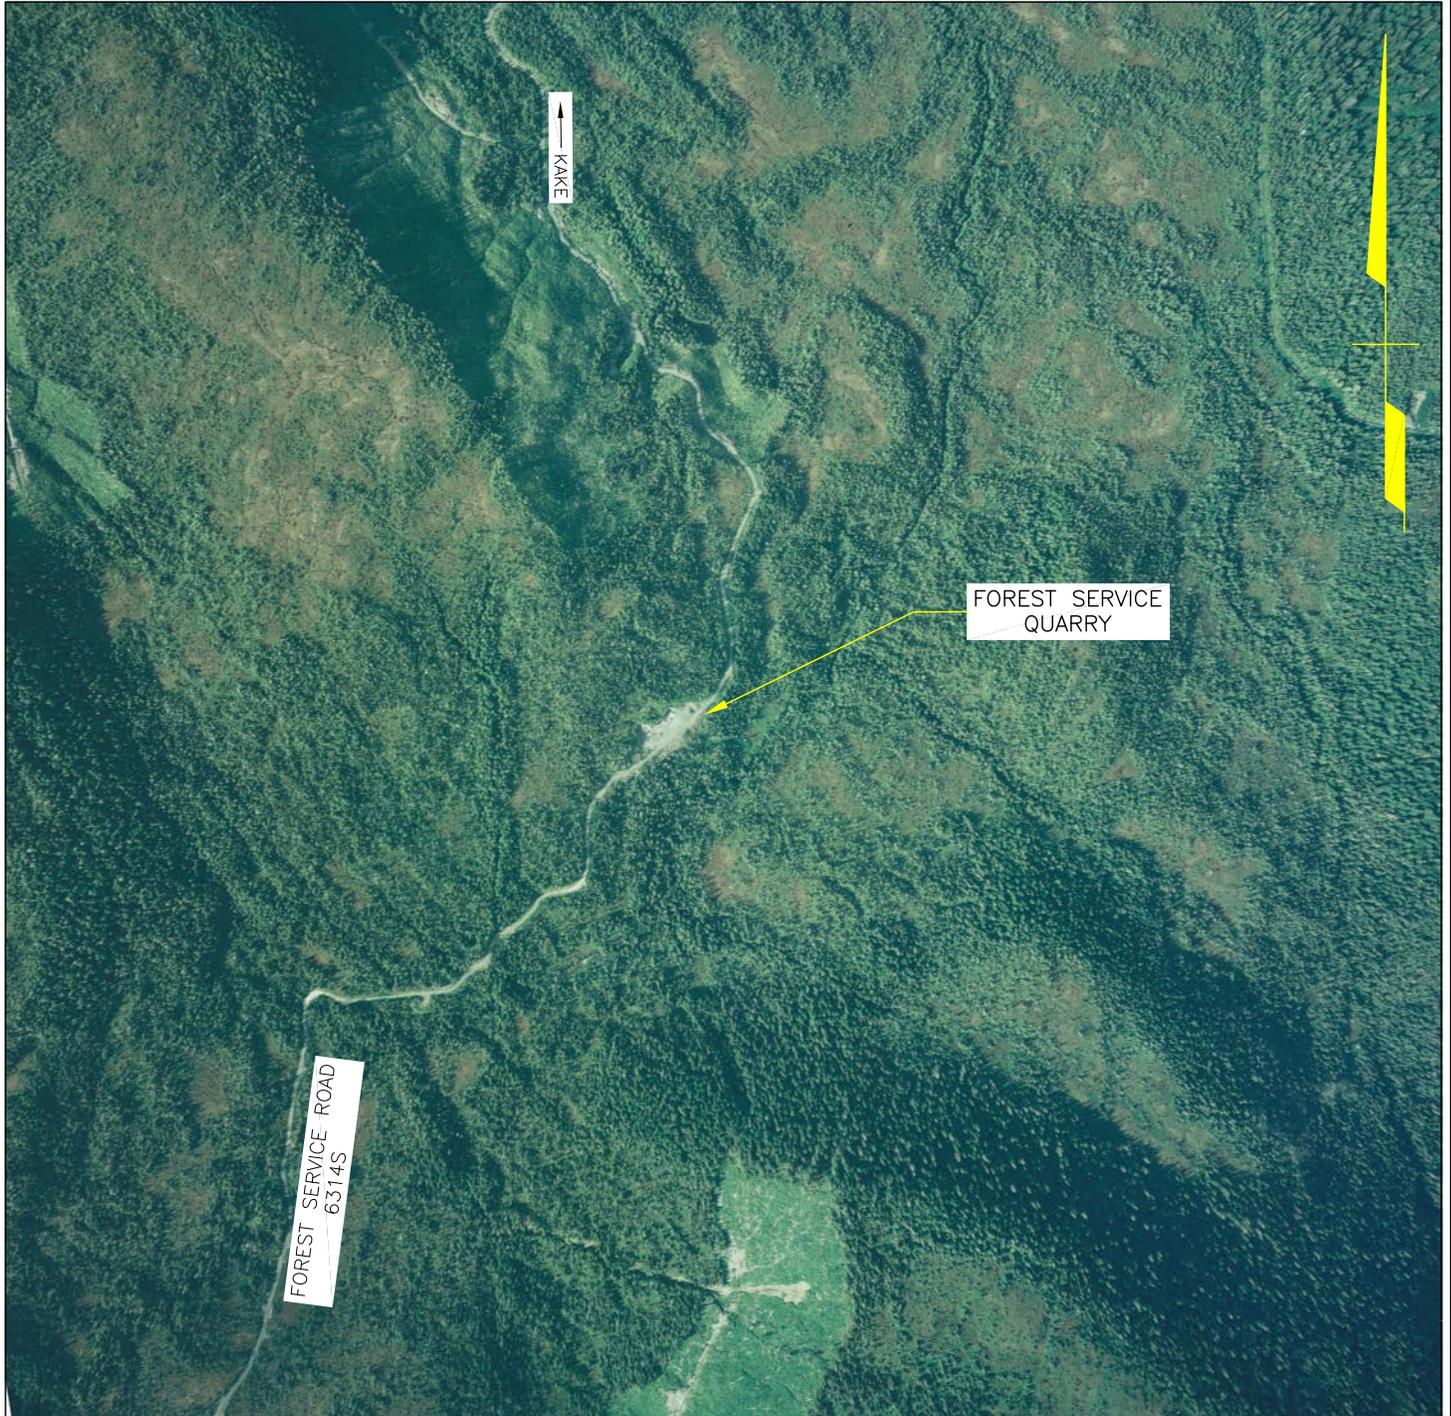
SITE MAP (HA-E9)

BASE MAP IS AUGUST 14, 2012 AERIAL PHOTOGRAPHY.
THIS IS A PLANNING DOCUMENT ONLY.

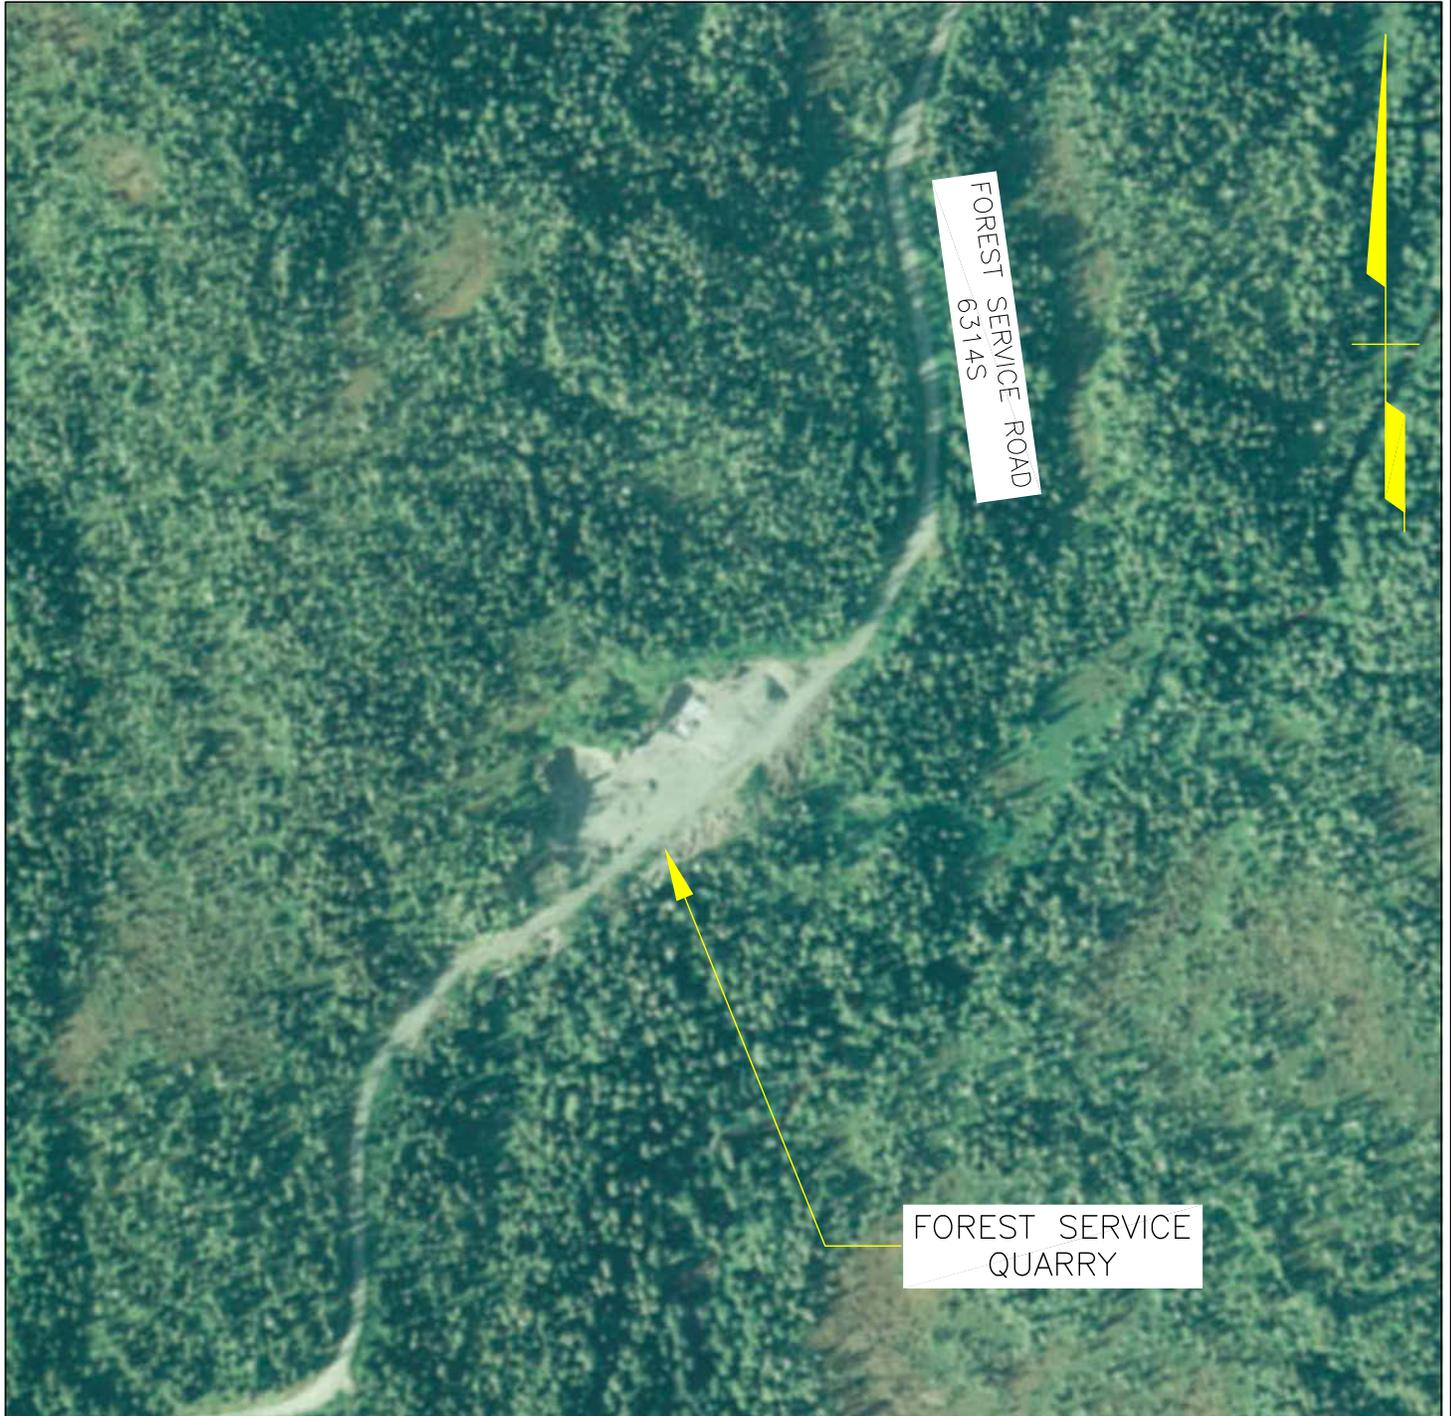
SITE MAP (HA-E9)

BASE MAP IS AUGUST 14, 2012 AERIAL PHOTOGRAPHY.
THIS IS A PLANNING DOCUMENT ONLY.

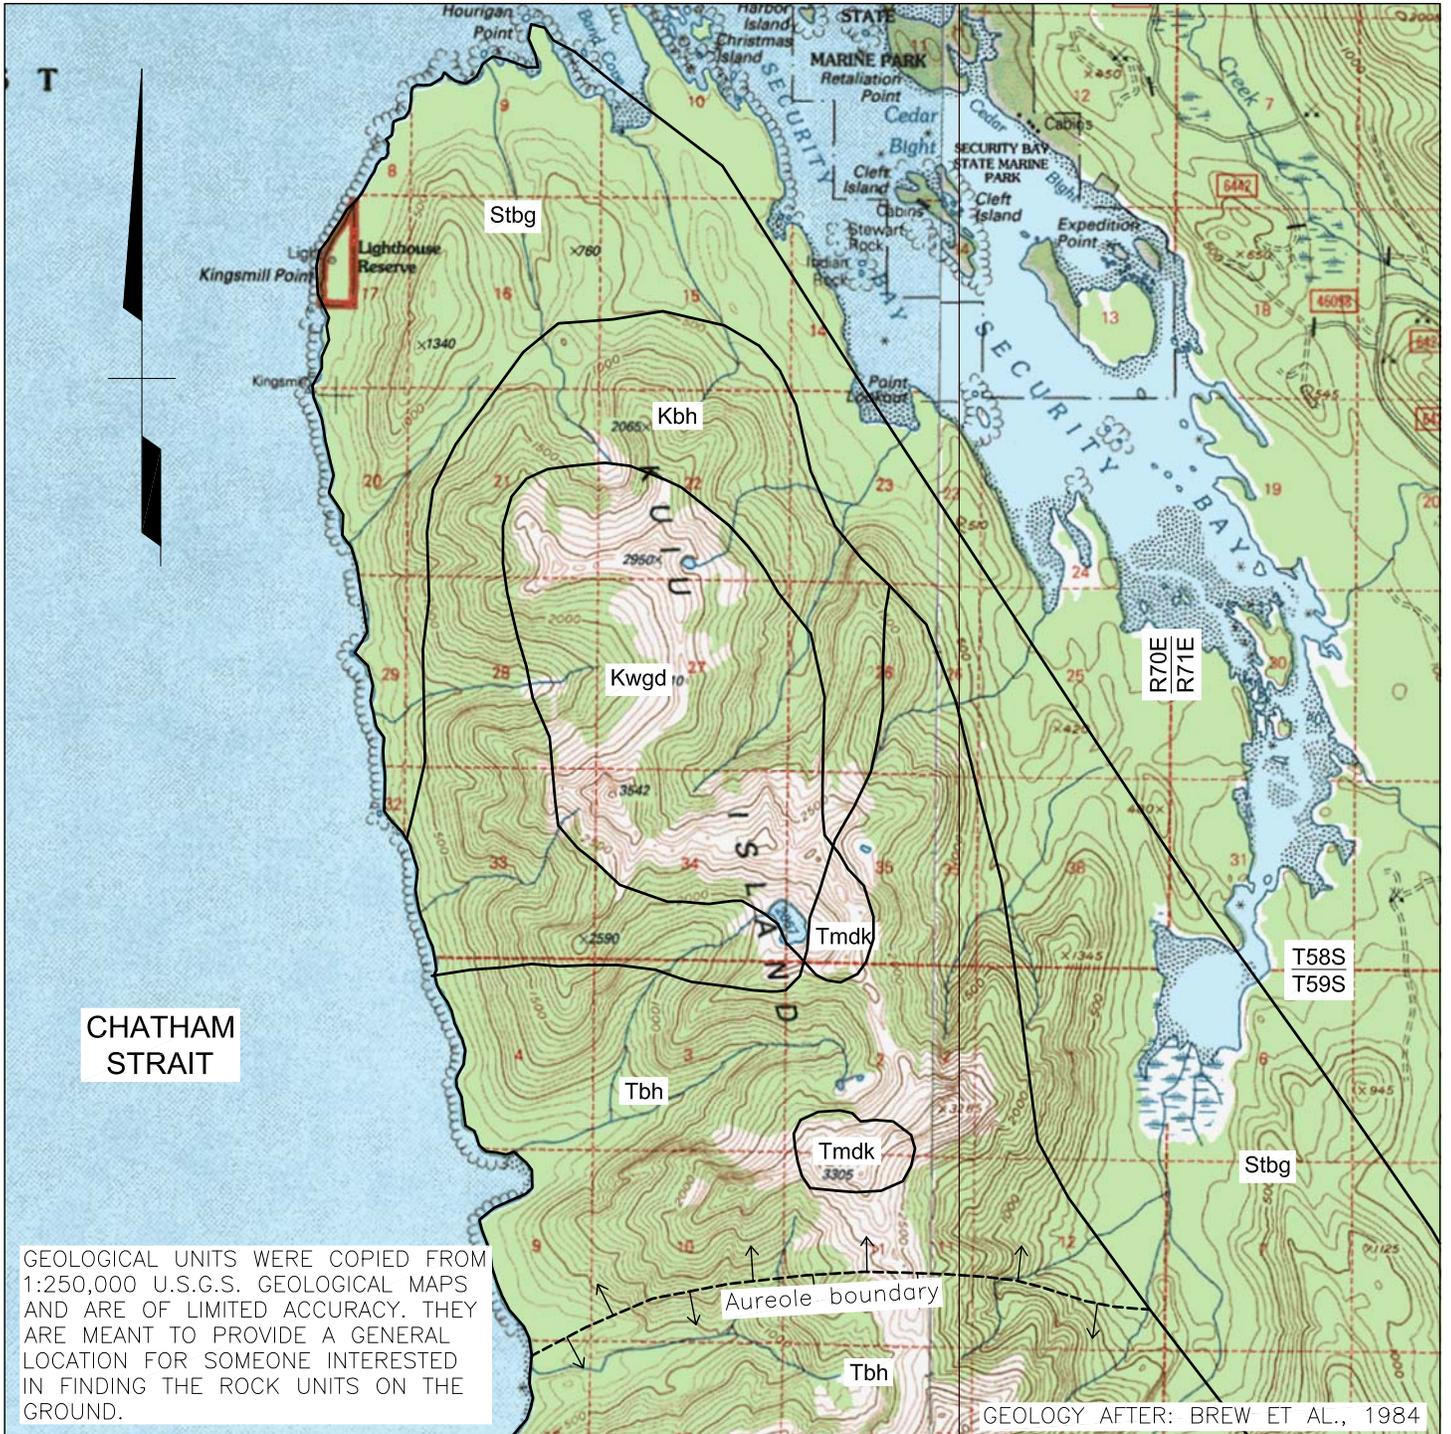
LOCATION MAP (HA-F1)

U.S.G.S. QUADRANGLE: PORT ALEXANDER (D-1) & (D-2)

Stbg-Sandstone
 Tmdk-Gabbro/Diorite
 Tbh/Kbh-Hornfels
 Kwgd-Granodiorite

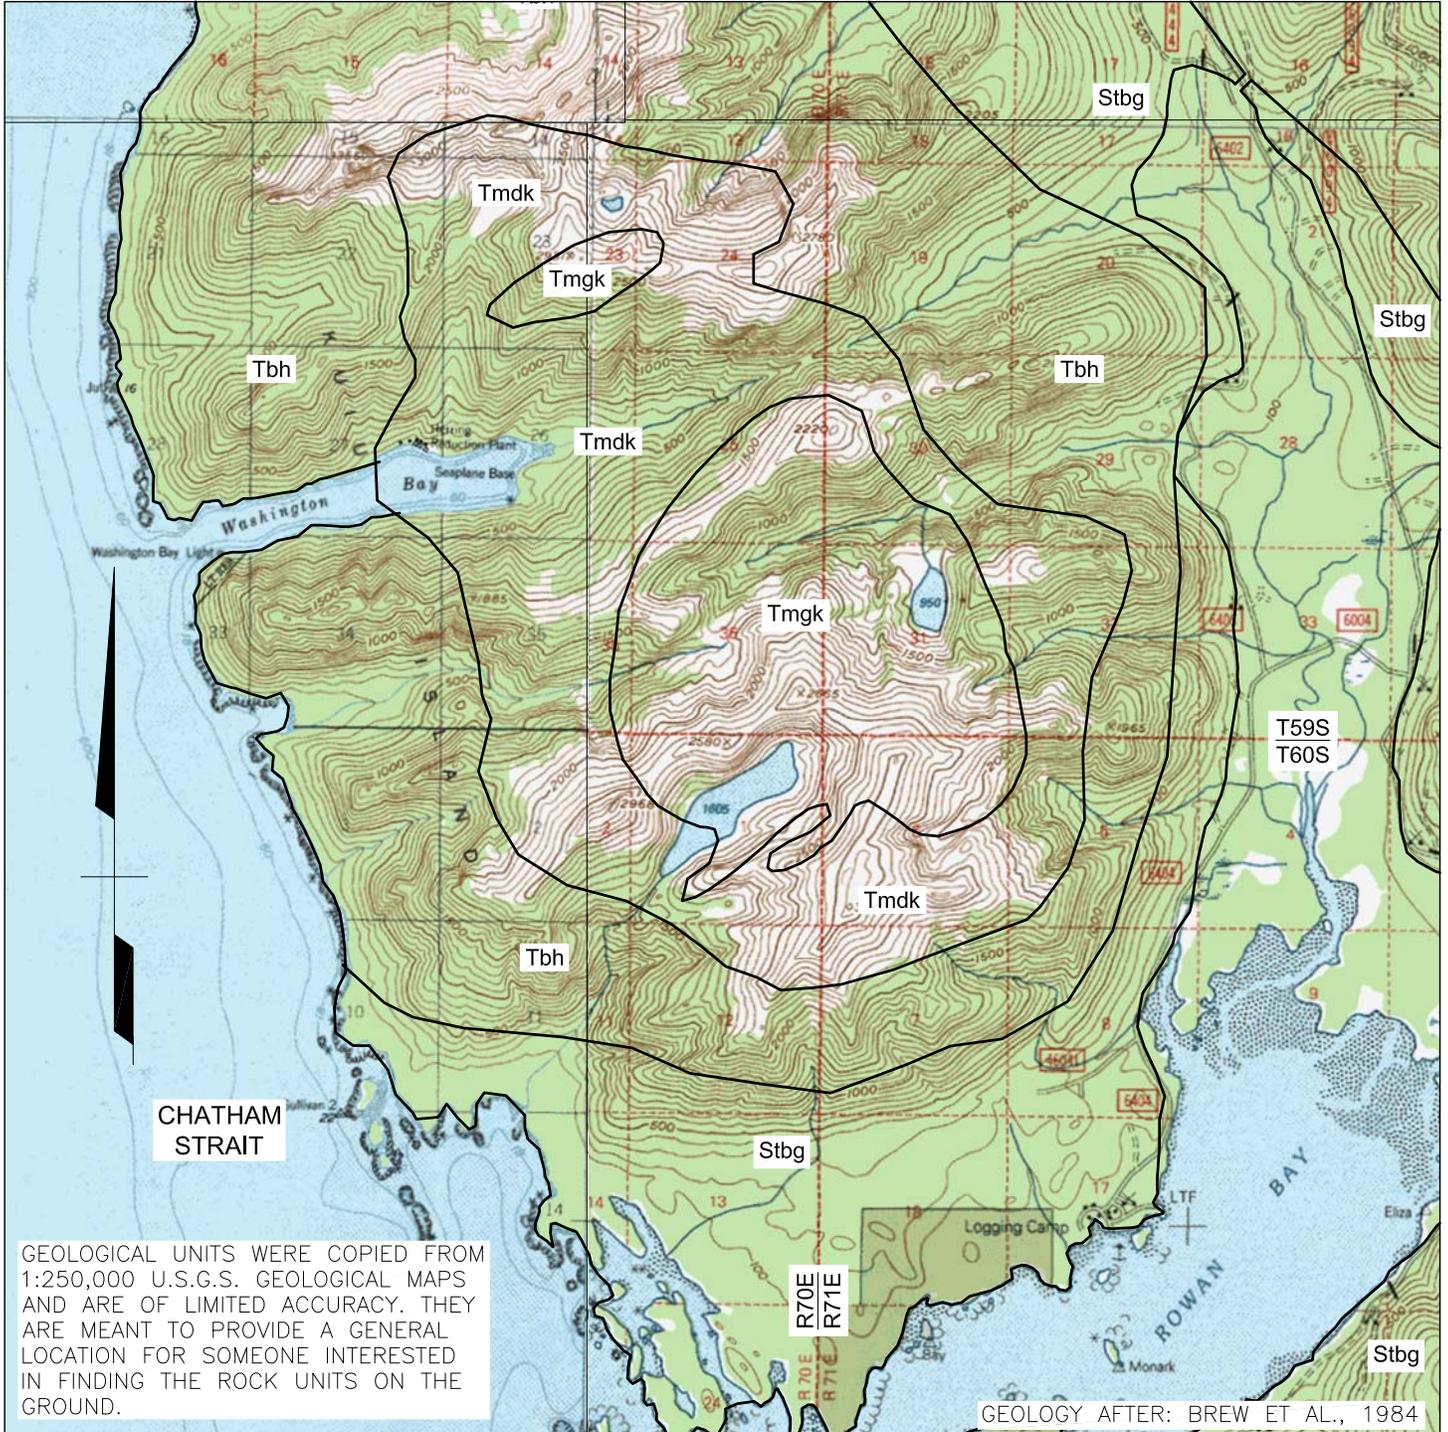
LOCATION MAP (HA-F2)

GEOLOGICAL UNITS WERE COPIED FROM 1:250,000 U.S.G.S. GEOLOGICAL MAPS AND ARE OF LIMITED ACCURACY. THEY ARE MEANT TO PROVIDE A GENERAL LOCATION FOR SOMEONE INTERESTED IN FINDING THE ROCK UNITS ON THE GROUND.

GEOLOGY AFTER: BREW ET AL., 1984

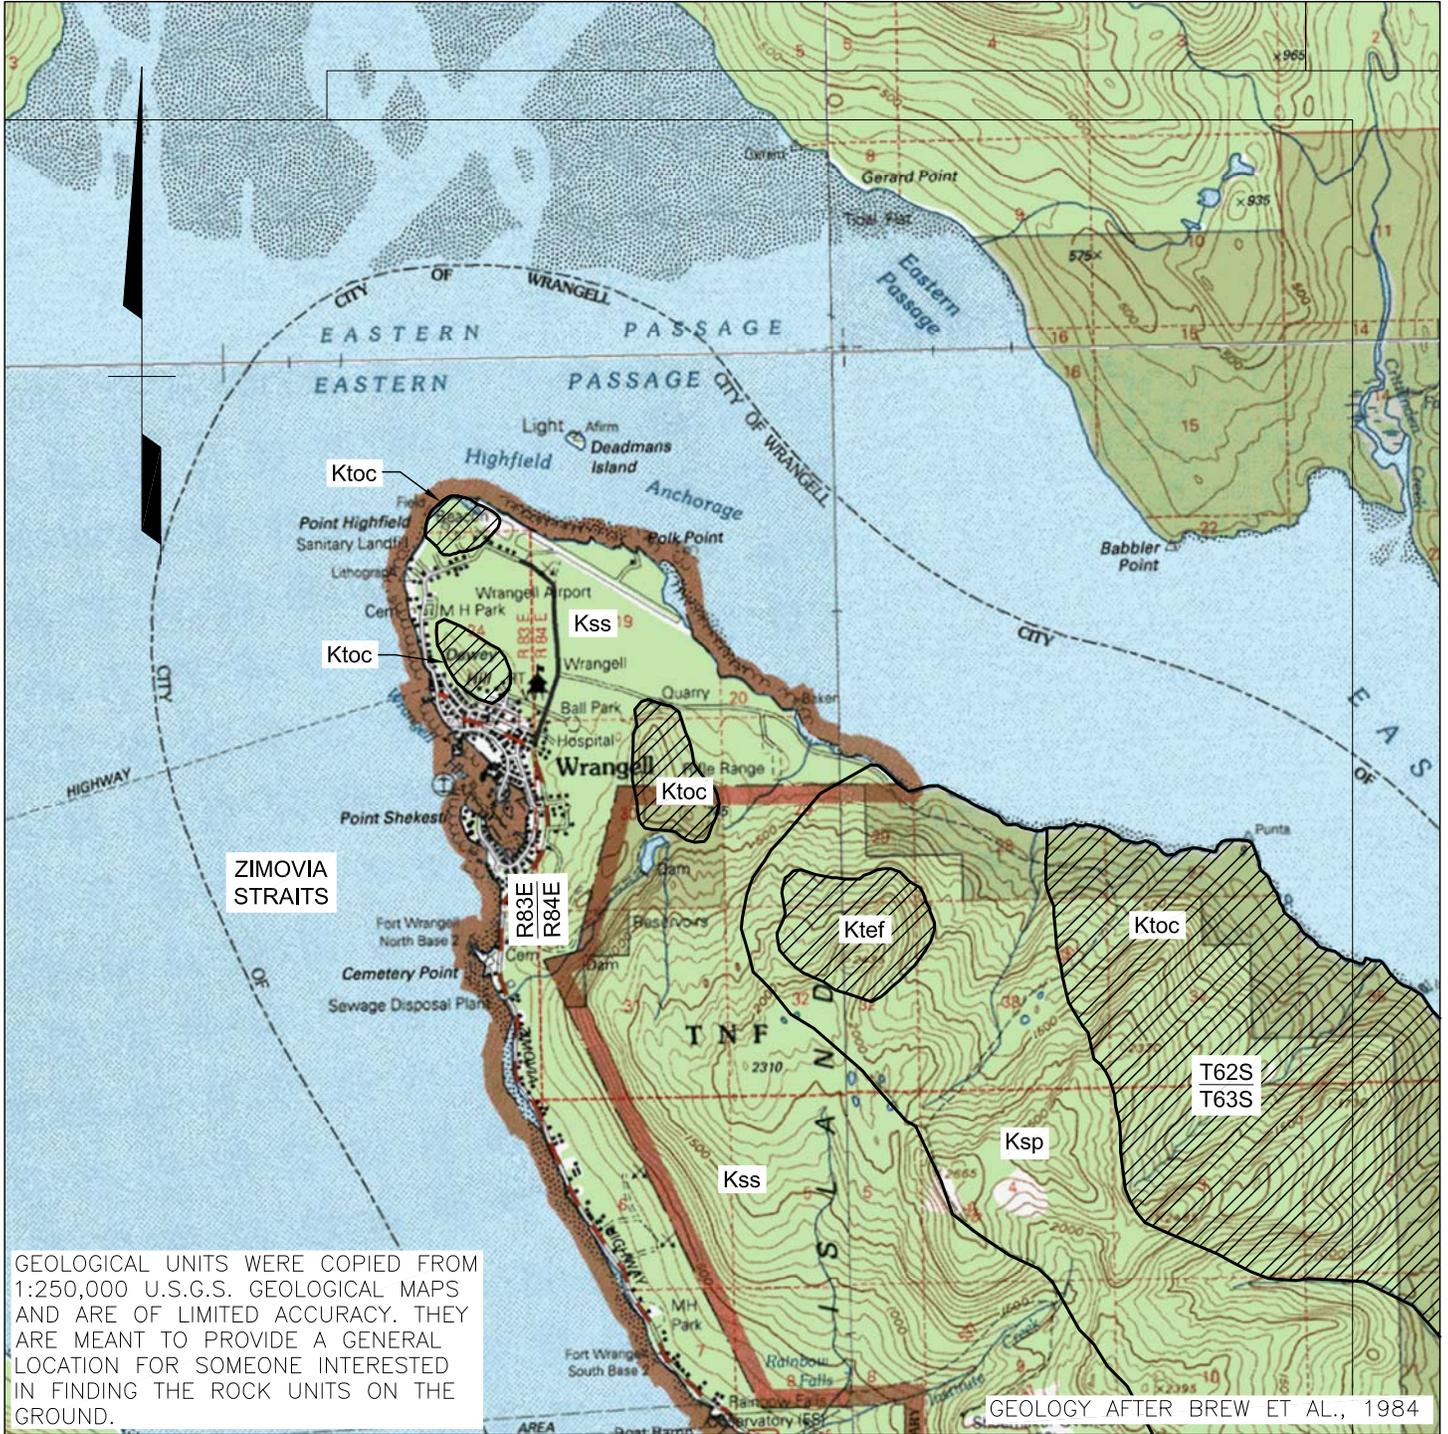
LOCATION MAP (HA-G1)

U.S.G.S. QUADRANGLE: PETERSBURG (B-1), (B-2), (C-1) & (C-2)

POTENTIAL HARD AGGREGATE SOURCE WRANGELL ISLAND

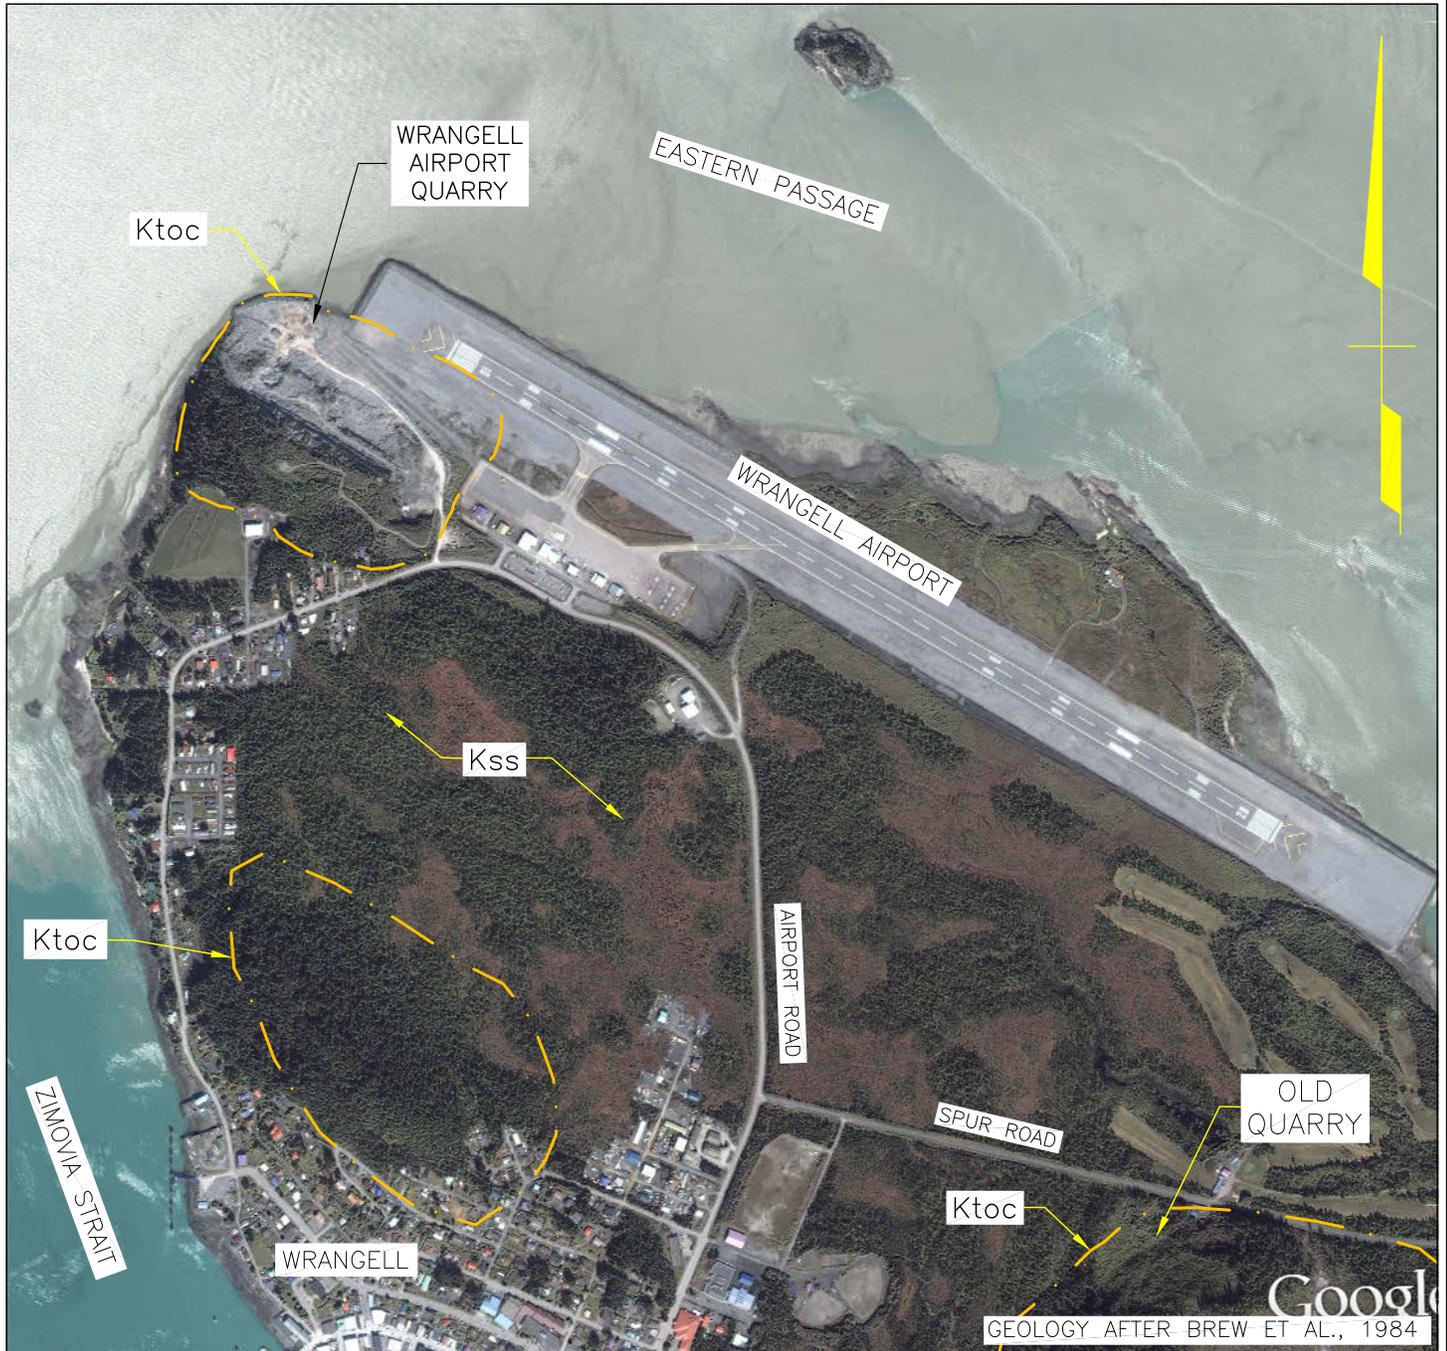
SITE MAP (HA-G1)

BASE MAP IS JULY 24, 2012 GEOEYE SATELLITE IMAGERY.
THIS IS A PLANNING DOCUMENT ONLY.

Ktoci-Tonalite
Kssi-Schist

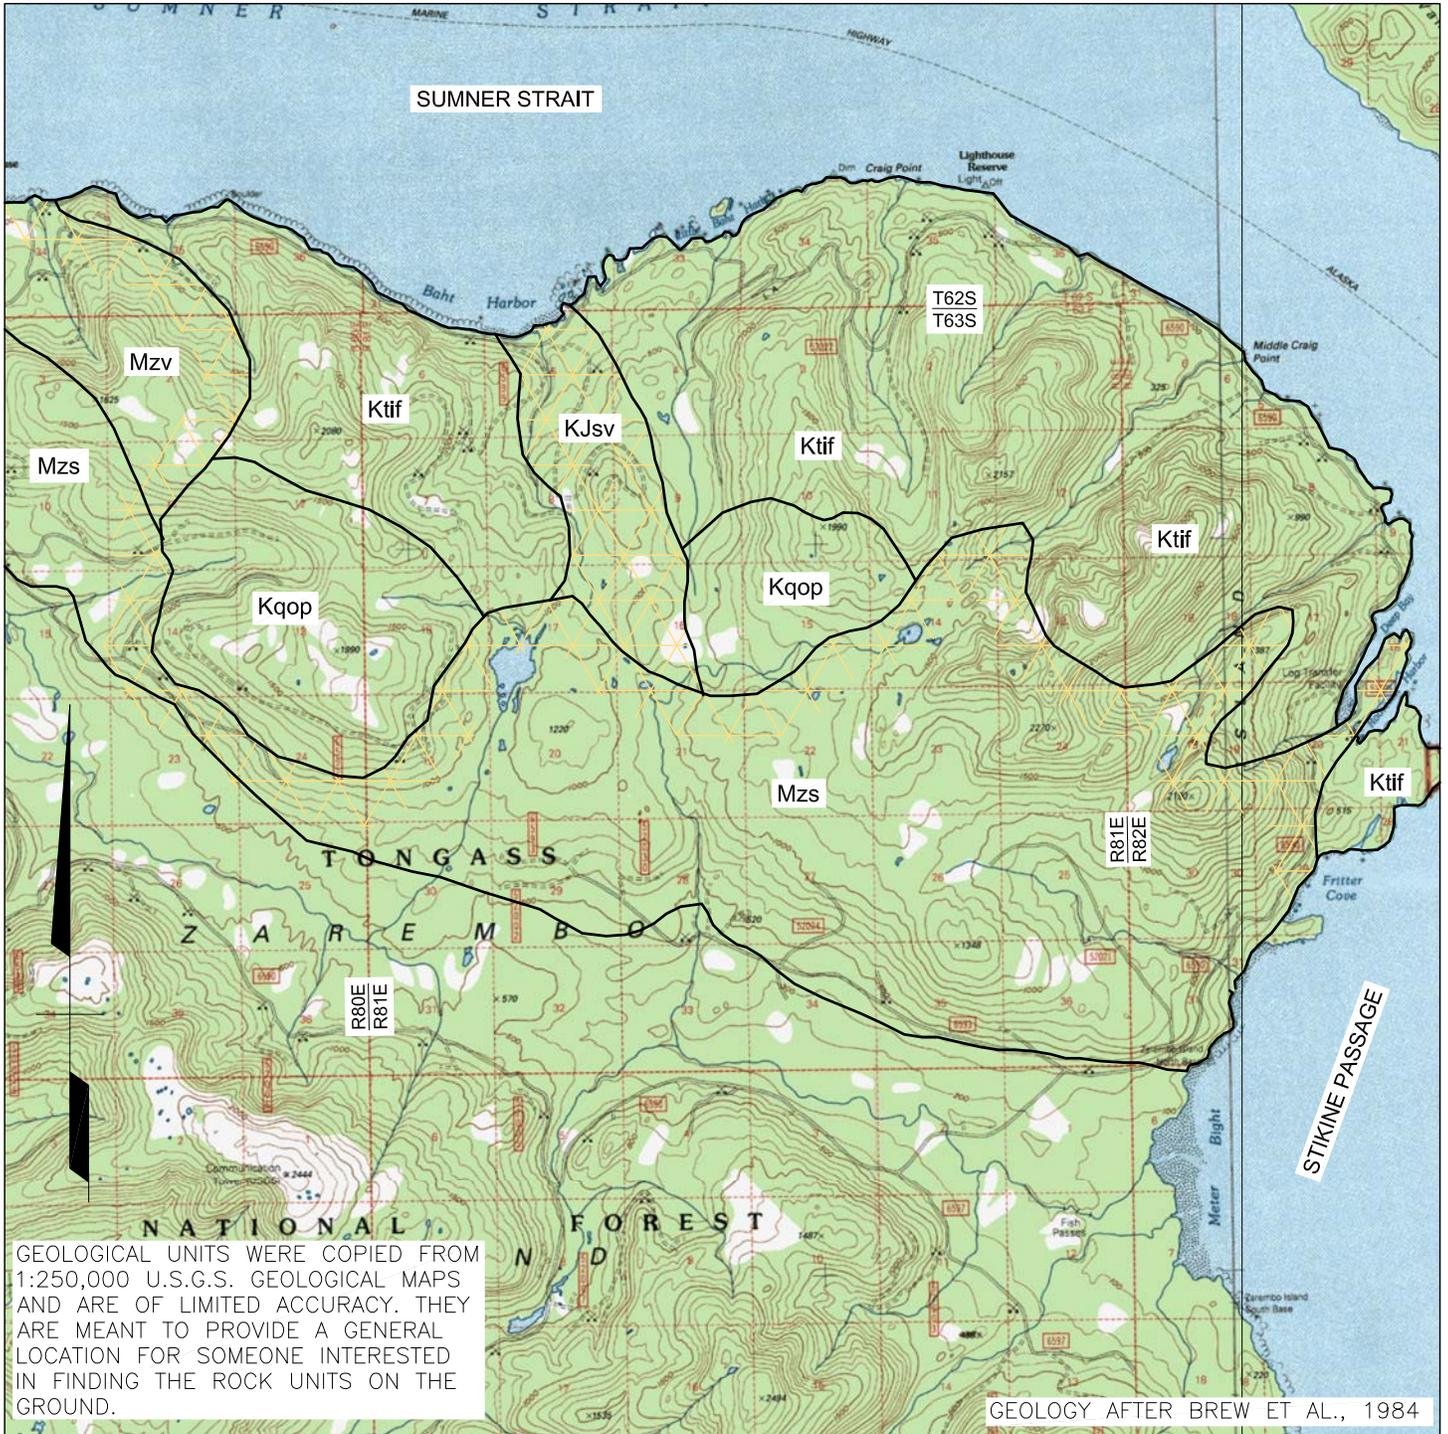
LOCATION MAP (HA-H1)

GEOLOGICAL UNITS WERE COPIED FROM 1:250,000 U.S.G.S. GEOLOGICAL MAPS AND ARE OF LIMITED ACCURACY. THEY ARE MEANT TO PROVIDE A GENERAL LOCATION FOR SOMEONE INTERESTED IN FINDING THE ROCK UNITS ON THE GROUND.

GEOLOGY AFTER BREW ET AL., 1984

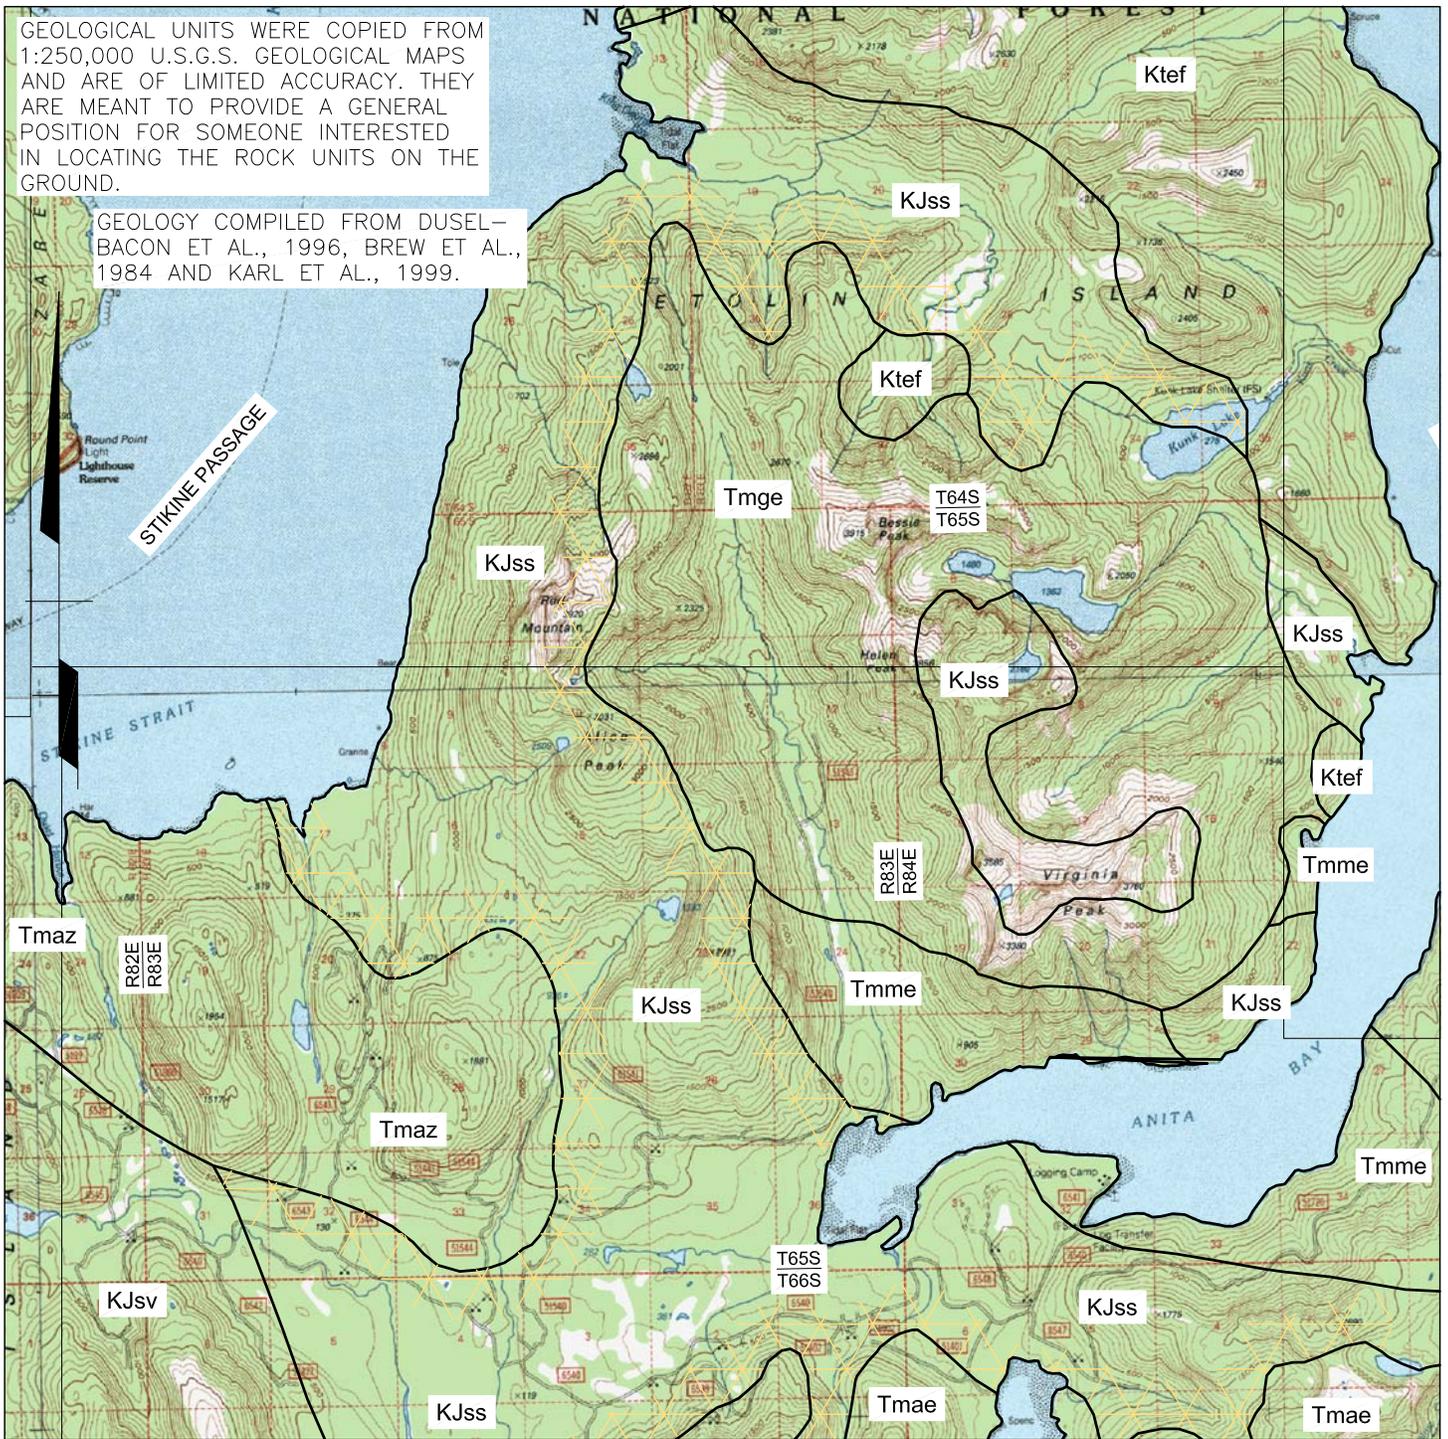
GEOLOGICAL UNITS WERE COPIED FROM 1:250,000 U.S.G.S. GEOLOGICAL MAPS AND ARE OF LIMITED ACCURACY. THEY ARE MEANT TO PROVIDE A GENERAL POSITION FOR SOMEONE INTERESTED IN LOCATING THE ROCK UNITS ON THE GROUND.

GEOLOGY COMPILED FROM DUSEL-BACON ET AL., 1996, BREW ET AL., 1984 AND KARL ET AL., 1999.

U.S.G.S. QUADRANGLE: PETERSBURG (A-2), (A-3), (B-2) & (B-3)

POTENTIAL HARD AGGREGATE SOURCE ETOLIN ISLAND

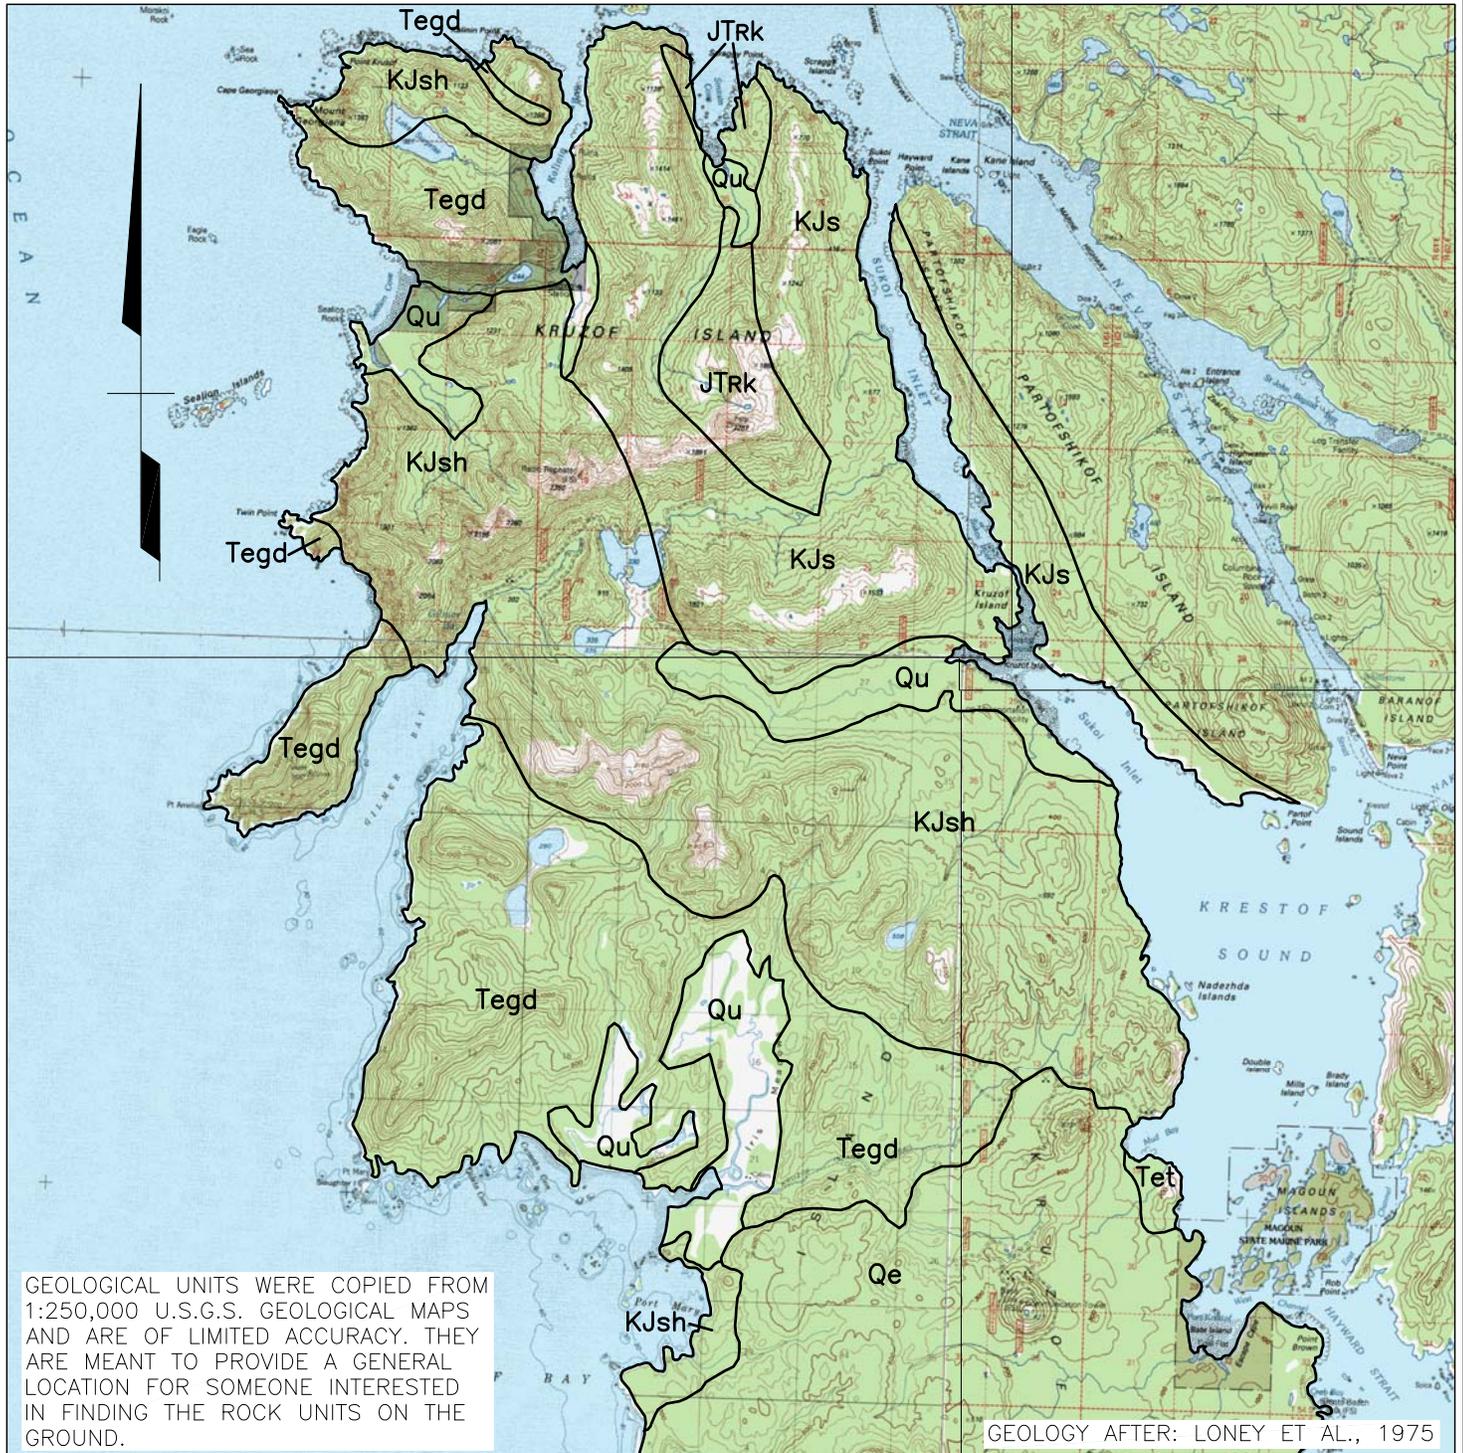
LOCATION MAP (HA-J1)

GEOLOGICAL UNITS WERE COPIED FROM 1:250,000 U.S.G.S. GEOLOGICAL MAPS AND ARE OF LIMITED ACCURACY. THEY ARE MEANT TO PROVIDE A GENERAL LOCATION FOR SOMEONE INTERESTED IN FINDING THE ROCK UNITS ON THE GROUND.

GEOLOGY AFTER: LONEY ET AL., 1975
