STATEWIDE MATERIAL SITE INVENTORY

POTENTIAL HARD AGGREGATE
SOURCE REPORT

Federal Project No. STP-000S(823)
AKSAS Project No. 76149

CHUGACH MOUNTAINS
BURNT BUTTE

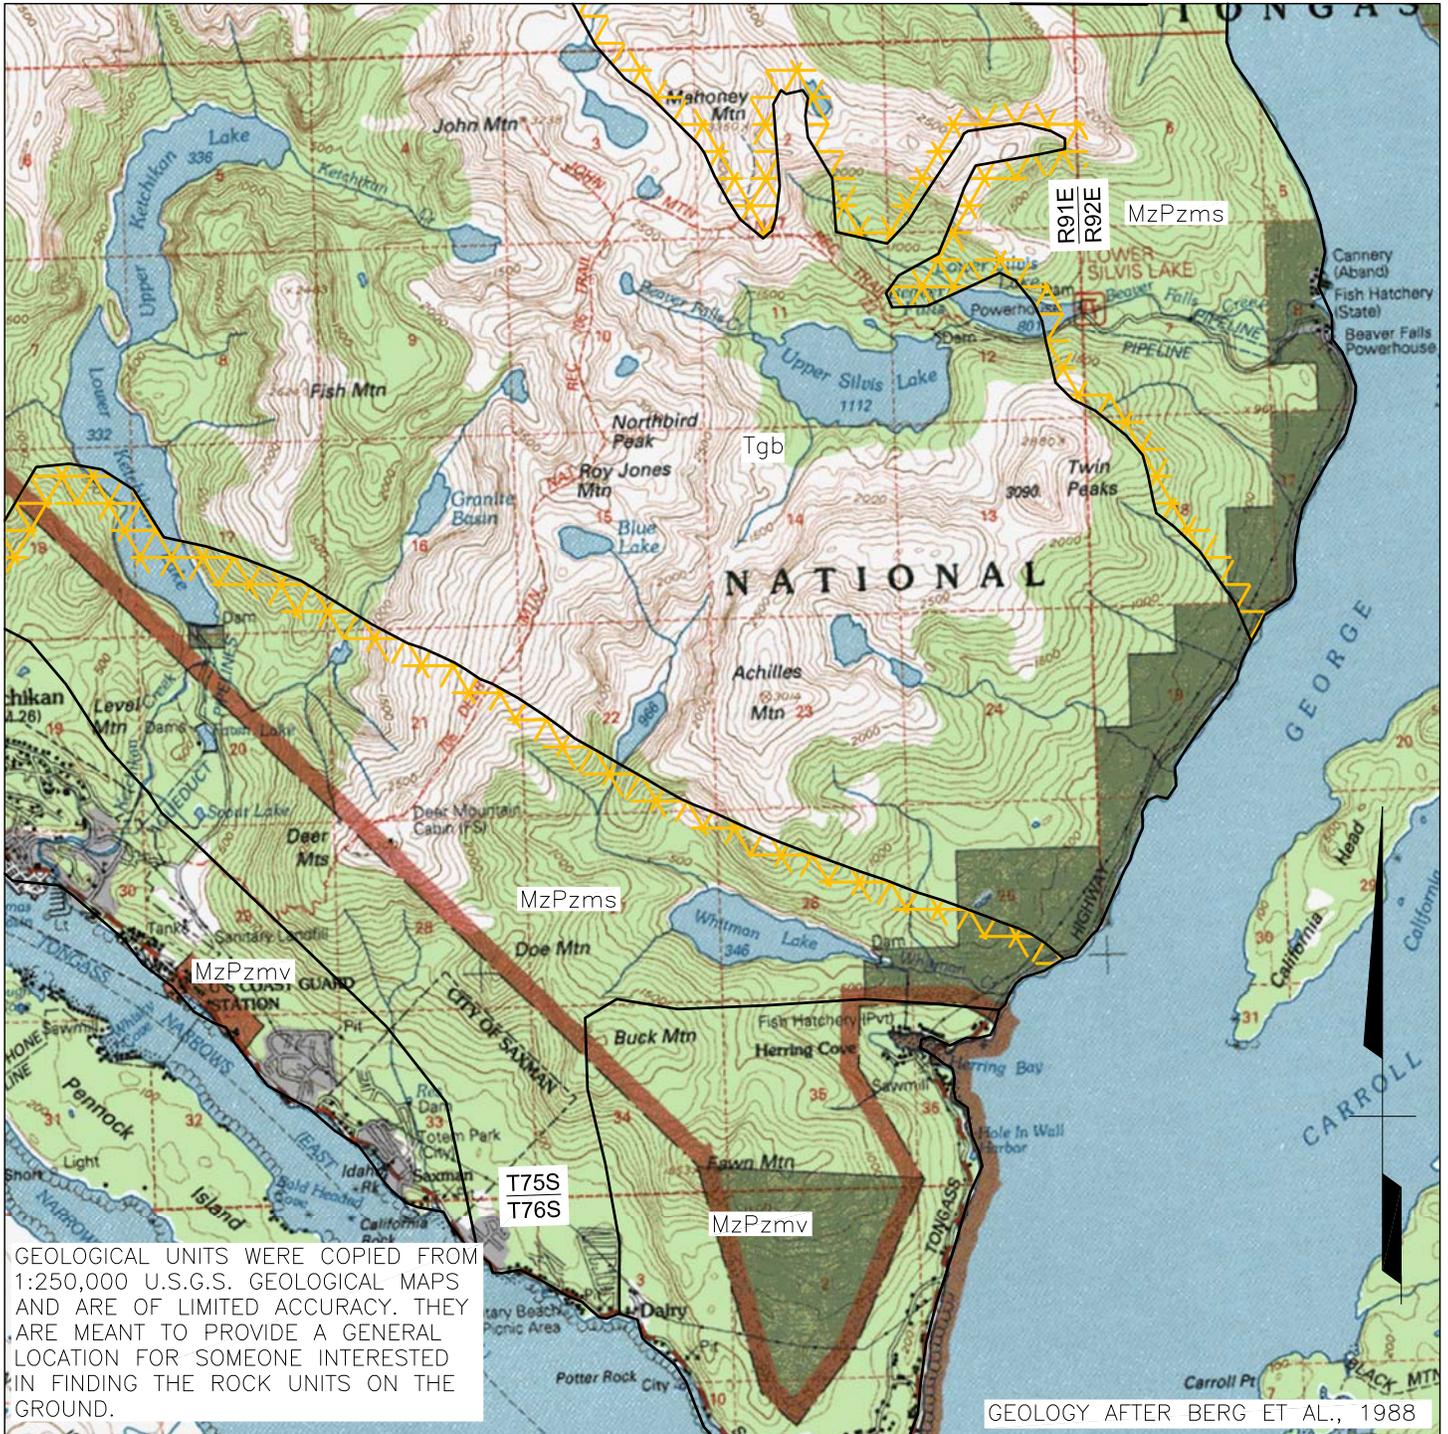
LOCATION MAP (HA-K1)

GEOLOGICAL UNITS WERE COPIED FROM 1:250,000 U.S.G.S. GEOLOGICAL MAPS AND ARE OF LIMITED ACCURACY. THEY ARE MEANT TO PROVIDE A GENERAL LOCATION FOR SOMEONE INTERESTED IN FINDING THE ROCK UNITS ON THE GROUND.

GEOLOGY AFTER BERG ET AL., 1988

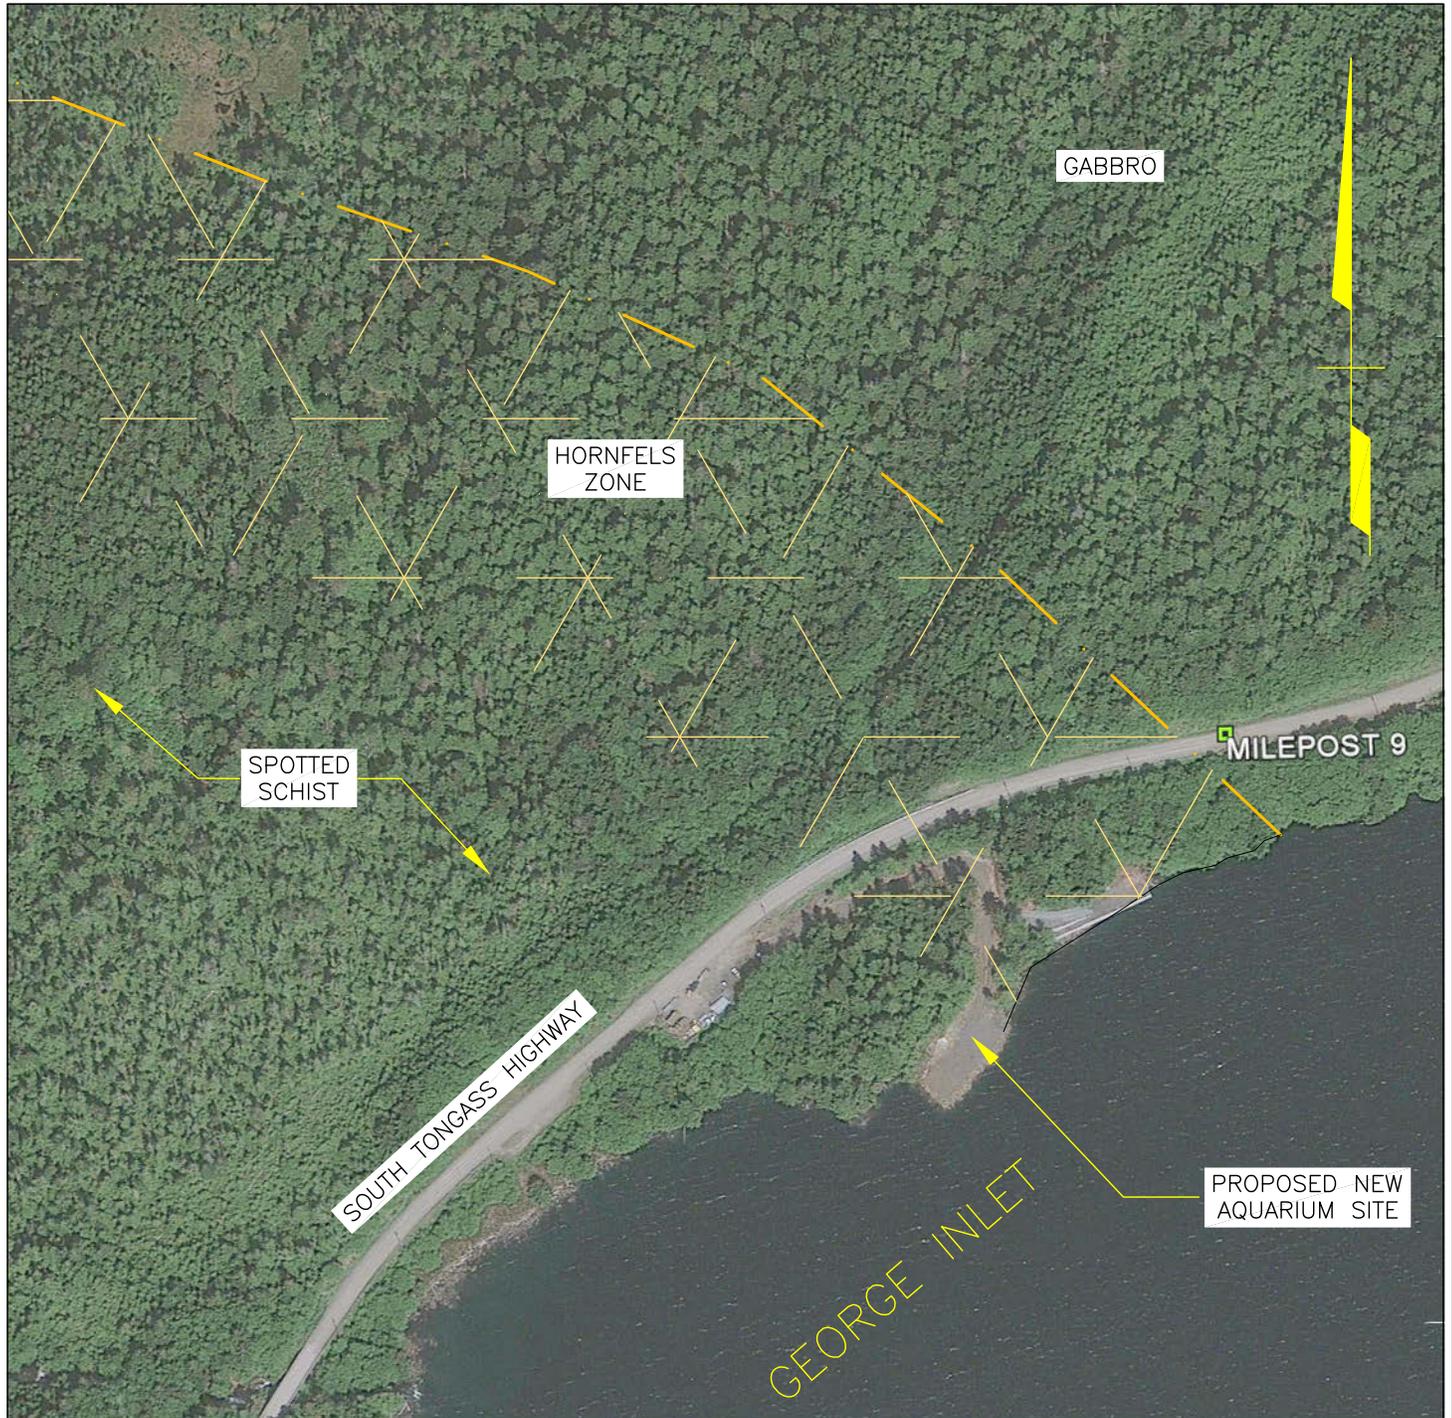
SITE MAP (HA-K1)

BASE MAP IS MAY 26, 2010 GEOEYE SATELLITE IMAGERY.
THIS IS A PLANNING DOCUMENT ONLY.

POTENTIAL HARD AGGREGATE SOURCE REVILLAGIGEDO ISLAND

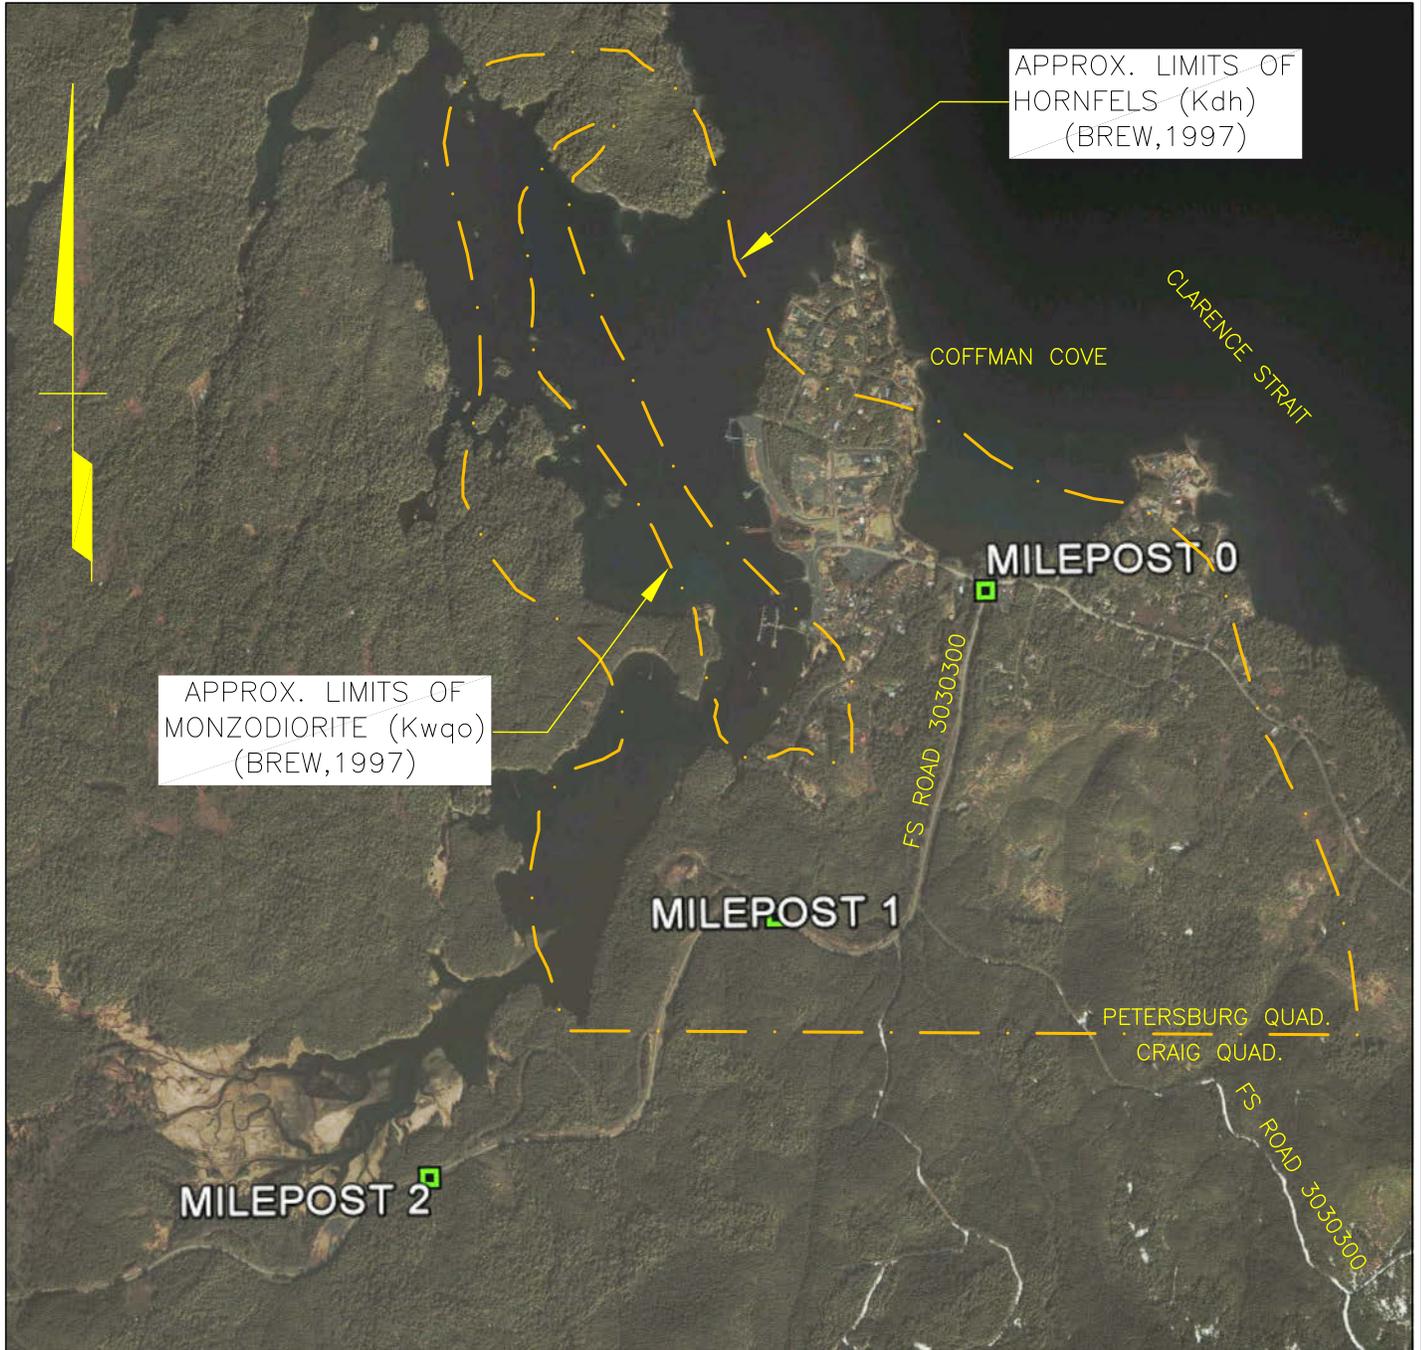
SITE MAP (HA-L1)

BASE MAP IS APRIL 15, 2012 DIGITALGLOBE SATELLITE IMAGERY.
THIS IS A PLANNING DOCUMENT ONLY.

POTENTIAL HARD AGGREGATE SOURCE PRINCE OF WALES ISLAND

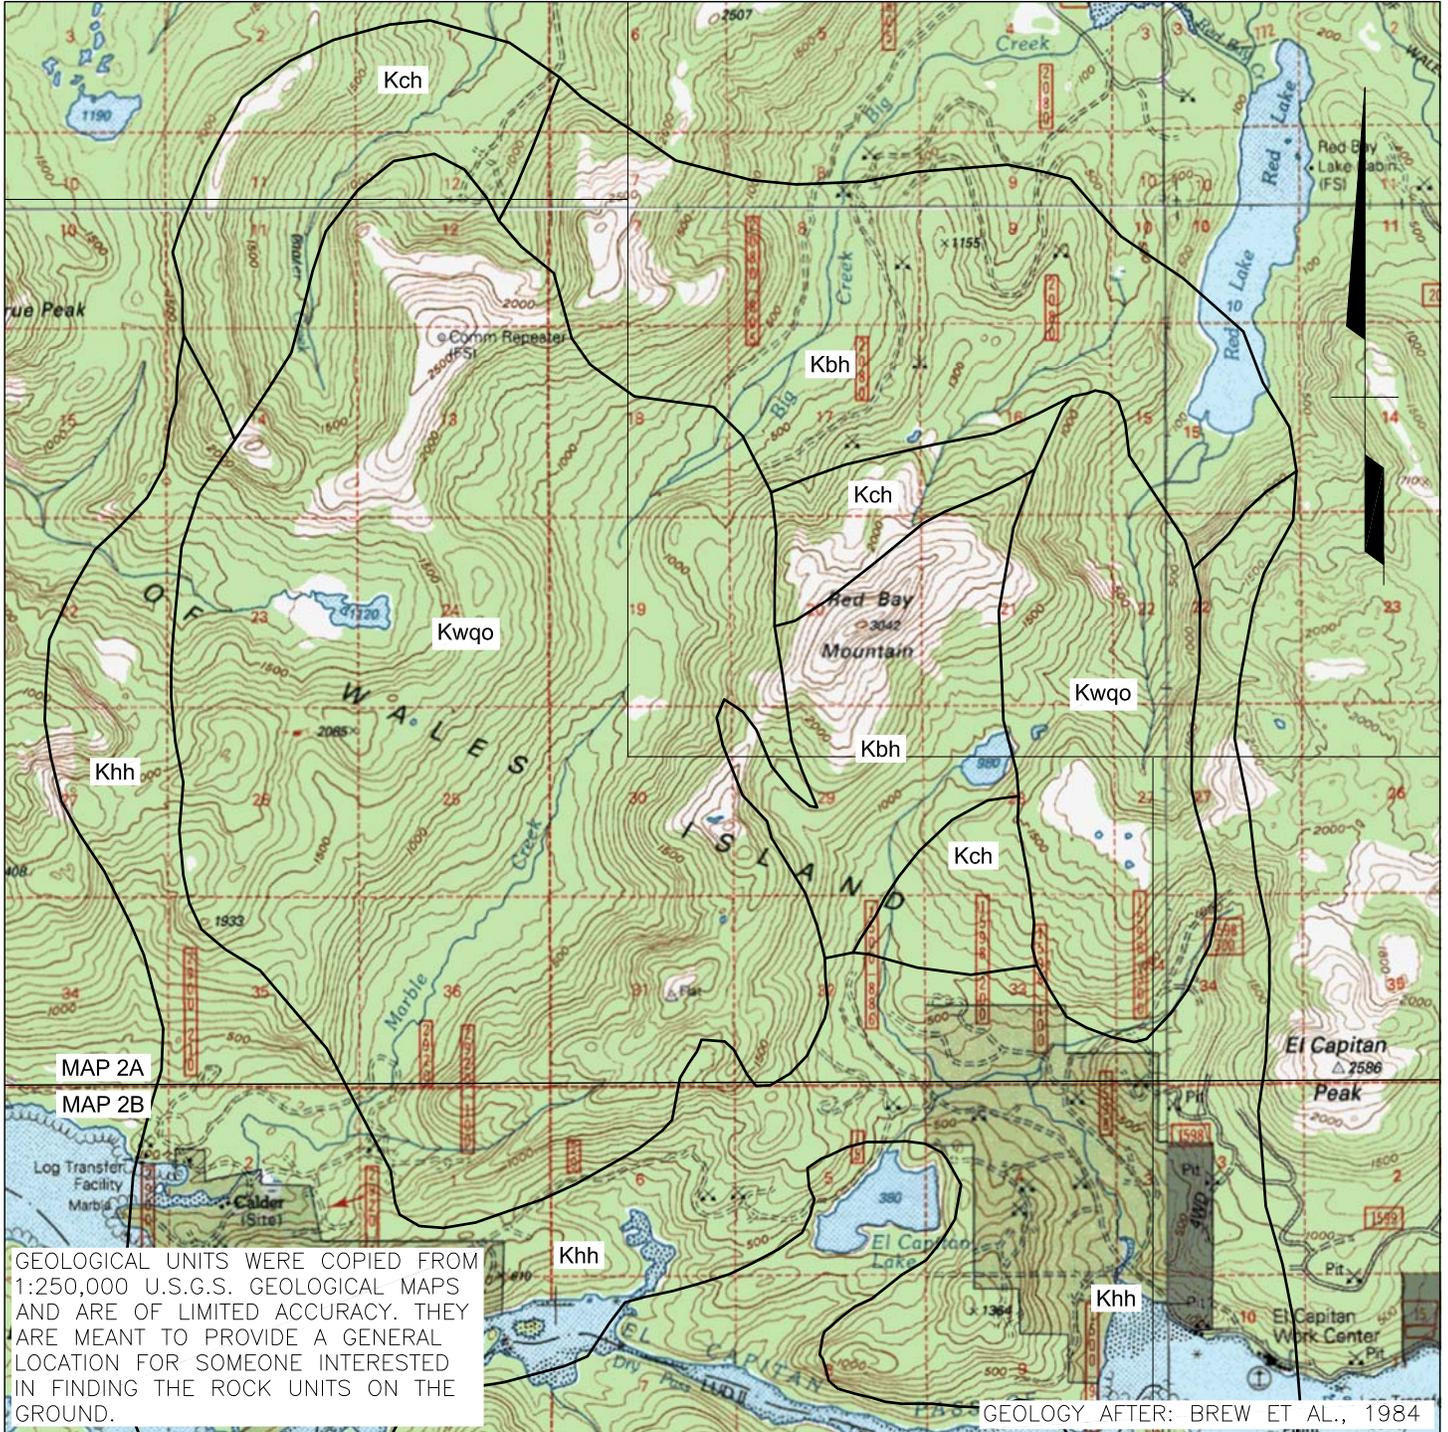
LOCATION MAP (HA-M1)

U.S.G.S. QUADRANGLE: PETERSBURG (A-4), (A-5), (B-4) & (B-5)

Kwqo-Monzodiorite
Khh-Marble
Kbh/Kch-Hornfels

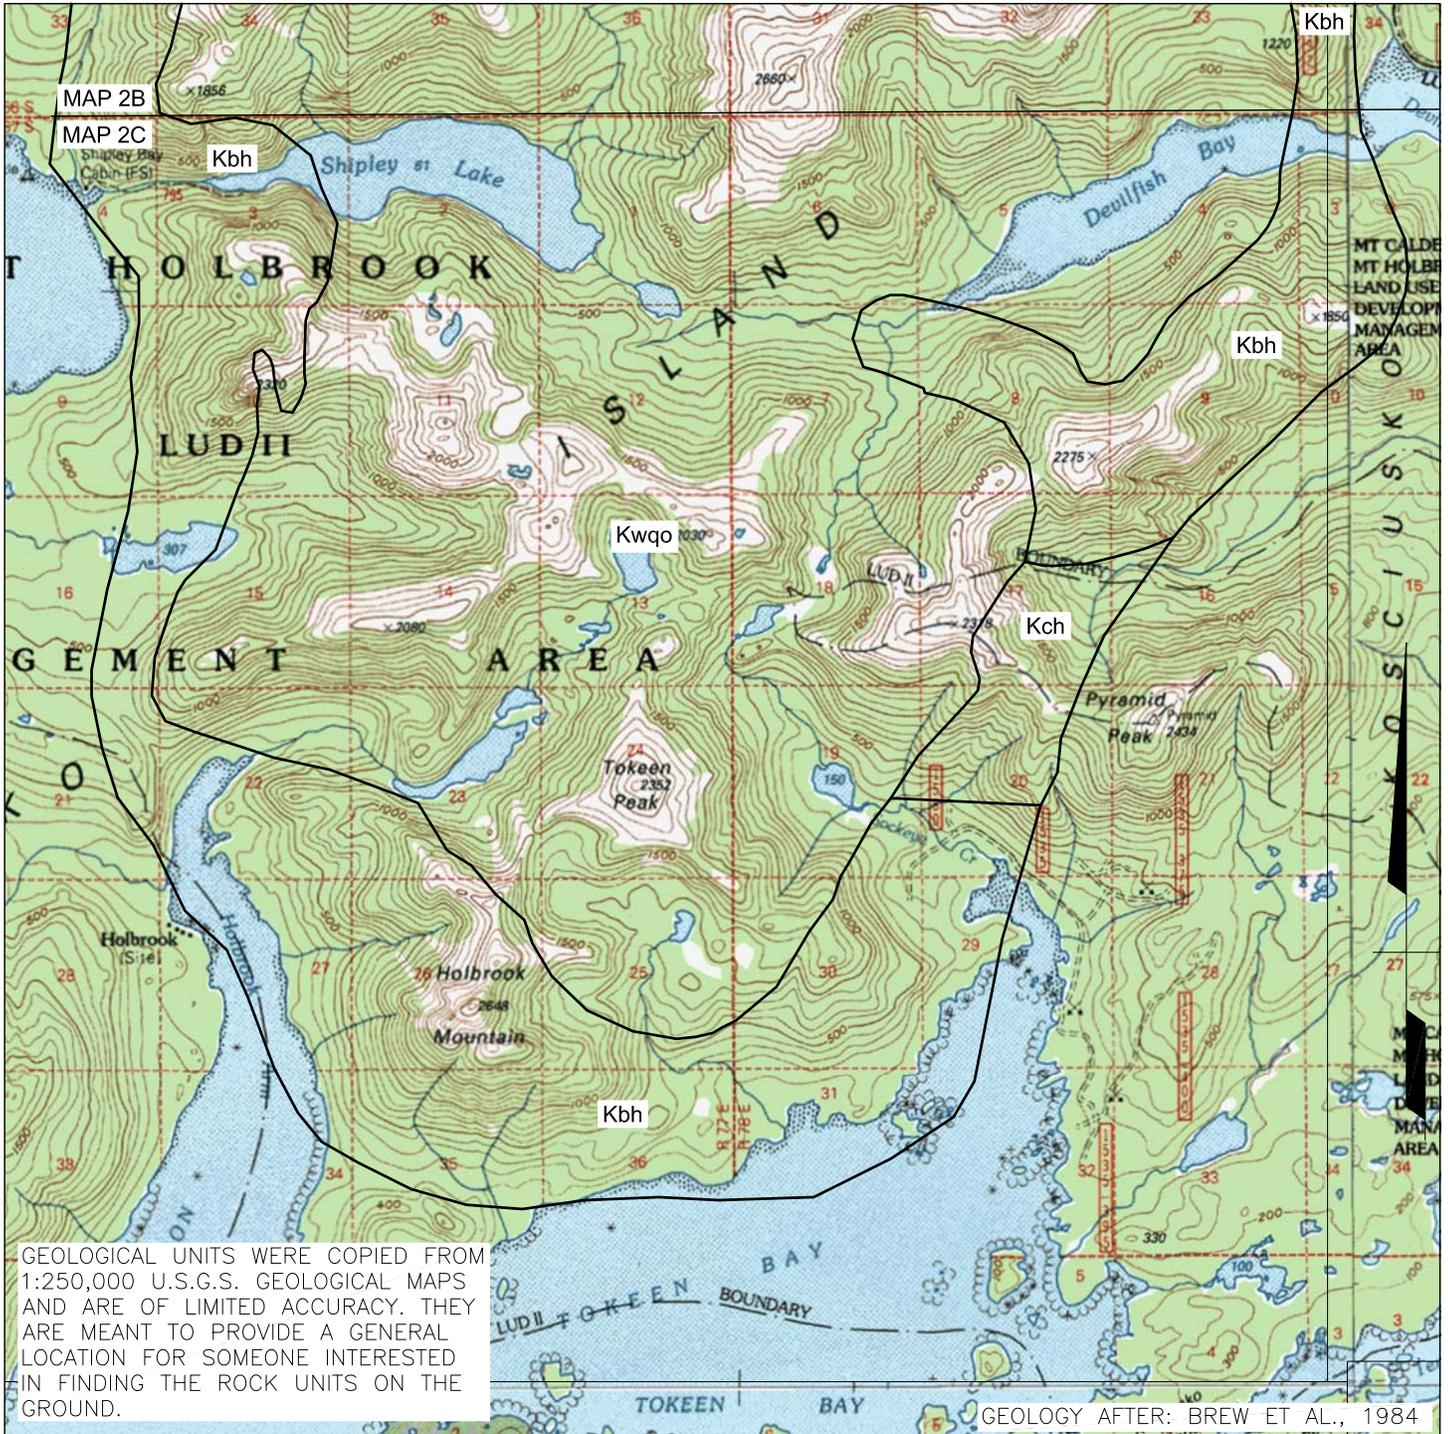
LOCATION MAP (HA-M2)

U.S.G.S. QUADRANGLE: PETERSBURG (A-4) & (A-5)
AND CRAIG (D-4) & (D-5)

Kwqo-Monzodiorite
Khh-Marble
Kbh/Kch-Hornfels
