Alaska Department of Transportation  
and Public Facilities

# 2012 Alaska Pavement Report

October 2012

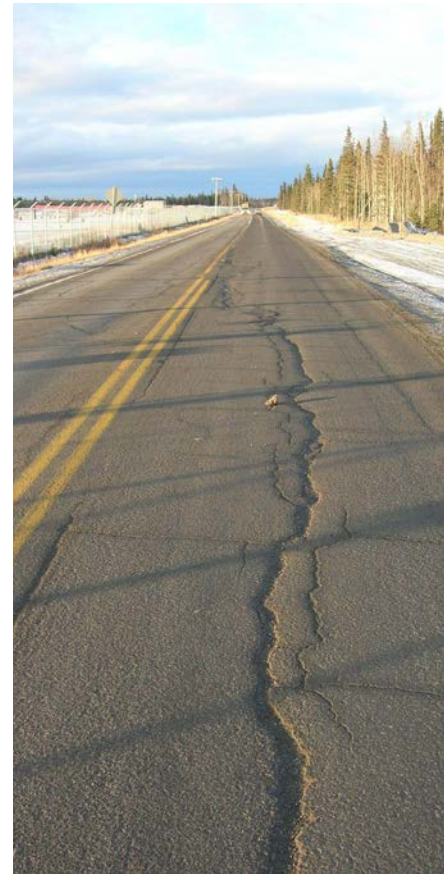
*Cracking on the Funny River Road; photo by Jim Horn, ADOT&PF*

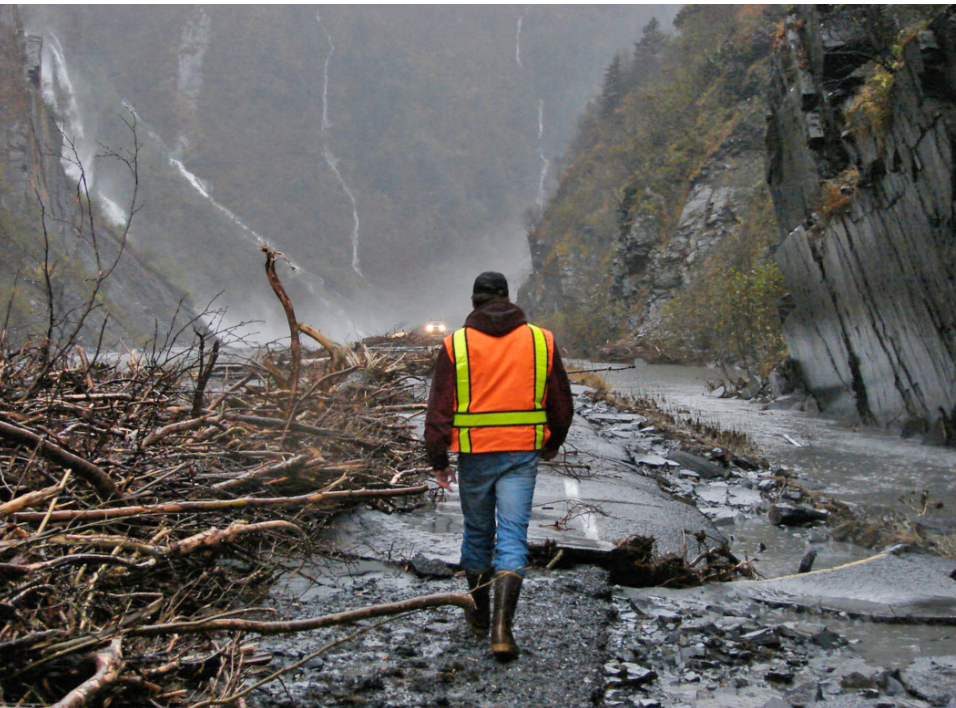
Flood Damage on the Richardson Highway; photo by Mike Coffey ADOT&PF

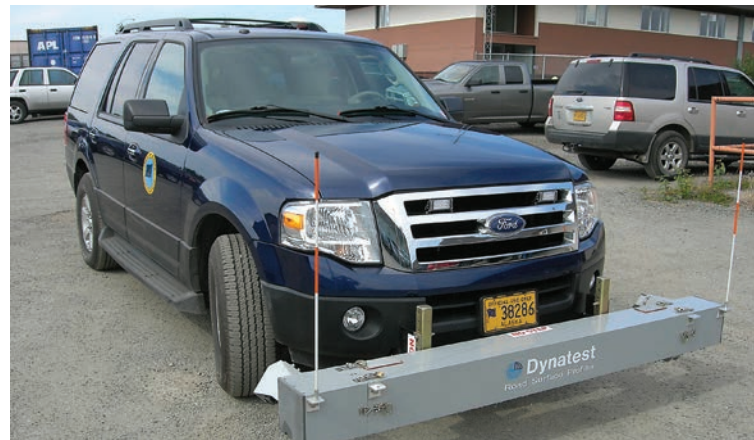
Road Surface Profiler; photo by Jim Horn ADOT&PF

The department collects data under a contract with Dynatest Consulting, Inc., using Road Surface Profiling (RSP) equipment. The collected highway surface data is downloaded to the Performance and Economic Rating System (PERS) software, then uploaded to the Department's Pavement Management System database, along with up-to-date traffic information and new construction and repair information. PERS stores the data for every section of Alaska's road network. A typical section is 1-mile in length, but may be longer or shorter depending on roadway structural differences or physical boundaries such as bridges. Examples of the types of data stored in PERS are:

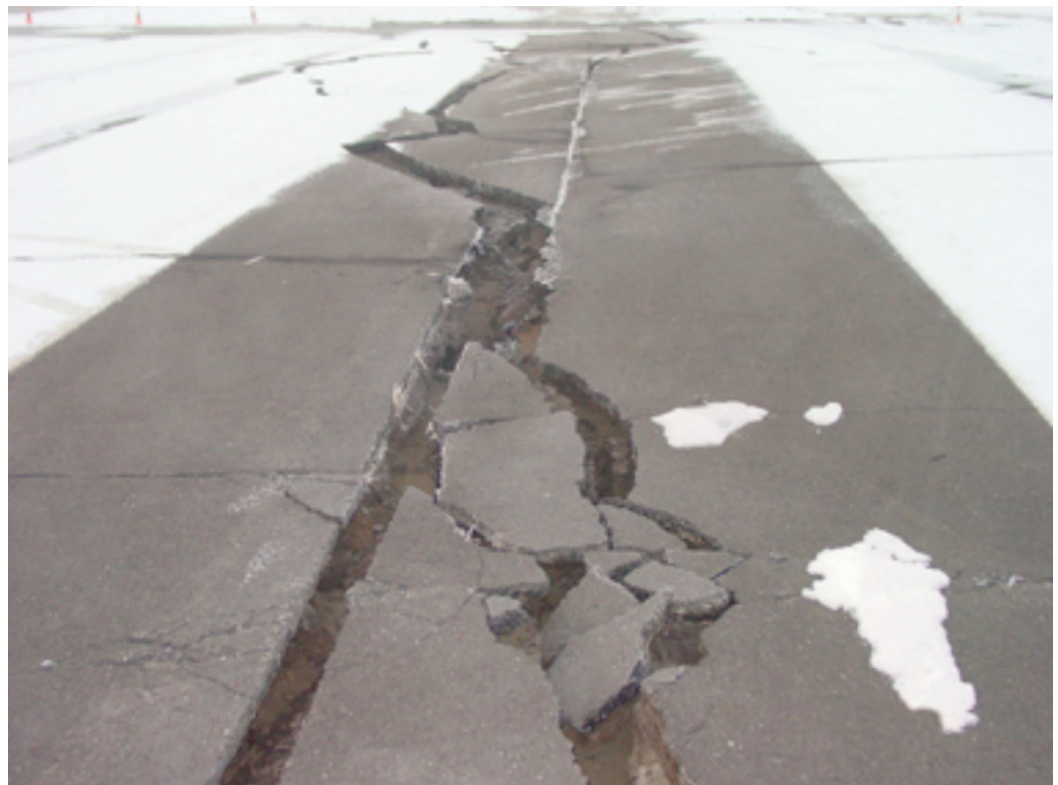
Earthquake Damage at the Northway Airport; photo courtesy of the Federal Highway Administration

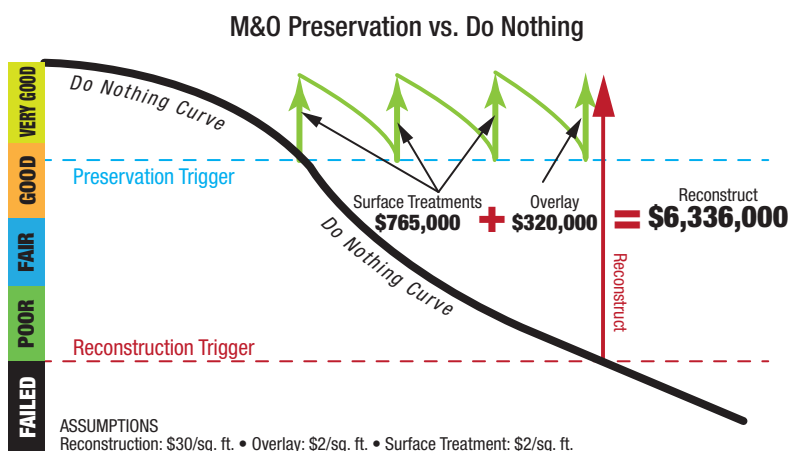
The advantage of implementing an asset management program for preserving highway and airfield pavements is apparent in Figure 14. As the graph shows, a preservation-based approach, where pavements are preserved through early surface treatments, provides considerable cost efficiencies compared to the more traditional “worst first” approach, where pavements deteriorate to a degree that more expensive remediation, or even reconstruction, is required.

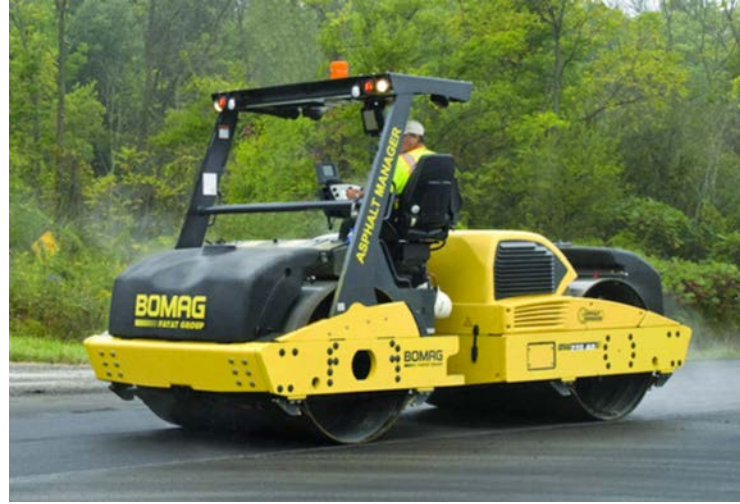
*A new generation of "intelligent" compactors will improve work quality and lead to longer-lasting pavements. A compactor can now be equipped with a GPS unit and with sensors that continually read the level of compaction of the asphalt mix. With this technology, the operator can view a color-coded graphic image that locates portions of the pavement where compaction meets specifications and where additional compaction is needed. This reduces both equipment and operator time while providing for optimal compaction and longer pavement life.*

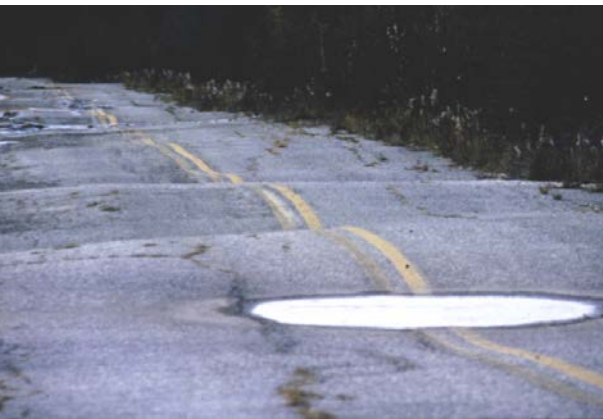
*Effects of Permafrost on the Road Surface  
Photo by Mike Coffey ADOT&PF*

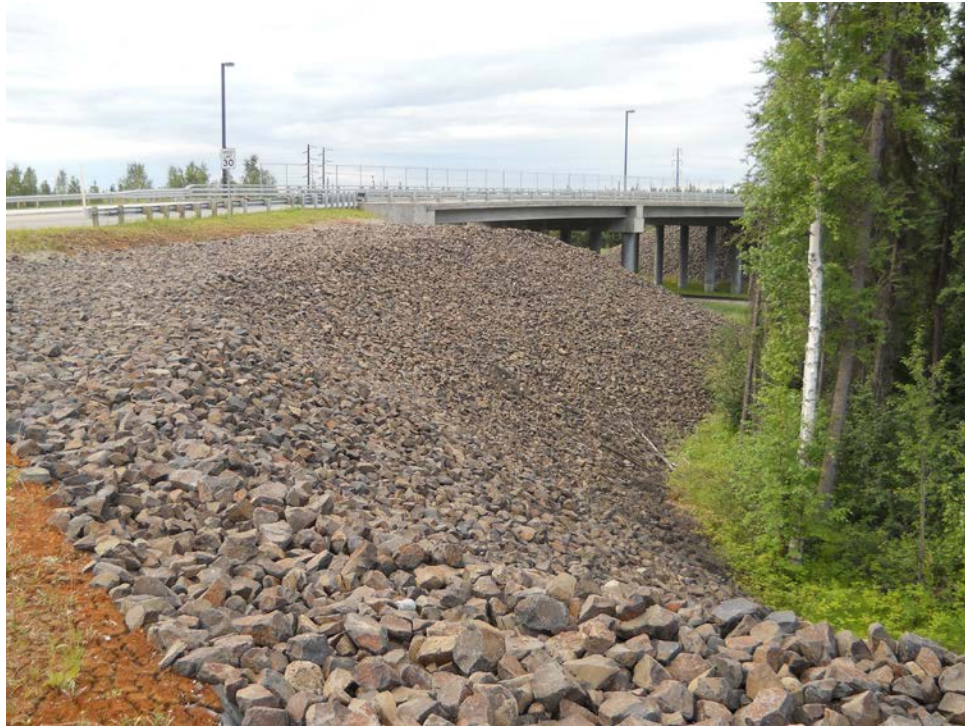
*Air Conditioned Embankment, Thompson Drive, Fairbanks, photo by Jeff Currey, ADOT&PF*

***An “air convection embankment,” like that of Fairbank’s Thompson Drive (above), uses large sized rock to allow air to circulate. The system design promotes vigorous air circulation during the low temperatures of winter. The net effect is an enhanced cooling of the permafrost layer below the surface. Supplying enhanced cooling during winter months enables the permafrost to survive the warm summer period without melting.***

thicker embankments and/or insulation and supercooling, using either thermosyphons or Air Convection Embankments (see caption at right). The department performs thermal modeling using a computer program called TEMP/W to determine embankment thicknesses necessary to prevent seasonal thawing into the permafrost sub-grade.

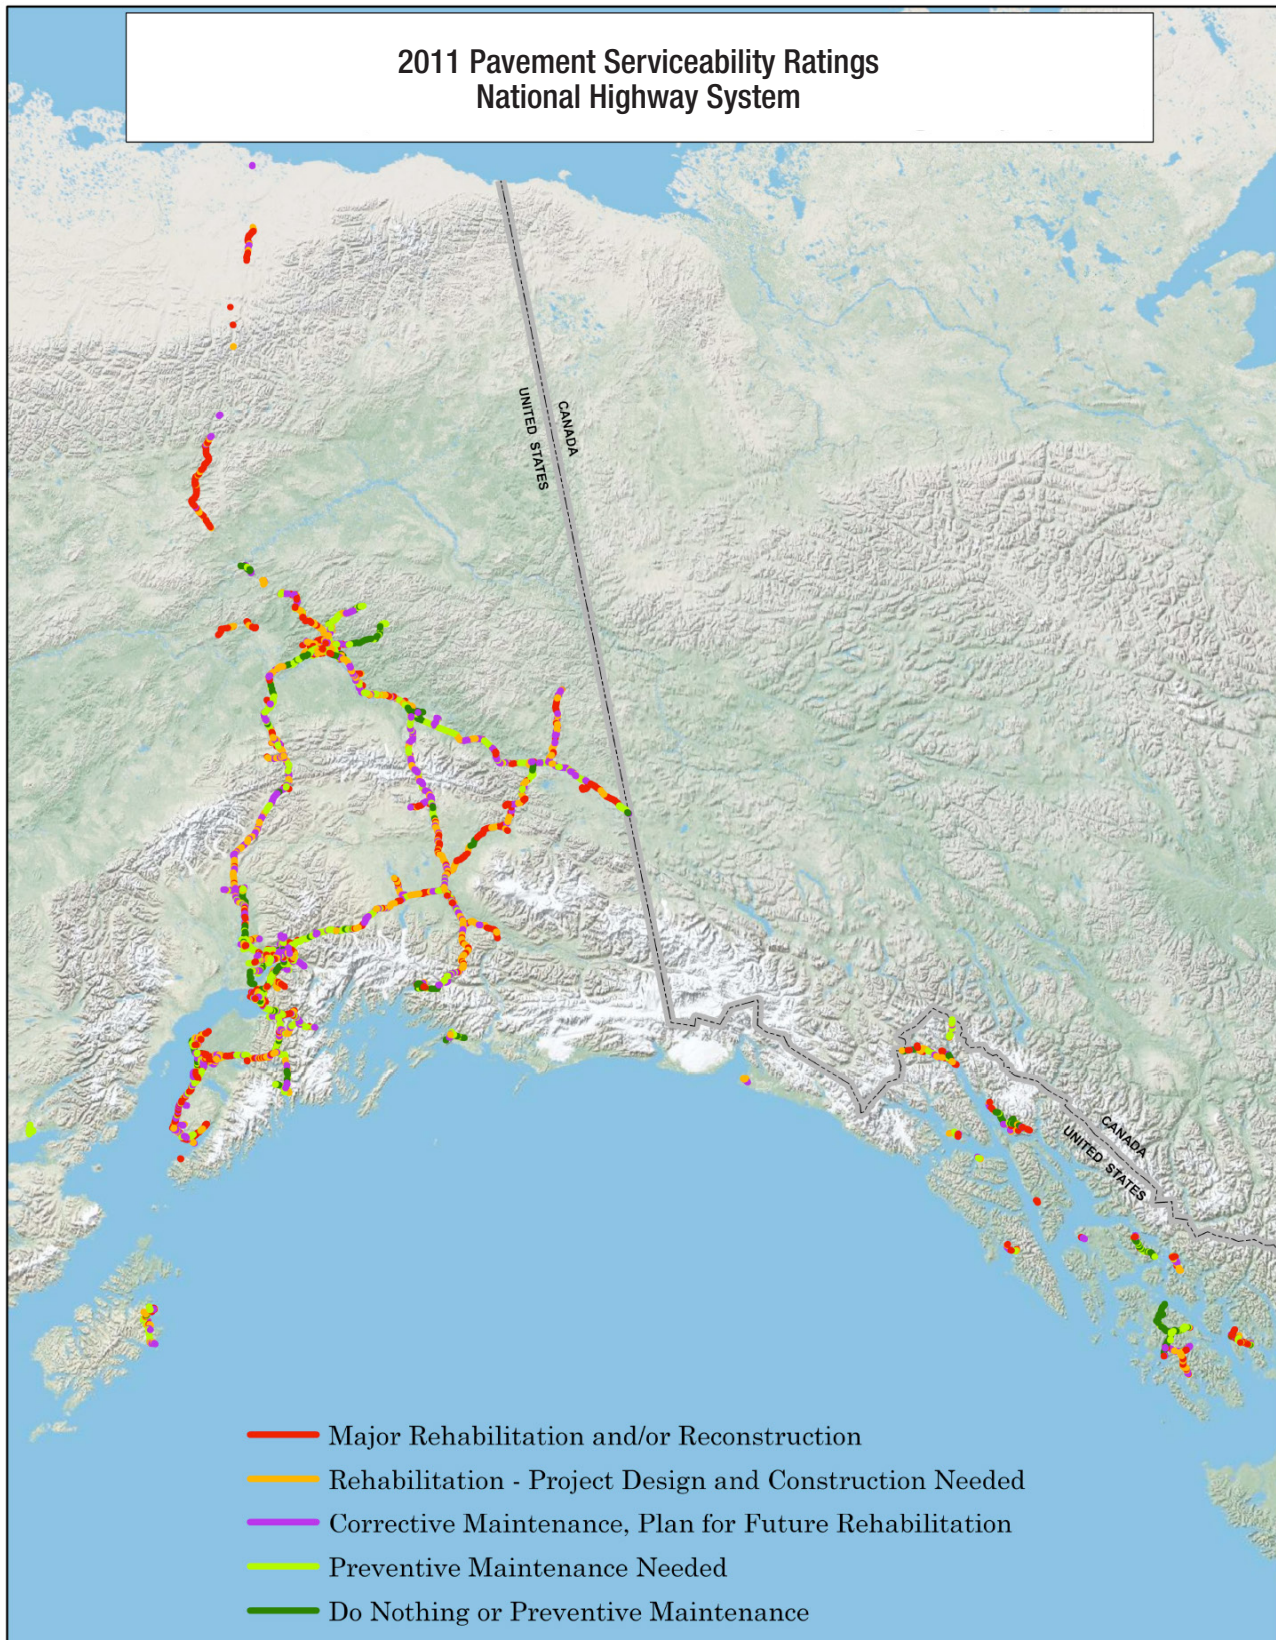
## Appendix B

PSR data has been digitized and is now displayed graphically using Google Earth.™ Appendix B displays a map showing the 2011 pavement serviceability ratings on the state's National and Alaska Highway systems. The PSR ratings may also be viewed at <http://www.dot.state.ak.us/stwdmno/pvmtmgt/>, then clicking on the "2011 PSR" link.

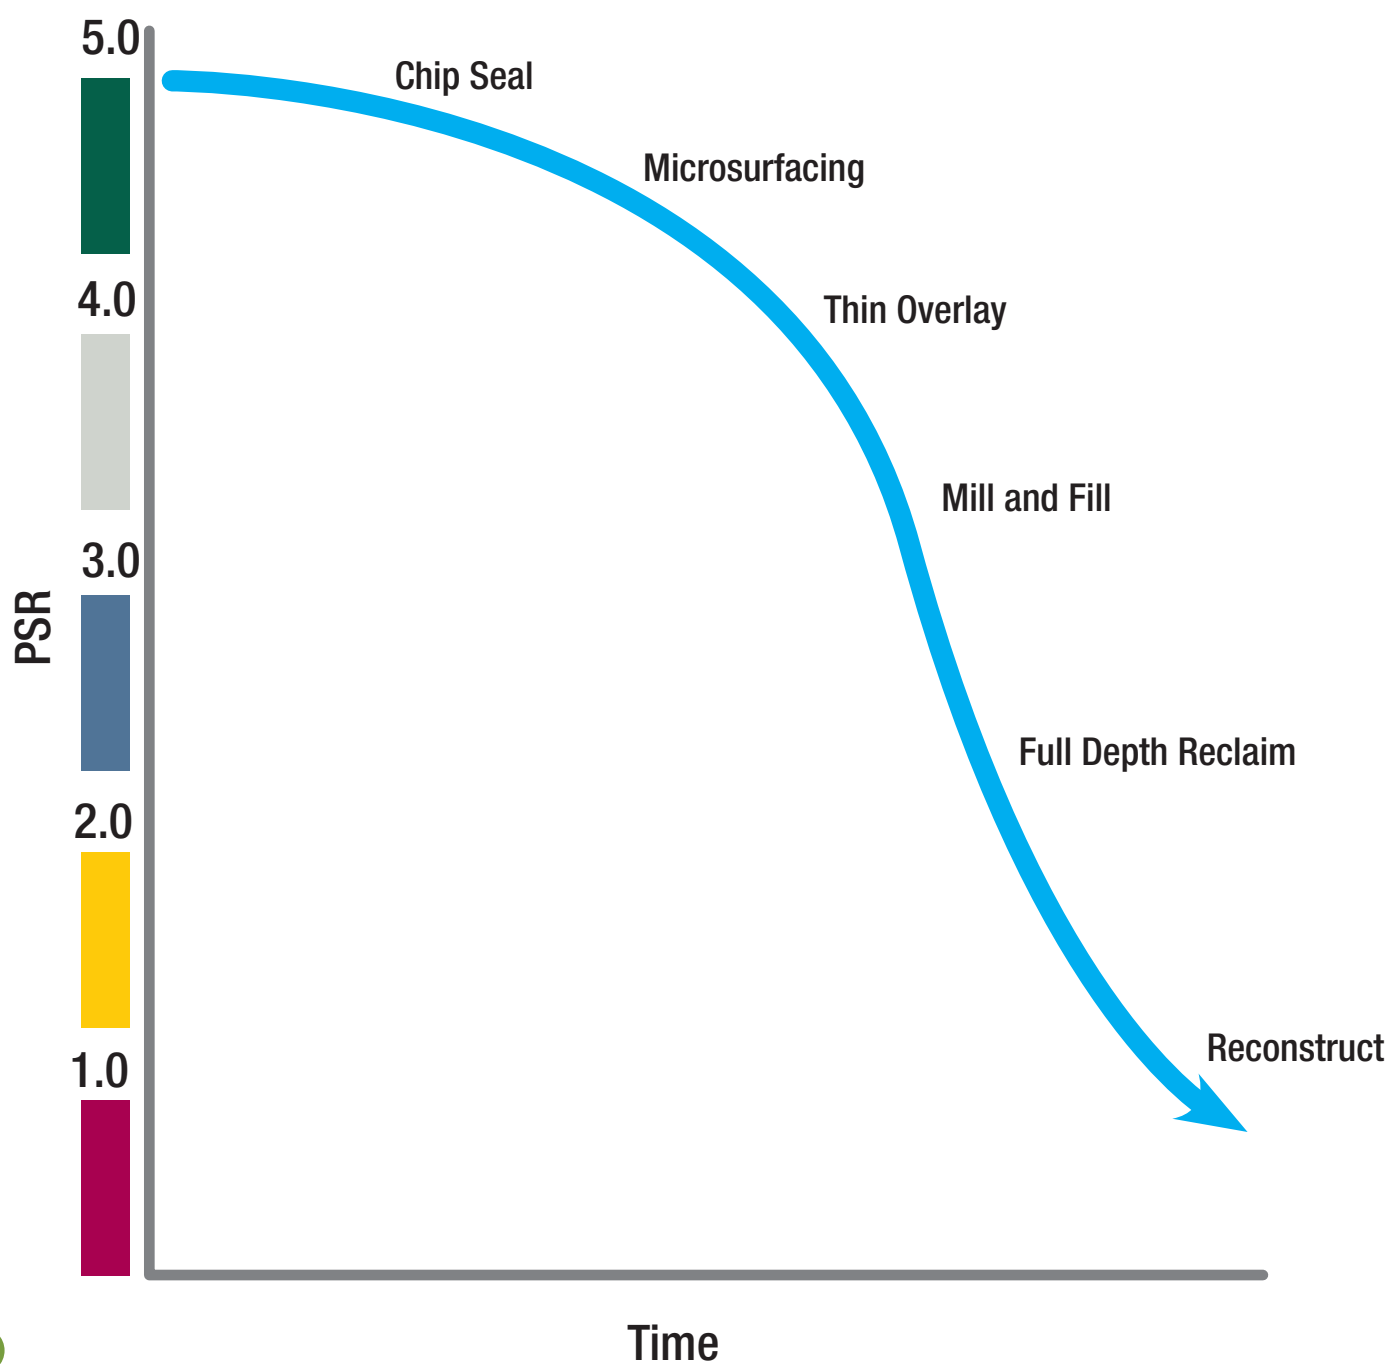
## Appendix C

### Recommended Treatment per Pavement Serviceability Rating (PSR) Level

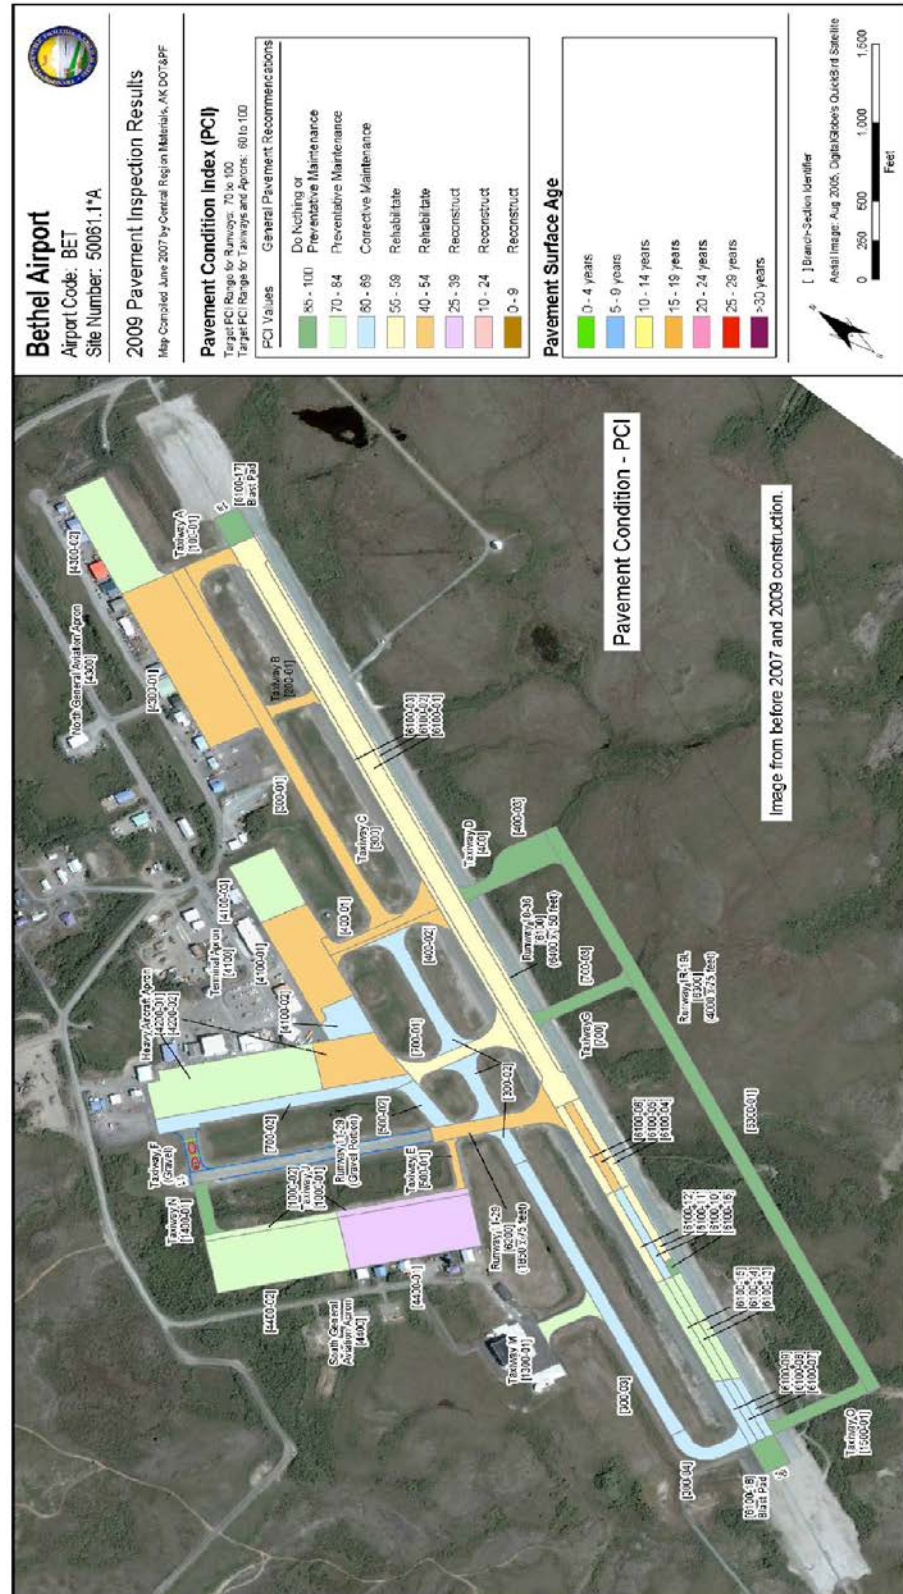
# Appendix E

## Bethel Airport Pavement Condition Index 2009
