HISTORY OF AVALANCHE WORK ON THE SEWARD HIGHWAY

Matt Murphy

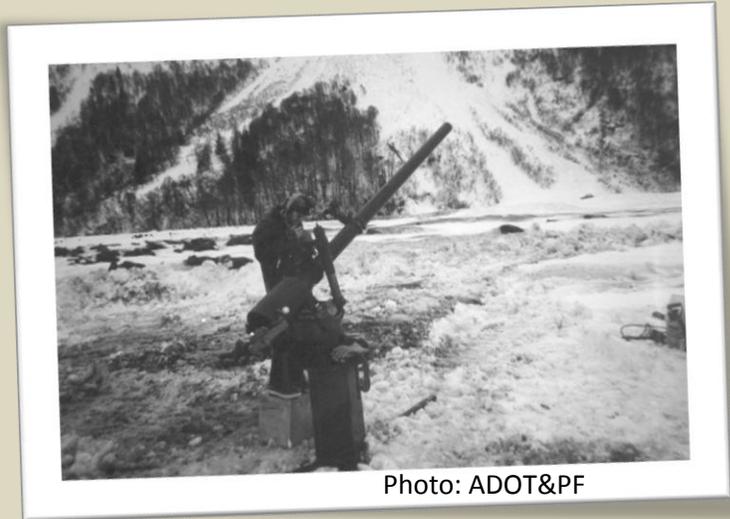
Photo: ADOT&PF

Between the years 1955-1968, the U.S. Army proved to be very cooperative for artillery support for avalanche blasting, but there were certain limitations making it difficult for the Department of Highways to have immediate access to artillery during avalanche cycles. In 1969, The Department of Highways entered an agreement with the United States Forest Service to lease a 75mm Recoilless Rifle from the U.S. Army for highway avalanche control work.

At the time, the U.S. Forest Service was the only civilian agency in the United States that was allowed to use military weapons leased from the U.S. Army for the purpose of avalanche control. Primarily, the USFS used artillery for ski resort avalanche operations, but the Alaska Department of Highways was able get assistance from the USFS for avalanche work for the Seward Highway. Between 1969 and 1975 U.S. Forest Service employees fired this weapon for the Department of Highways; but similar to the Army, there were problems with immediate access to personnel and artillery. This affected the efficient timing of shooting, and did not produce the most desirable avalanche hazard reduction results. (Hamre, 1979)

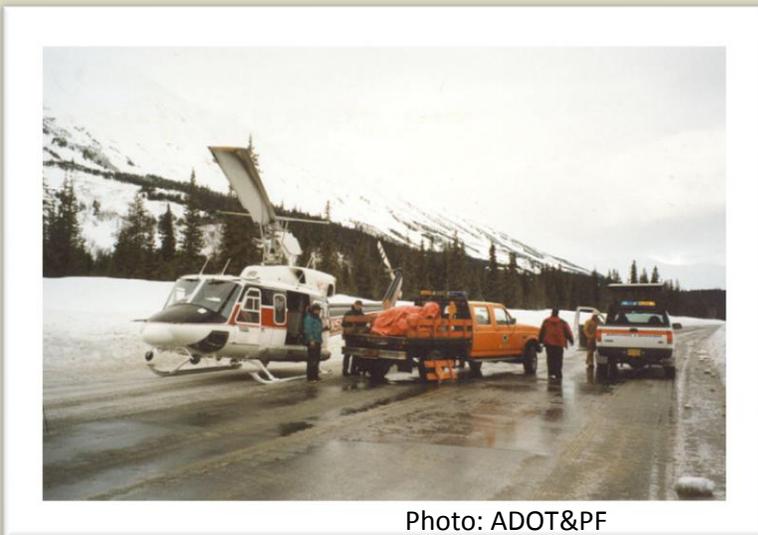
Photo: ADOT&PF

Also during the mid to late 1970's, helicopter delivery of explosives was used for the Seward Highway.

This method is cost effective and it is still used occasionally; however, it is limited to periods of good weather, which does not always coincide with when the snowpack is most receptive to explosives. Helicopters were used almost exclusively during a massive avalanche cycle in March 1979 (Hamre, 1979). It is a valuable supplement for explosive avalanche work, but artillery is still the primary

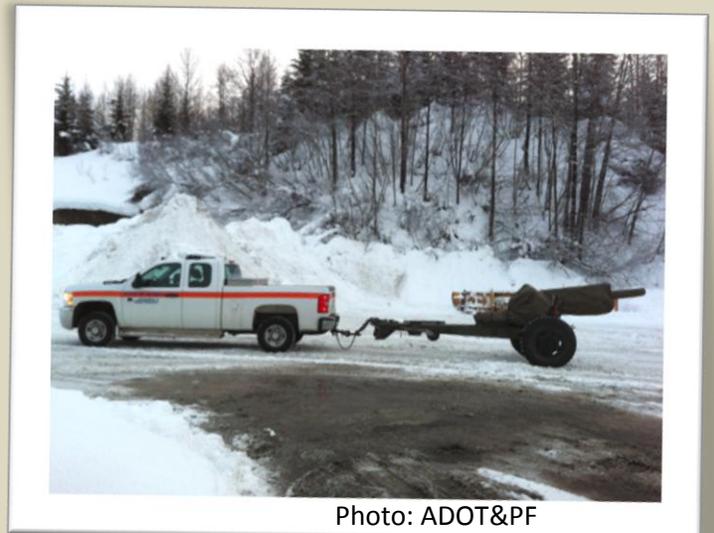
Photo: ADOT&PF

1999 also started the transition from the 105mm Recoilless Rifle to the M101A1 105mm Howitzer for avalanche work. Ammunition availability and replacement parts for the Recoilless Rifles started to arise in the early 1990's; so, a suitable replacement was needed. The M101A1 Howitzer was agreed upon as the next weapon of choice for avalanche operations by the U.S. Army and avalanche artillery users. Presently, ADOT&PF uses 2 howitzers and the Alaska Railroad Corporation uses one of their howitzers at 8 different gun mounts to shoot the highest frequency avalanche paths along the Seward Highway between mileposts 21-99.
