**ALASKA DEPARTMENT OF TRANSPORTATION**

**Evaluation of Bioengineered Stream Bank  
Stabilization in Alaska**

**Date** June 2003

FHWA-AK-RD-03-03

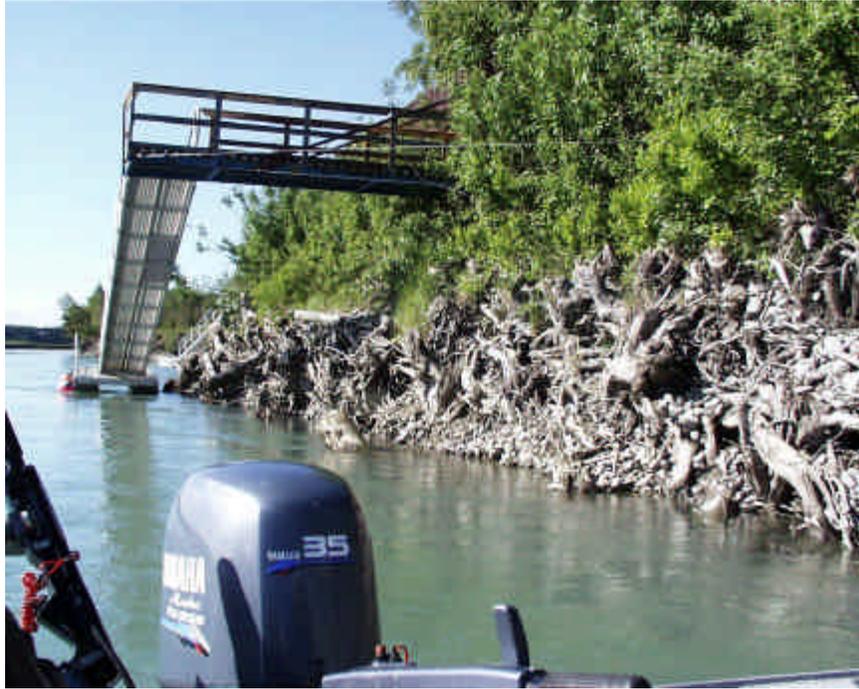
The HEC-RAS analysis for this site shows low to moderate ratios of average to critical shear stress. For example, the average to critical ratios for bed and bank shear stress for the October 31, 2002 discharge of 23,100 cfs are 0.55 and 0.80, indicating low potential for bed or bank channel erosion. Hydraulic modeling at this BECS is complicated by the fact that the structure is located within the intertidal zone. However, velocity profile measurements made during the first two hours of the outflow of a 24-foot high tide show low water velocities within the willow plants extending from the top of the root wad structure. The BECS is in good condition, and appears to be structurally intact after 7 years of operation (Figure 9).

Figure 9. Root wads at Kenai River-Riddles.

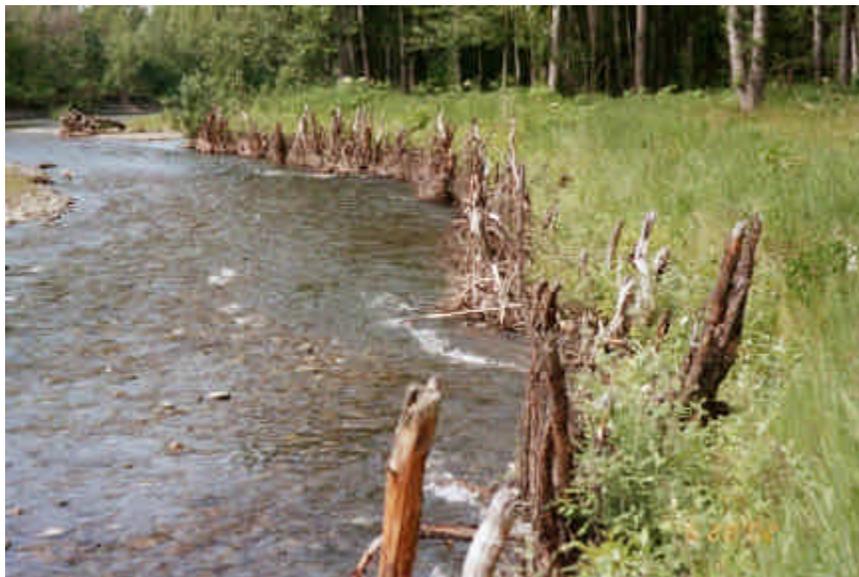
The HEC-RAS analysis for the Cottonwood Park site shows low potential for bed erosion, and slightly higher potential for bank erosion. The average to critical shear stress ratios for bed and bank for the largest flood of project life (826 cfs) are 0.60 and 0.98. However, the average to critical bank shear stress ratios for the 50-year and 100-year flood events are 1.30 and 1.35, indicating some potential for bank erosion at larger flows. The structure is in good condition (Figure 10). The structure is only a few years old and has not been subjected to flows above the 2-year flood to date.

Figure 10. Root wads/brush layering at Ship Creek-Cottonwood Park.

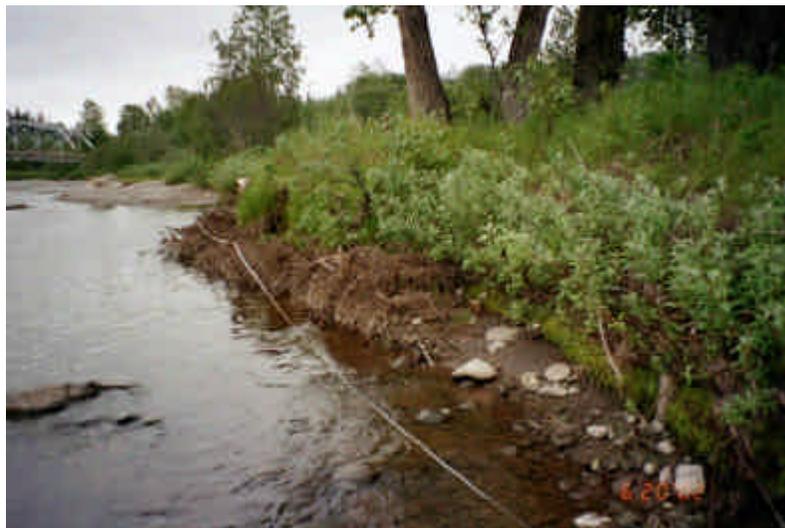
This site was completely inundated by flooding conditions during fall 2002.

Figure 14. Anchor River at Silverking Campground, looking upstream (06/20/2003).

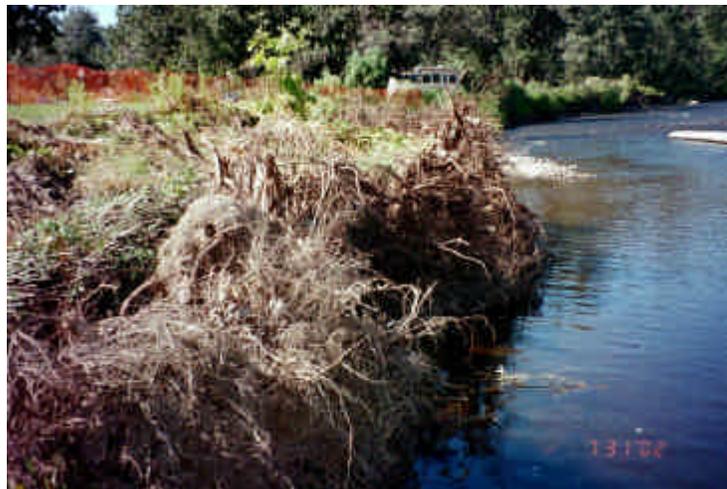
This site was completely inundated by flooding conditions during fall 2002.

Figure 15. Anchor River at Steelhead Campground, looking downstream (07/31/2003).

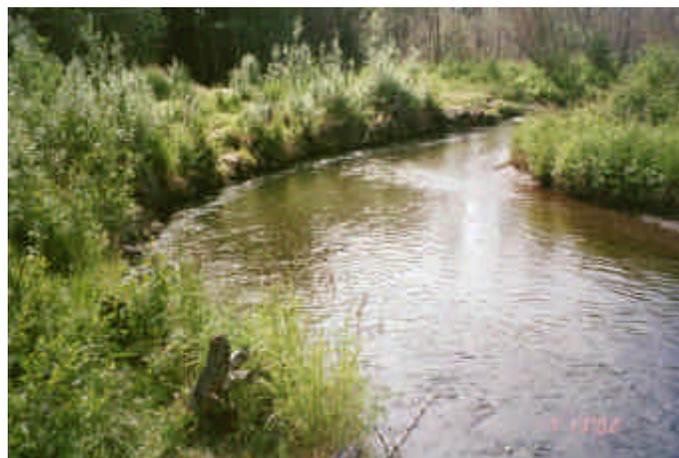
Figure 16. Campbell Creek near Taku Park (07/13/2003).

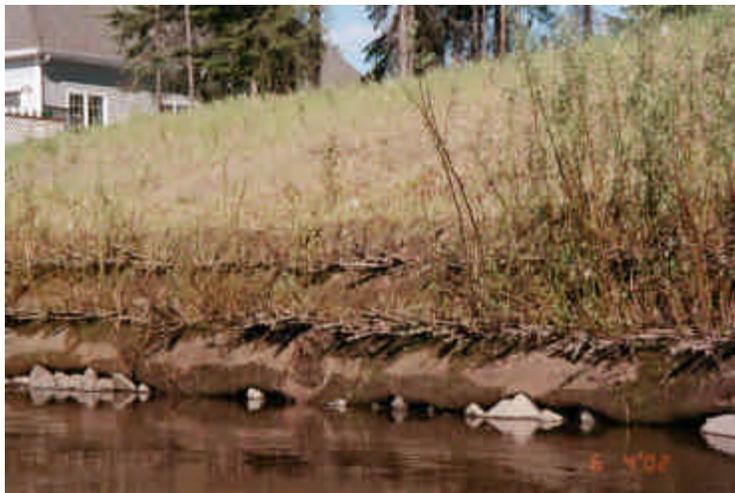
Figure 17. Chena River at Doyon Estates (06/04/2003).

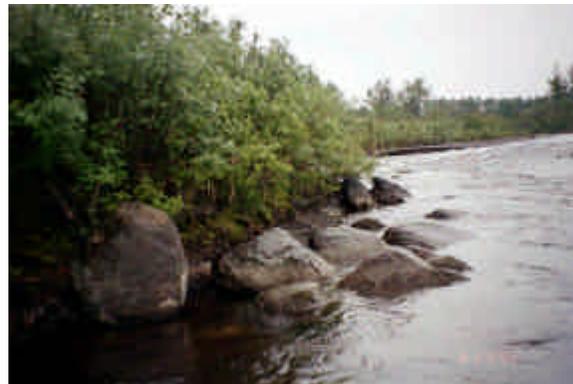
Figure 18. Deep Creek, looking upstream (06/23/2003).

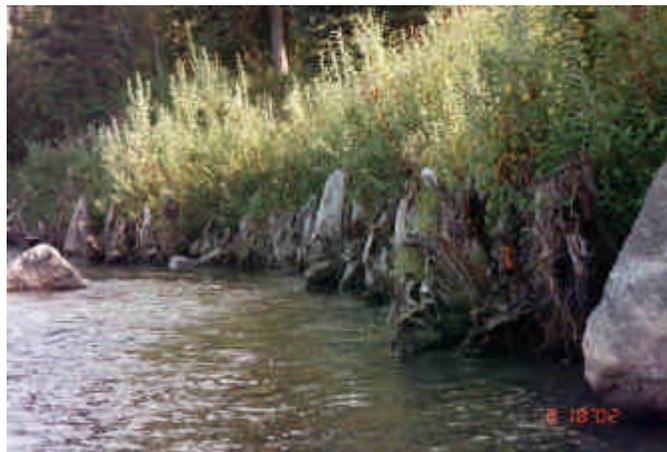
Though four fabric-encapsulated soil lifts layered with willow were shown on the design document, only two or three were observed. The lifts were constructed using a wrap mat, made of woven coir fiber twine, and an inner liner mat, made of biodegradable natural coconut coir fiber. Live cut willow stalks, at least 4 feet long, were placed on top of the soil lifts; the design documents specified a density of 25 branches per linear yard.

Figure 19. Kenai River at Centennial Park (08/18/2003)

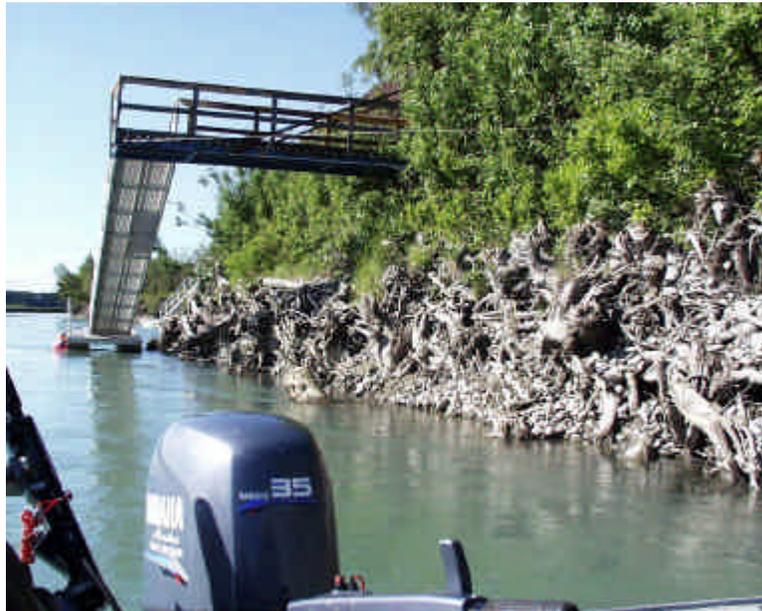
Figure 20. Kenai River at Riddles property (06/22/2003).

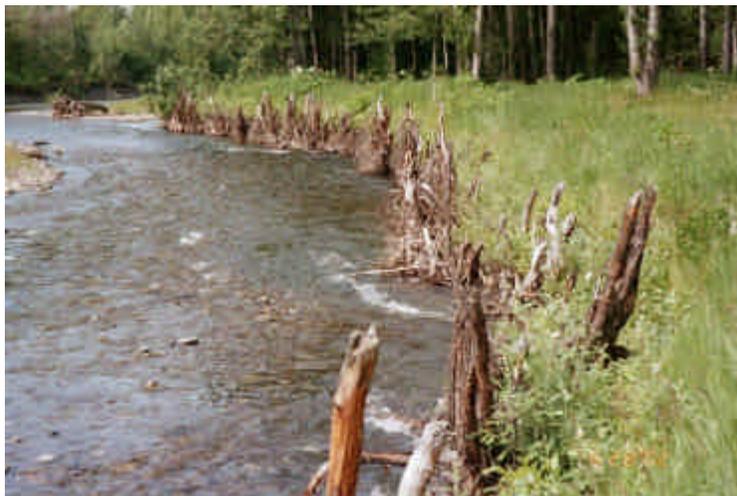
Figure 21. Ship Creek at Cottonwood Park (06/28/2003).

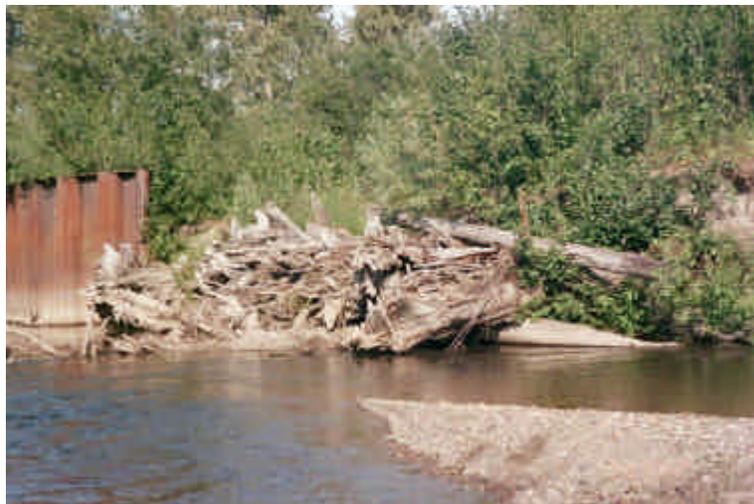
Figure 22. Theodore River (07/27/2003).

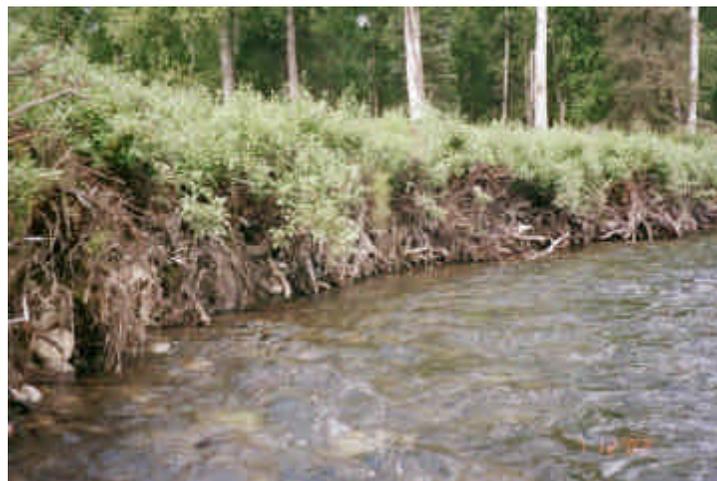
Figure 23. Willow Creek at Lapham property (07/12/2003).

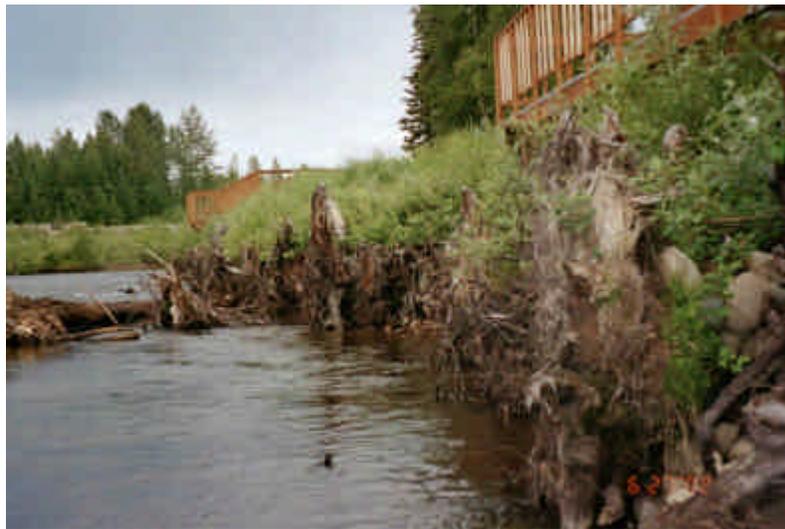
Figure 24. Willow Creek at Pioneer Lodge, looking upstream (06/27/2003).
